Turkey Creek			wa-1028-001		Severity Score 4.75	
<u>Common:</u> 7mi N of Mossy Head <u>Drainage:</u> Shoal River <u>GPS:</u> 30.849801722, -86.25527761 <u>Land owner:</u> Martha Pridgen			<u>County:</u> Walton <u>PLSS(T-R-S):</u> 4N-20W-16 <u>Parcel No.:</u> 4		<u>State:</u> Florida

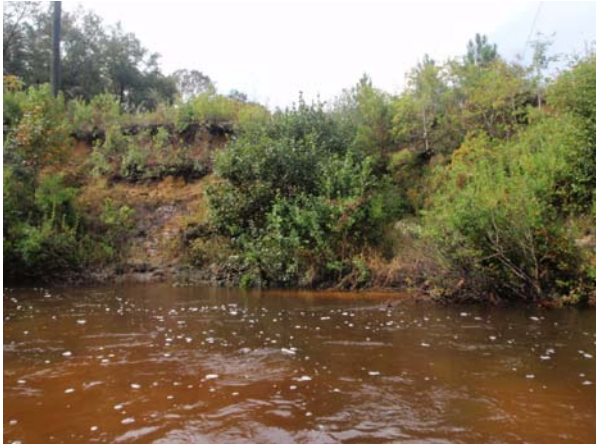
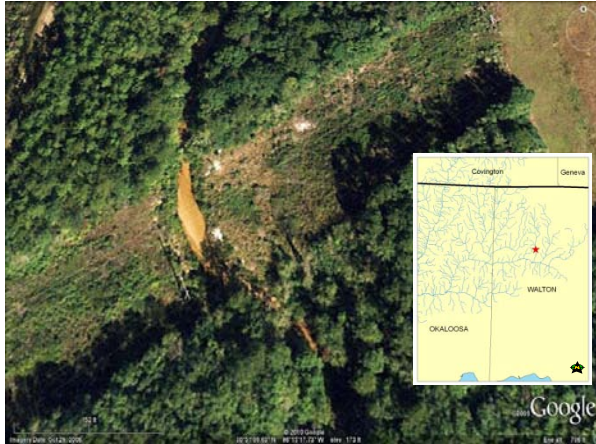
RB						
Risk Factor	Ranking	Score	Feature	Within Range	Descriptive Field	
Channel Stability	Fair	1	303(d)	Yes	COLIFORMS, TURBIDITY	
Channel Alteration	None	0	Wetland Species	No	N/A	
Bank Erosion	Active	1	Rare and Imperiled	No	N/A	
BEHI	High	1	Land Use/Cover	Yes	AGRICULTURAL/ STREAMS AND WATERWAYS	
Local NPSP	No Evidence	0	Candidate Mussels	No	N/A	
Shoring Structures	Not Present	0	Sturgeon C.H.	No	N/A	
Pipe Discharge	Not Present	0	Additional Site Features <u>Stream Channel Woody Material:</u> Infrequent <u>Impoundments:</u> None <u>Substrate Composition:</u> Clay Marl <u>Bank Material:</u> Clay			
Water Odors	Not Present	0

Fish Passage Barrier	Not Present	0				
RB: Riparian Buffer	0-29 ft	0.75				
LB: Riparian Buffer	100 + ft	0				
RB: Floodplain Access	None	0.75				
LB: Floodplain Access	Partial	0.25				
River Threat Index:		4.75

Notes: Power line crossing. Very low sinuosity.
