Unnamed tributary		co-0731-r-011	Sedimentation Risk Index 34																																																																		
<u>Common:</u> 1.8mi SW of Florala <u>Drainage:</u> Pond Creek <u>GPS:</u> 30.997090, -86.356523 <u>Land owner:</u> EPC Holdings Rayonier Crenshaw LLC		<u>County:</u> Covington <u>State:</u> Alabama <u>PLSS (T-R-S):</u> 6N-21W-29/28 <u>Parcel No.:</u> 1 <u>Road Name:</u> One Bridge Rd

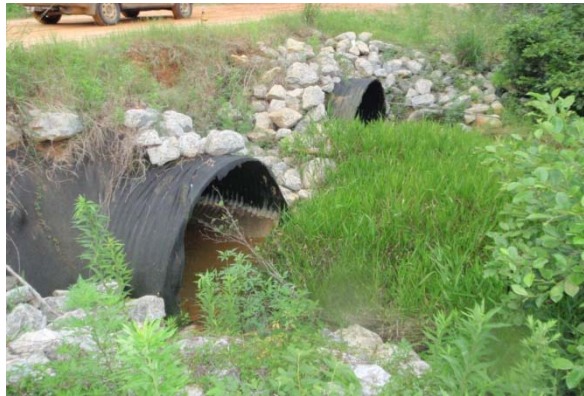
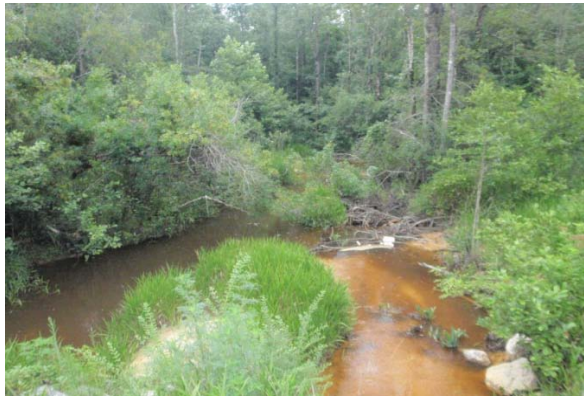
Crossing Structure: DS		DS																																																																			
<table border="1"> <thead> <tr> <th>Risk Factor</th> <th>Ranking</th> <th>Score</th> </tr> </thead> <tbody> <tr><td>US Channel Morph</td><td>BEAVER DAM</td><td>3</td></tr> <tr><td>DS Channel Morph</td><td>DA</td><td>3</td></tr> <tr><td>DS Bank Alteration</td><td>HIGH</td><td>1</td></tr> <tr><td>Upstream Skew Angle</td><td>5-30°</td><td>3</td></tr> <tr><td>Crossing fill condition</td><td>Fair/Rip Rap</td><td>3</td></tr> <tr><td>Inlet/Outlet Condition</td><td>Sed Islands/Scouring</td><td>3</td></tr> <tr><td>Road Approach Material</td><td>All Sand/Clay</td><td>3</td></tr> <tr><td>Potential Eroded Volume Mean</td><td>21-40 y³</td><td>3</td></tr> <tr><td>Approach Slope Mean</td><td>2.1-4%</td><td>3</td></tr> <tr><td>Soil K Factor</td><td><0.20</td><td>5</td></tr> <tr><td>Upstream Rt Outlet</td><td>Vegetated</td><td>1</td></tr> <tr><td>Upstream Lt Outlet</td><td>Bare soil</td><td>0</td></tr> <tr><td>Upstream Rt Ditch</td><td>Bare soil</td><td>0</td></tr> <tr><td>Upstream Lt Ditch</td><td>Bare soil</td><td>0</td></tr> <tr><td>Downstream Rt Outlet</td><td>Vegetated</td><td>1</td></tr> <tr><td>Downstream Lt Outlet</td><td>Vegetated</td><td>1</td></tr> <tr><td>Downstream Rt Ditch</td><td>Bare soil</td><td>0</td></tr> <tr><td>Downstream Lt Ditch</td><td>Bare soil</td><td>0</td></tr> <tr><td>Outlet Total</td><td>Partially Improved Outlet System</td><td>3</td></tr> <tr><td>Ditches Total</td><td>Unimproved Drainage System</td><td>1</td></tr> <tr><td>SRI Total</td><td>High Risk</td><td>34</td></tr> </tbody> </table>		Risk Factor	Ranking	Score	US Channel Morph	BEAVER DAM	3	DS Channel Morph	DA	3	DS Bank Alteration	HIGH	1	Upstream Skew Angle	5-30°	3	Crossing fill condition	Fair/Rip Rap	3	Inlet/Outlet Condition	Sed Islands/Scouring	3	Road Approach Material	All Sand/Clay	3	Potential Eroded Volume Mean	21-40 y ³	3	Approach Slope Mean	2.1-4%	3	Soil K Factor	<0.20	5	Upstream Rt Outlet	Vegetated	1	Upstream Lt Outlet	Bare soil	0	Upstream Rt Ditch	Bare soil	0	Upstream Lt Ditch	Bare soil	0	Downstream Rt Outlet	Vegetated	1	Downstream Lt Outlet	Vegetated	1	Downstream Rt Ditch	Bare soil	0	Downstream Lt Ditch	Bare soil	0	Outlet Total	Partially Improved Outlet System	3	Ditches Total	Unimproved Drainage System	1	SRI Total	High Risk	34

Notes: Vegetated island between culverts DS
