Unnamed tributary		co-0810-r-017	Sedimentation Risk Index 30																																																																		
<u>Common:</u> 9.5mi S of Andalusia <u>Drainage:</u> Hog Foot Creek <i>GPS:</i> 31.172308, -86.510336 <u>Land owner:</u> Harold & Elizabeth Barrow DS, Beatrice & Fred Forte - US		<u>County:</u> Covington <i>State:</i> Alabama <u>PLSS (T-R-S):</u> 2N-15E-1 <u>Parcel No.:</u> 6; 3 <u>Road Name:</u> Groger Rd

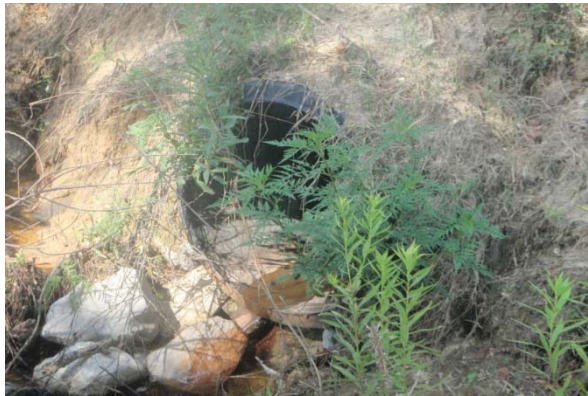
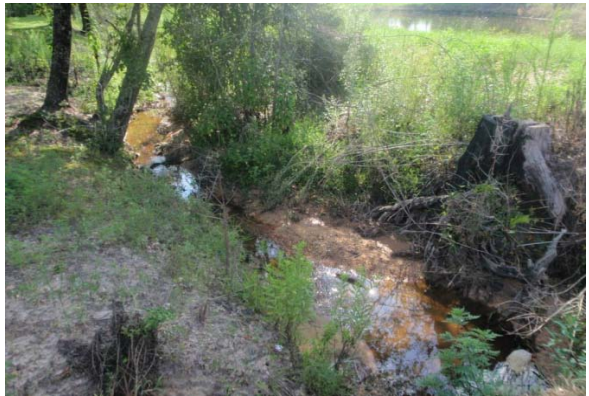
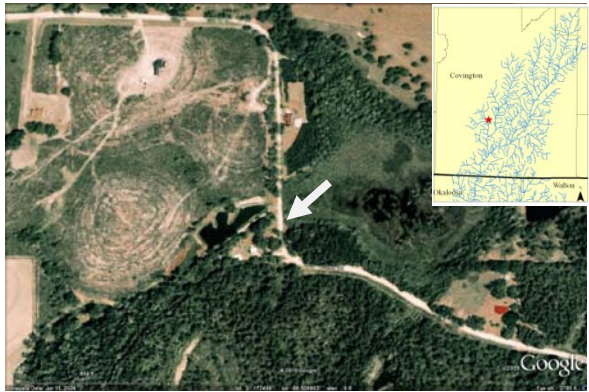
Crossing Structure: DS		DS																																																																			
<table border="1"> <thead> <tr> <th>Risk Factor</th> <th>Ranking</th> <th>Score</th> </tr> </thead> <tbody> <tr><td>US Channel Morph</td><td>BEAVER DAM</td><td>3</td></tr> <tr><td>DS Channel Morph</td><td>PONDED</td><td>1</td></tr> <tr><td>DS Bank Alteration</td><td>HIGH</td><td>1</td></tr> <tr><td>Upstream Skew Angle</td><td>5-30°</td><td>3</td></tr> <tr><td>Crossing fill condition</td><td>Poor/Bare soil</td><td>1</td></tr> <tr><td>Inlet/Outlet Condition</td><td>Sed Islands/Scouring</td><td>3</td></tr> <tr><td>Road Approach Material</td><td>All Sand/Clay</td><td>3</td></tr> <tr><td>Potential Eroded Volume Mean</td><td><21 y³</td><td>5</td></tr> <tr><td>Approach Slope Mean</td><td>2.1-4%</td><td>3</td></tr> <tr><td>Soil K Factor</td><td>0.21-0.40</td><td>3</td></tr> <tr><td>Upstream Rt Outlet</td><td>Vegetated</td><td>1</td></tr> <tr><td>Upstream Lt Outlet</td><td>Bare soil</td><td>0</td></tr> <tr><td>Upstream Rt Ditch</td><td>Bare soil</td><td>0</td></tr> <tr><td>Upstream Lt Ditch</td><td>Bare soil</td><td>0</td></tr> <tr><td>Downstream Rt Outlet</td><td>Bare soil</td><td>0</td></tr> <tr><td>Downstream Lt Outlet</td><td>Vegetated</td><td>1</td></tr> <tr><td>Downstream Rt Ditch</td><td>Bare soil</td><td>0</td></tr> <tr><td>Downstream Lt Ditch</td><td>Bare soil</td><td>0</td></tr> <tr><td>Outlet Total</td><td>Partially Improved Outlet System</td><td>3</td></tr> <tr><td>Ditches Total</td><td>Unimproved Drainage System</td><td>1</td></tr> <tr><td>SRI Total</td><td>High Risk</td><td>30</td></tr> </tbody> </table>		Risk Factor	Ranking	Score	US Channel Morph	BEAVER DAM	3	DS Channel Morph	PONDED	1	DS Bank Alteration	HIGH	1	Upstream Skew Angle	5-30°	3	Crossing fill condition	Poor/Bare soil	1	Inlet/Outlet Condition	Sed Islands/Scouring	3	Road Approach Material	All Sand/Clay	3	Potential Eroded Volume Mean	<21 y ³	5	Approach Slope Mean	2.1-4%	3	Soil K Factor	0.21-0.40	3	Upstream Rt Outlet	Vegetated	1	Upstream Lt Outlet	Bare soil	0	Upstream Rt Ditch	Bare soil	0	Upstream Lt Ditch	Bare soil	0	Downstream Rt Outlet	Bare soil	0	Downstream Lt Outlet	Vegetated	1	Downstream Rt Ditch	Bare soil	0	Downstream Lt Ditch	Bare soil	0	Outlet Total	Partially Improved Outlet System	3	Ditches Total	Unimproved Drainage System	1	SRI Total	High Risk	30

Notes: DS channel parallels private pond.
