Shoal River			ok-0423-007		Severity Score 3.25
<u>Common:</u> 3.6mi SE of Crestview <u>Drainage:</u> Yellow River <u>GPS:</u> 30.732367, -86.520503 <u>Land owner:</u> Haiseal Timber Co			<u>County:</u> Okaloosa <u>State:</u> Florida <u>PLSS(T-R-S):</u> 3N-23W-26 <u>Parcel No.:</u> 9

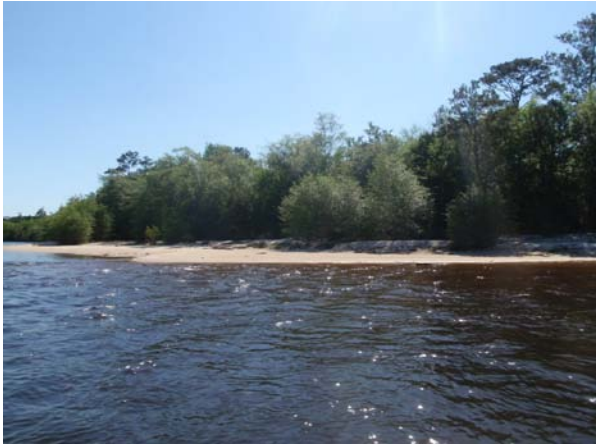
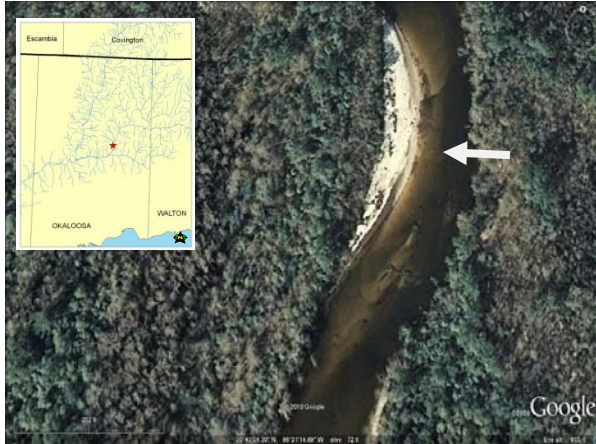
RB					
Risk Factor	Ranking	Score	Feature	Within Range	Descriptive Field
Channel Stability	Poor	1.5	303(d)	No	N/A
Channel Alteration	None	0	Wetland Species	Yes	1-3 FOCAL SPECIES IN UPLAND AREAS
Bank Erosion	Not eroding	0	Rare and Imperiled	Yes	GOLDSTRIPE DARTER, IRONCOLOR SHINER, SPECKLED CHUB
BEHI	High	1	Land Use/Cover	Yes	N/A / STREAMS AND WATERWAYS
Local NPSP	No Evidence	0	Candidate Mussels	No	N/A
Shoring Structures	Not Present	0	Sturgeon C.H.	No	N/A
Pipe Discharge	Not Present	0			
Water Odors	Not Present	0			
Fish Passage Barrier	Not Present	0			
RB: Riparian Buffer	0-29 ft	0.75			
LB: Riparian Buffer	100+ ft	0

RB: Floodplain Access	Full	0			
LB: Floodplain Access	Full	0			
River Threat Index:		3.25	<b>Additional Site Features</b> <u>Stream Channel Woody Material:</u> Moderate <u>Impoundments:</u> None <u>Substrate Composition:</u> Medium Sand <u>Bank Material:</u> Sand

Notes: Aggradational site.
