Yellow River		co-0805-005	Severity Score 3.75																																																																																	
<u>Common:</u> 16mi S of Andalusia <u>Drainage:</u> Blackwater Bay <u>GPS:</u> 31.0770612, -86.488424621 <u>Land owner:</u> RB: USA / LB: James & Patricia Battles		<u>County:</u> Covington <u>State:</u> Alabama <u>PLSS(T-R-S):</u> 1N-16E-6 <u>Parcel No.:</u> RB: 2/339AC / LB:1/272AC

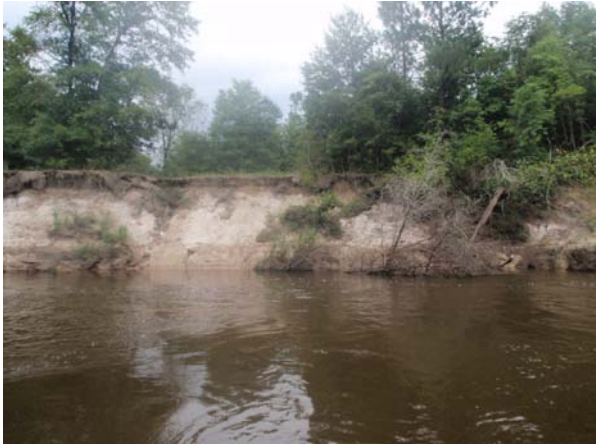
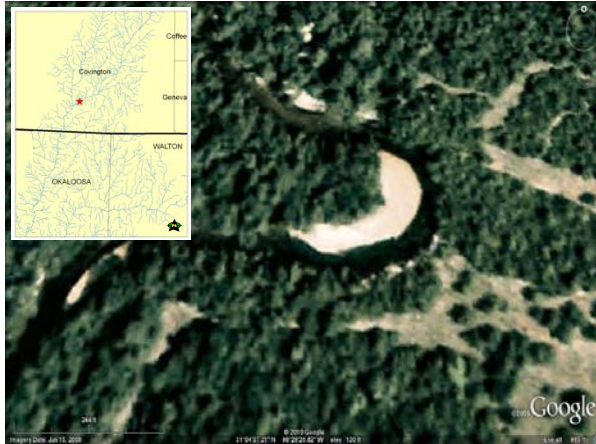
Notes: Lack of vegetation on left bank could lead to further active erosion.
