Unnamed tributary		co-1103-r-001	Sedimentation Risk Index 50																																																																		
<u>Common:</u> 1.4mi NE of Eoda <u>Drainage:</u> Good Springs <u>GPS:</u> 31.383869544,-86.297141303 <u>Land owner:</u> Austin & Robin Baley		<u>County:</u> Covington <u>State:</u> Alabama <u>PLSS (T-R-S):</u> 5N-17E-24 <u>Parcel No.:</u> 05 <u>Road Name:</u> Meadows Rd

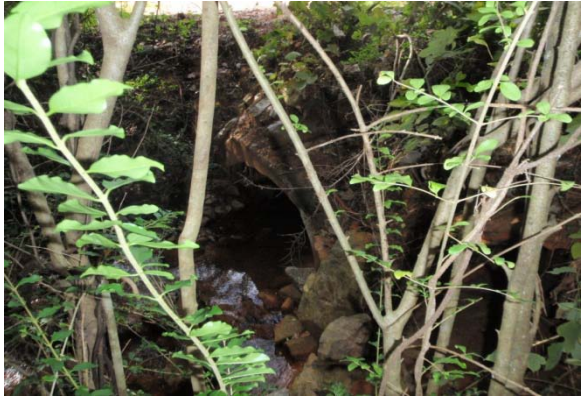
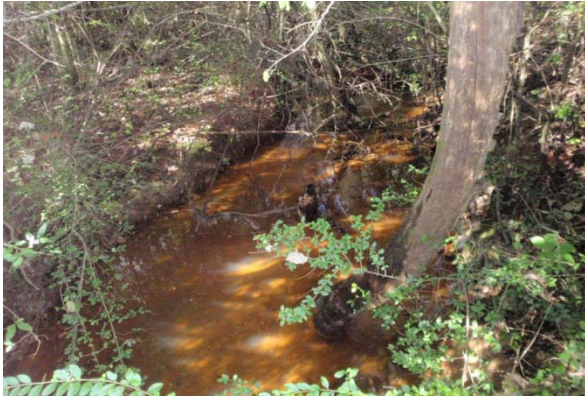
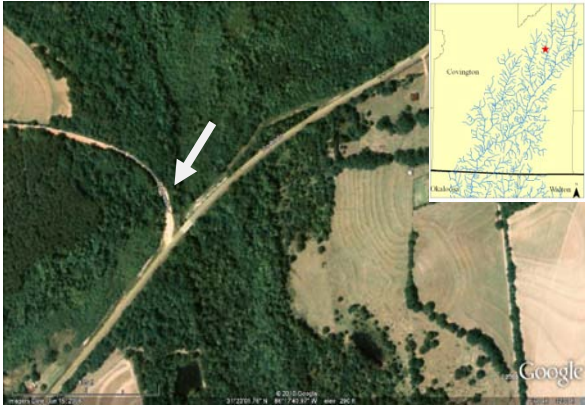
Crossing Structure: DS		US																																																																			
<table border="1"> <thead> <tr> <th>Risk Factor</th> <th>Ranking</th> <th>Score</th> </tr> </thead> <tbody> <tr><td>US Channel Morph</td><td>C</td><td>5</td></tr> <tr><td>DS Channel Morph</td><td>C</td><td>5</td></tr> <tr><td>DS Bank Alteration</td><td>MINOR/PARTIAL</td><td>3</td></tr> <tr><td>Upstream Skew Angle</td><td><5°</td><td>5</td></tr> <tr><td>Crossing fill condition</td><td>Fair/Rip Rap</td><td>3</td></tr> <tr><td>Inlet/Outlet Condition</td><td>No Impairment</td><td>5</td></tr> <tr><td>Road Approach Material</td><td>All Sand/Clay</td><td>3</td></tr> <tr><td>Potential Eroded Volume Mean</td><td><21 y³</td><td>5</td></tr> <tr><td>Approach Slope Mean</td><td><2%</td><td>5</td></tr> <tr><td>Soil K Factor</td><td><0.20</td><td>5</td></tr> <tr><td>Upstream Rt Outlet</td><td>Vegetated</td><td>1</td></tr> <tr><td>Upstream Lt Outlet</td><td>Vegetated</td><td>1</td></tr> <tr><td>Upstream Rt Ditch</td><td>Vegetated</td><td>1</td></tr> <tr><td>Upstream Lt Ditch</td><td>Bare soil</td><td>0</td></tr> <tr><td>Downstream Rt Outlet</td><td>Bare soil</td><td>0</td></tr> <tr><td>Downstream Lt Outlet</td><td>Bare soil</td><td>0</td></tr> <tr><td>Downstream Rt Ditch</td><td>Bare soil</td><td>0</td></tr> <tr><td>Downstream Lt Ditch</td><td>Bare soil</td><td>0</td></tr> <tr><td>Outlet Total</td><td>Partially Improved Outlet System</td><td>3</td></tr> <tr><td>Ditches Total</td><td>Partially Improved Drainage System</td><td>3</td></tr> <tr><td>SRI Total</td><td>Low Risk</td><td>50</td></tr> </tbody> </table>		Risk Factor	Ranking	Score	US Channel Morph	C	5	DS Channel Morph	C	5	DS Bank Alteration	MINOR/PARTIAL	3	Upstream Skew Angle	<5°	5	Crossing fill condition	Fair/Rip Rap	3	Inlet/Outlet Condition	No Impairment	5	Road Approach Material	All Sand/Clay	3	Potential Eroded Volume Mean	<21 y ³	5	Approach Slope Mean	<2%	5	Soil K Factor	<0.20	5	Upstream Rt Outlet	Vegetated	1	Upstream Lt Outlet	Vegetated	1	Upstream Rt Ditch	Vegetated	1	Upstream Lt Ditch	Bare soil	0	Downstream Rt Outlet	Bare soil	0	Downstream Lt Outlet	Bare soil	0	Downstream Rt Ditch	Bare soil	0	Downstream Lt Ditch	Bare soil	0	Outlet Total	Partially Improved Outlet System	3	Ditches Total	Partially Improved Drainage System	3	SRI Total	Low Risk	50

Notes: Rip rap in stream bed creating partial fish passage barrier.
