Unnamed tributary		wa-0626-r-008	Sedimentation Risk Index 48																																																																		
<u>Common:</u> 6.4mi SE of Florala <u>Drainage:</u> Turkey Creek <u>GPS:</u> 30.926191, -86.270866 <u>Land owner:</u> James & Elizabeth Hall- US, Cynthia Wise- DS		<u>County:</u> Walton <u>State:</u> Florida <u>PLSS(T-R-S):</u> 17-5N-20; 20-5N-20 <u>Parcel No.:</u> 5;3 <u>Road Name:</u> Pittman Rd

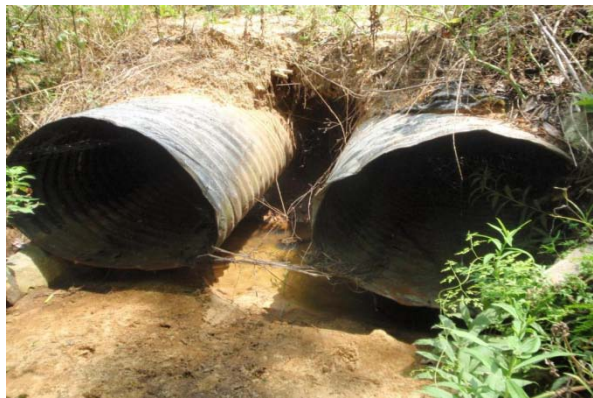
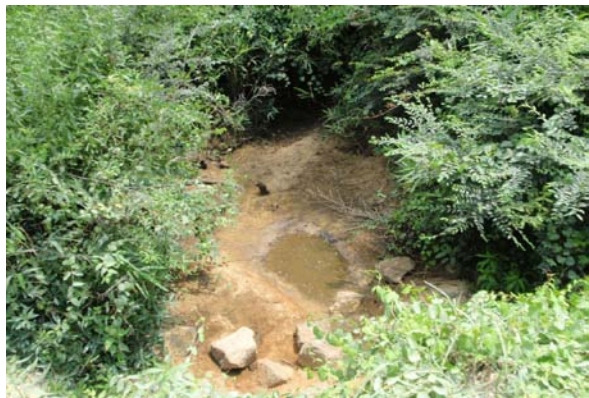
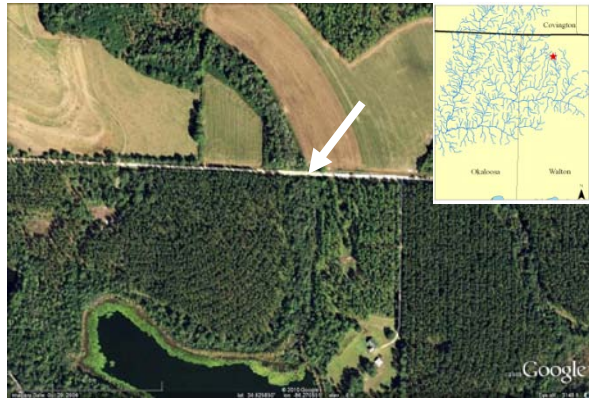
Crossing Structure: US		DS																																																																			
<table border="1"> <thead> <tr> <th>Risk Factor</th> <th>Ranking</th> <th>Score</th> </tr> </thead> <tbody> <tr><td>US Channel Morph</td><td>C</td><td>5</td></tr> <tr><td>DS Channel Morph</td><td>C</td><td>5</td></tr> <tr><td>DS Bank Alteration</td><td>MINOR/PARTIAL</td><td>3</td></tr> <tr><td>Upstream Skew Angle</td><td>5-30°</td><td>3</td></tr> <tr><td>Crossing fill condition</td><td>Fair/Rip Rap</td><td>3</td></tr> <tr><td>Inlet/Outlet Condition</td><td>Sed Islands/Scouring</td><td>3</td></tr> <tr><td>Road Approach Material</td><td>All Aggregate</td><td>5</td></tr> <tr><td>Potential Eroded Volume Mean</td><td><21 y³</td><td>5</td></tr> <tr><td>Approach Slope Mean</td><td>2.1-4%</td><td>3</td></tr> <tr><td>Soil K Factor</td><td>0.21-0.40</td><td>3</td></tr> <tr><td>Upstream Rt Outlet</td><td>Vegetated</td><td>1</td></tr> <tr><td>Upstream Lt Outlet</td><td>Vegetated</td><td>1</td></tr> <tr><td>Upstream Rt Ditch</td><td>Vegetated</td><td>1</td></tr> <tr><td>Upstream Lt Ditch</td><td>Vegetated</td><td>1</td></tr> <tr><td>Downstream Rt Outlet</td><td>Vegetated</td><td>1</td></tr> <tr><td>Downstream Lt Outlet</td><td>Vegetated</td><td>1</td></tr> <tr><td>Downstream Rt Ditch</td><td>Vegetated</td><td>1</td></tr> <tr><td>Downstream Lt Ditch</td><td>Vegetated</td><td>1</td></tr> <tr><td>Outlet Total</td><td>Improved Outlet System</td><td>5</td></tr> <tr><td>Ditches Total</td><td>Improved Drainage System</td><td>5</td></tr> <tr><td>SRI Total</td><td>Low Risk</td><td>48</td></tr> </tbody> </table>		Risk Factor	Ranking	Score	US Channel Morph	C	5	DS Channel Morph	C	5	DS Bank Alteration	MINOR/PARTIAL	3	Upstream Skew Angle	5-30°	3	Crossing fill condition	Fair/Rip Rap	3	Inlet/Outlet Condition	Sed Islands/Scouring	3	Road Approach Material	All Aggregate	5	Potential Eroded Volume Mean	<21 y ³	5	Approach Slope Mean	2.1-4%	3	Soil K Factor	0.21-0.40	3	Upstream Rt Outlet	Vegetated	1	Upstream Lt Outlet	Vegetated	1	Upstream Rt Ditch	Vegetated	1	Upstream Lt Ditch	Vegetated	1	Downstream Rt Outlet	Vegetated	1	Downstream Lt Outlet	Vegetated	1	Downstream Rt Ditch	Vegetated	1	Downstream Lt Ditch	Vegetated	1	Outlet Total	Improved Outlet System	5	Ditches Total	Improved Drainage System	5	SRI Total	Low Risk	48

Notes: Culverts placed too high US. DS leading to impoundment.
