Unnamed tributary		wa-1005-r-006	Sedimentation Risk Index 46																																																																		
<u>Common:</u> 2.4mi NE of Mossy Head <u>Drainage:</u> Battle Creek <u>GPS:</u> 30.772010514, -86.294946031 <u>Land owner:</u> Joseph & Carolyn Guzzo-US, Pamela Jane Pillitteri-DS		<u>County:</u> Walton <u>State:</u> Florida <u>PLSS (T-R-S):</u> 3N-21-12-37050 <u>Parcel No.:</u> 2.0060; 3.0020 <u>Road Name:</u> Red Oak Rd

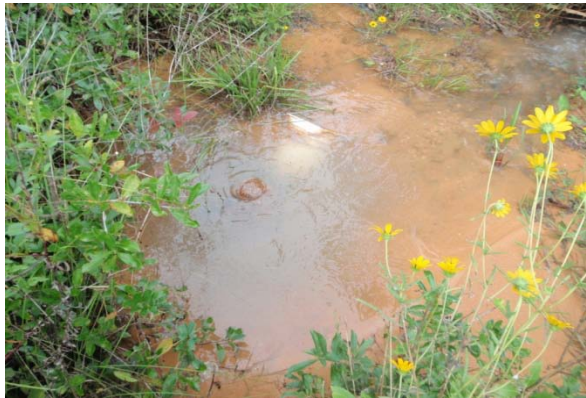
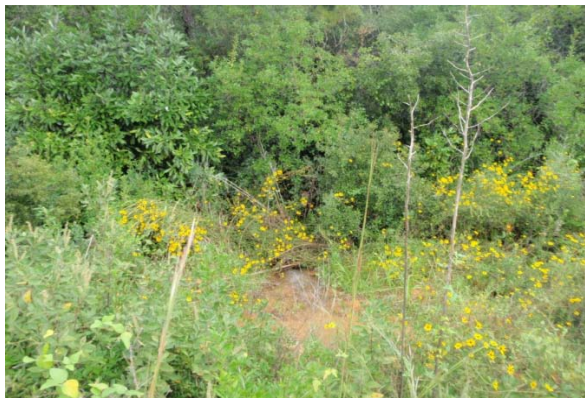
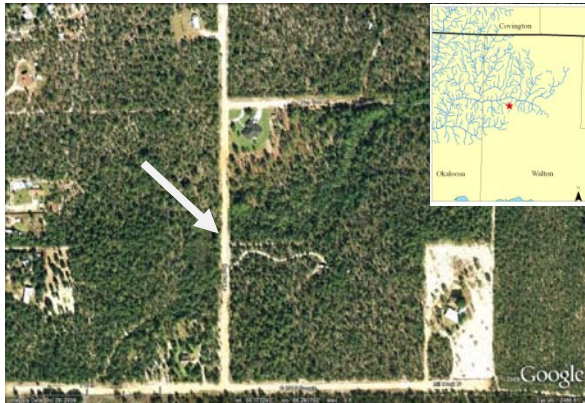
Crossing Structure: DS		DS																																																																			
<table border="1"> <thead> <tr> <th>Risk Factor</th> <th>Ranking</th> <th>Score</th> </tr> </thead> <tbody> <tr><td>US Channel Morph</td><td>C</td><td>5</td></tr> <tr><td>DS Channel Morph</td><td>C</td><td>5</td></tr> <tr><td>DS Bank Alteration</td><td>MINOR/PARTIAL</td><td>3</td></tr> <tr><td>Upstream Skew Angle</td><td><5°</td><td>5</td></tr> <tr><td>Crossing fill condition</td><td>Good/Vegetated</td><td>5</td></tr> <tr><td>Inlet/Outlet Condition</td><td>Sed Islands/Scouring</td><td>3</td></tr> <tr><td>Road Approach Material</td><td>All Sand/Clay</td><td>3</td></tr> <tr><td>Potential Eroded Volume Mean</td><td><21 y³</td><td>5</td></tr> <tr><td>Approach Slope Mean</td><td>>4%</td><td>1</td></tr> <tr><td>Soil K Factor</td><td><0.20</td><td>5</td></tr> <tr><td>Upstream Rt Outlet</td><td>Vegetated</td><td>1</td></tr> <tr><td>Upstream Lt Outlet</td><td>Vegetated</td><td>1</td></tr> <tr><td>Upstream Rt Ditch</td><td>Bare soil</td><td>0</td></tr> <tr><td>Upstream Lt Ditch</td><td>Bare soil</td><td>0</td></tr> <tr><td>Downstream Rt Outlet</td><td>Vegetated</td><td>1</td></tr> <tr><td>Downstream Lt Outlet</td><td>Vegetated</td><td>1</td></tr> <tr><td>Downstream Rt Ditch</td><td>Bare soil</td><td>0</td></tr> <tr><td>Downstream Lt Ditch</td><td>Bare soil</td><td>0</td></tr> <tr><td>Outlet Total</td><td>Improved Outlet System</td><td>5</td></tr> <tr><td>Ditches Total</td><td>Unimproved Drainage System</td><td>1</td></tr> <tr><td>SRI Total</td><td>Low Risk</td><td>46</td></tr> </tbody> </table>		Risk Factor	Ranking	Score	US Channel Morph	C	5	DS Channel Morph	C	5	DS Bank Alteration	MINOR/PARTIAL	3	Upstream Skew Angle	<5°	5	Crossing fill condition	Good/Vegetated	5	Inlet/Outlet Condition	Sed Islands/Scouring	3	Road Approach Material	All Sand/Clay	3	Potential Eroded Volume Mean	<21 y ³	5	Approach Slope Mean	>4%	1	Soil K Factor	<0.20	5	Upstream Rt Outlet	Vegetated	1	Upstream Lt Outlet	Vegetated	1	Upstream Rt Ditch	Bare soil	0	Upstream Lt Ditch	Bare soil	0	Downstream Rt Outlet	Vegetated	1	Downstream Lt Outlet	Vegetated	1	Downstream Rt Ditch	Bare soil	0	Downstream Lt Ditch	Bare soil	0	Outlet Total	Improved Outlet System	5	Ditches Total	Unimproved Drainage System	1	SRI Total	Low Risk	46

Notes: Unknown culvert material- buried. Water welling up from the ground.
