Yellow River		co-0805-003	Severity Score 1.75																																																																																
<u>Common:</u> 10.9mi NW of Florala <u>Drainage:</u> Blackwater Bay <u>GPS:</u> 31.081969381, -86.487947841 <u>Land owner:</u> RB: USA / LB: James & Patricia Battles		<u>County:</u> Covington <u>State:</u> Alabama <u>PLSS:</u> 1N-16E-6 <u>Parcel No.:</u> 2/1

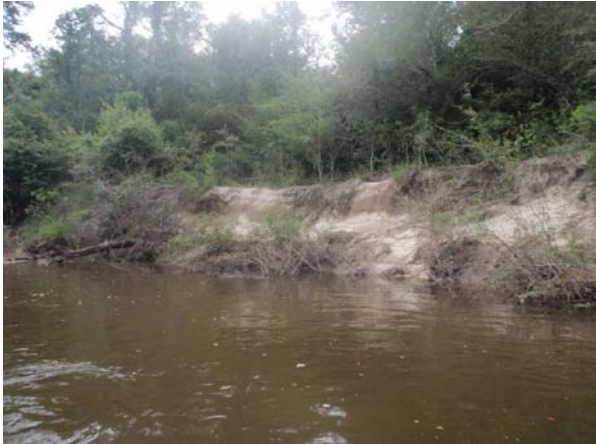
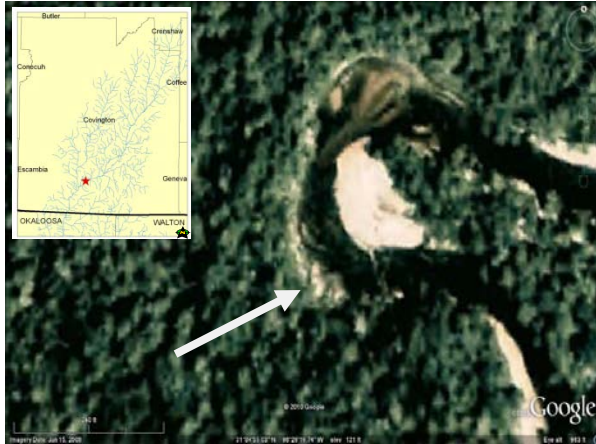
Notes: Some bank erosion apparent may be natural meander incision. Large aggradational site across channel could indicate some channel instability.
