Unnamed tributary		co-0820-r-009	Sedimentation Risk Index <b>46</b>																																																																		
<u>Common:</u> 6.6mi N of Florala <u>Drainage:</u> Clear Creek <u>GPS:</u> 31.101564654, -86.332444522 <u>Land owner:</u> Rayonier Forest Resources LP		<u>County:</u> Covington <u>State:</u> Alabama <u>PLSS (T-R-S):</u> 2N-17E-34 <u>Parcel No.:</u> 3 <u>Road Name:</u> Betty's Rd

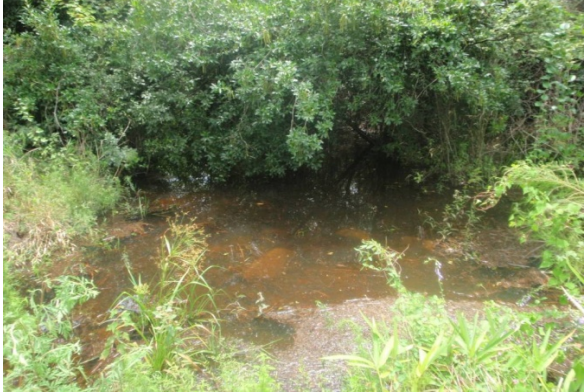
<p>Crossing Structure: DS</p>

Notes: Submerged culvert.
