## Diablo Model 31, G5, serial number 28685/1440, Restoration Notes

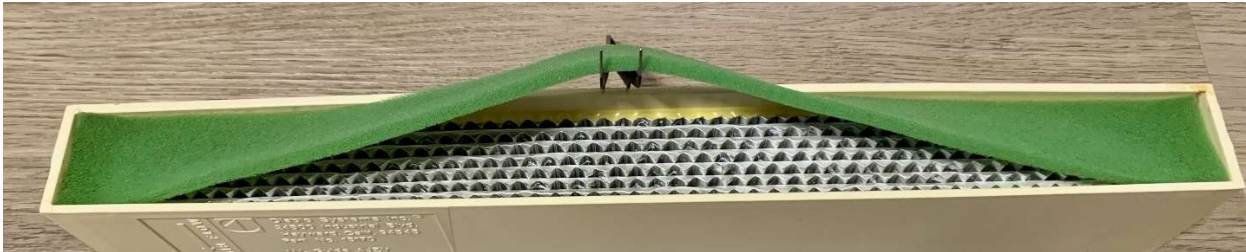
The old filter:

I was concerned about the air filtration to the spinning platter, and wanted this air channel to be as clean as possible. The old filter that came with the drive has a bunch of small white granules in the small channels in the filter.

Removed the old filter, wiped out the area where the filter is located, and installed the new filter.

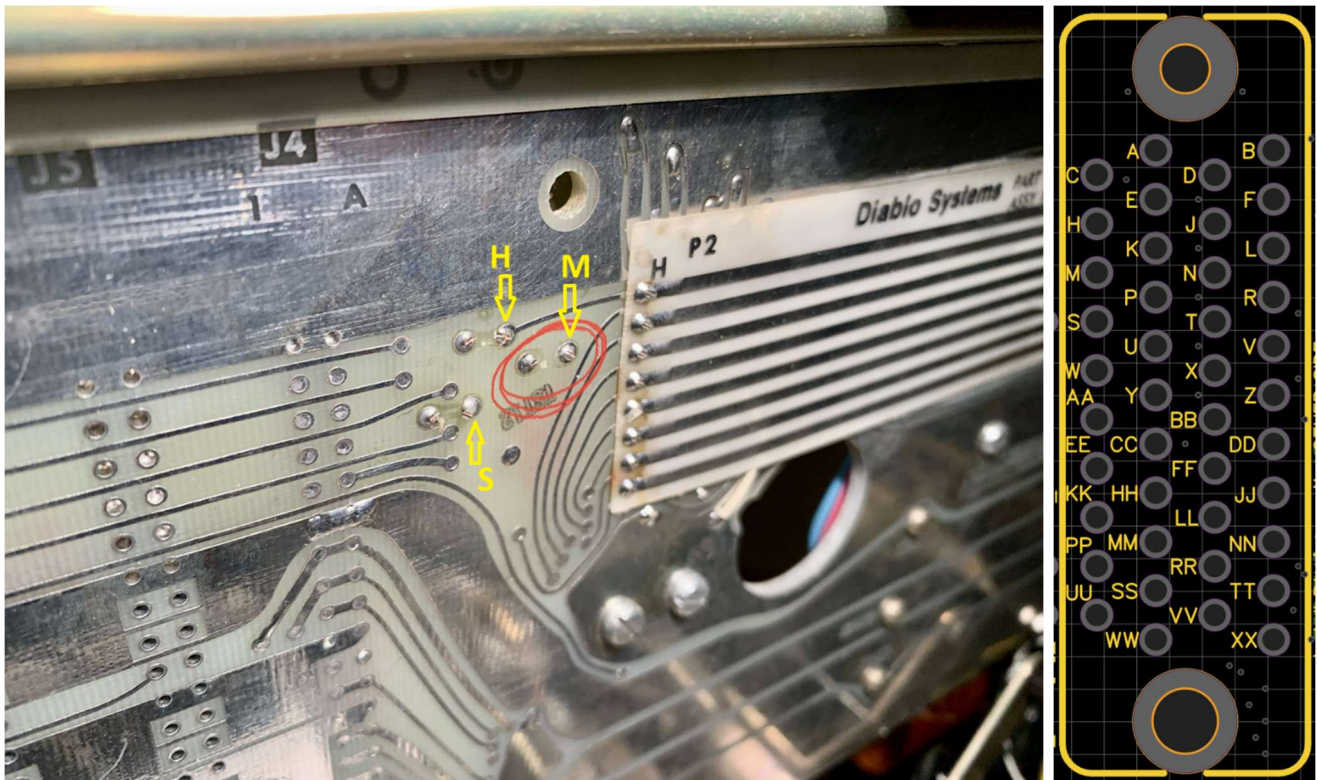
Now I found it by doing a conductivity test with the beeper in the digital meter, testing conductivity between various backplane traces and the "High Density Indication" signal on the J10 board!

The jumpers for the signals on MRAC pins H, M, and S were apparently removed by the previous owner.

It's strange that the board in J10 is configured for high density but the backplane jumper for the “High Density Indication” signal is removed

Added the “High Density Indication” jumper on the backplane.

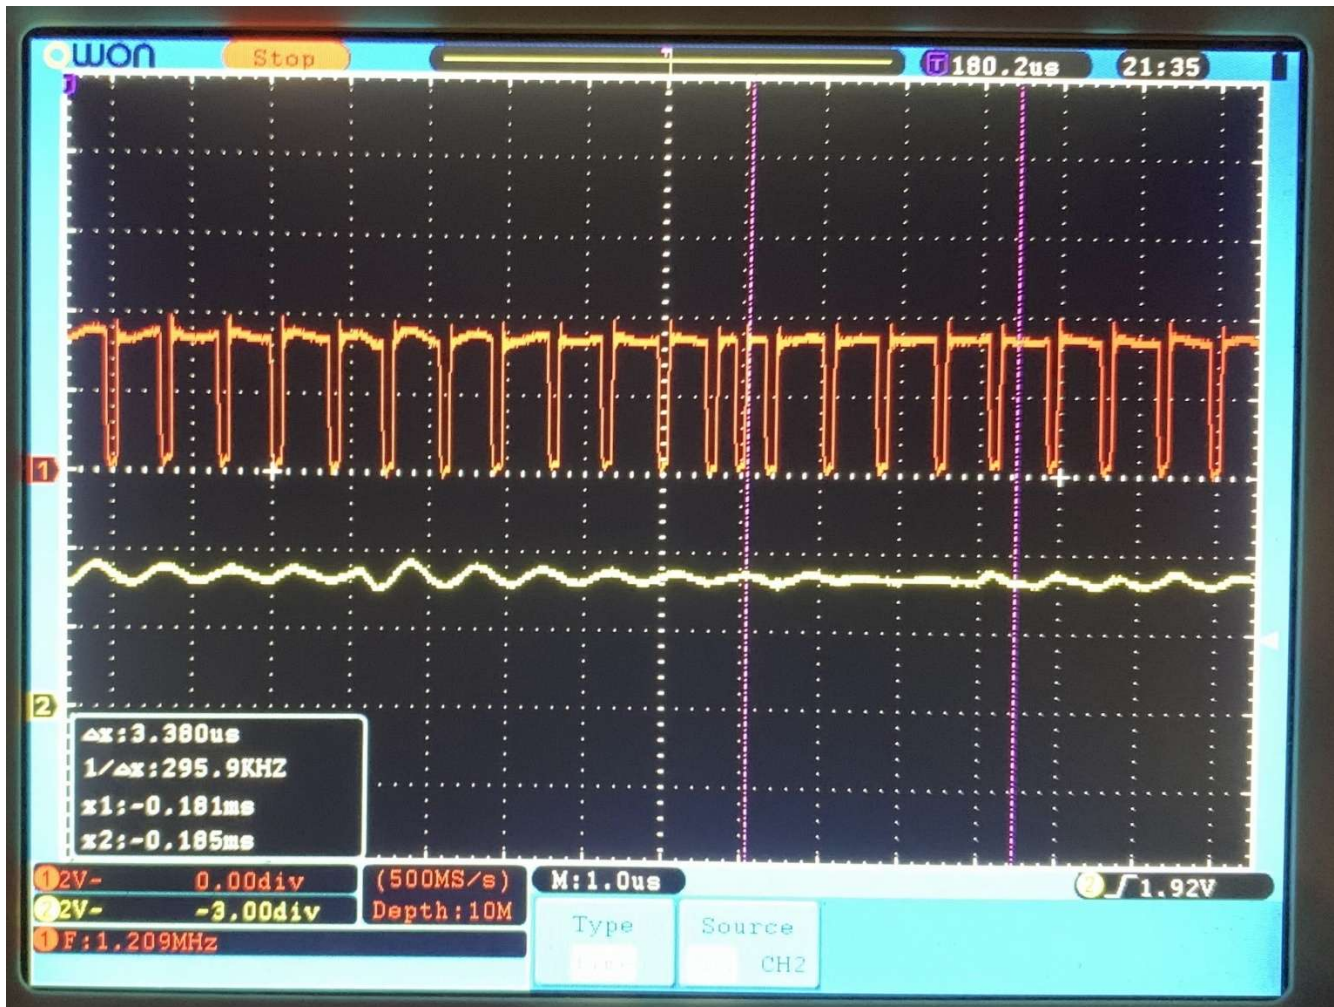
Read Clock is CH1 and Read Data is CH2. It appears that the data pulses are still present in the read clock, and data isn't being separated onto Read Data as it should be. The bit rate appears to be about 1.44 Mbps.

Cut the leg of F37 pin 6, the Q-bar output of the DM8601 retriggerable one-shot. Connected a jumper from F37 pin 8 (the Q output of the one-shot) to K74 pin 13 (input of the spare inverter). Connected a second jumper from K74 pin 12 (output of the spare inverter) to the pad beneath F37 pin 6 (where the Q-bar output of the one-shot was connected before the pin was cut). This is a temporary work-around until the replacment DM8601 arrives.

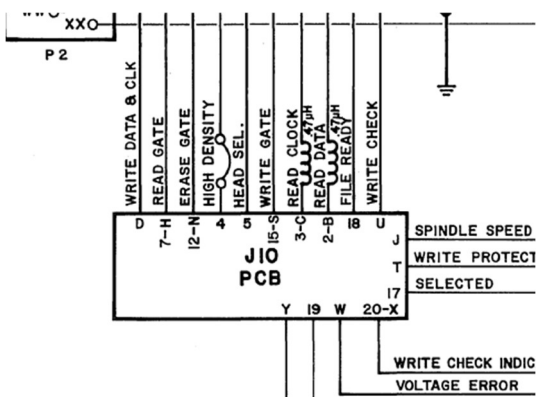
Trace Read Clock back from J10-3-C and Read Data back from J10-2-B.

On J10, TP3 looks like red trace above; TP4 always high; TP5 always low

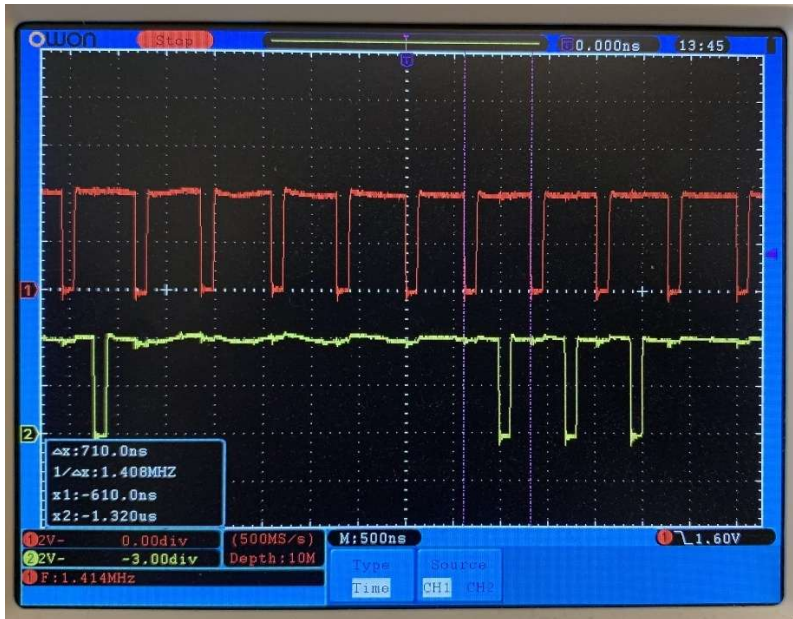
After this temporary fix, clock and data appear to be correct, with a stream of periodic clock pulses and data pulses that appear in the center between the clock pulses:

...and the data rate appears to be about 1.4 Mbps

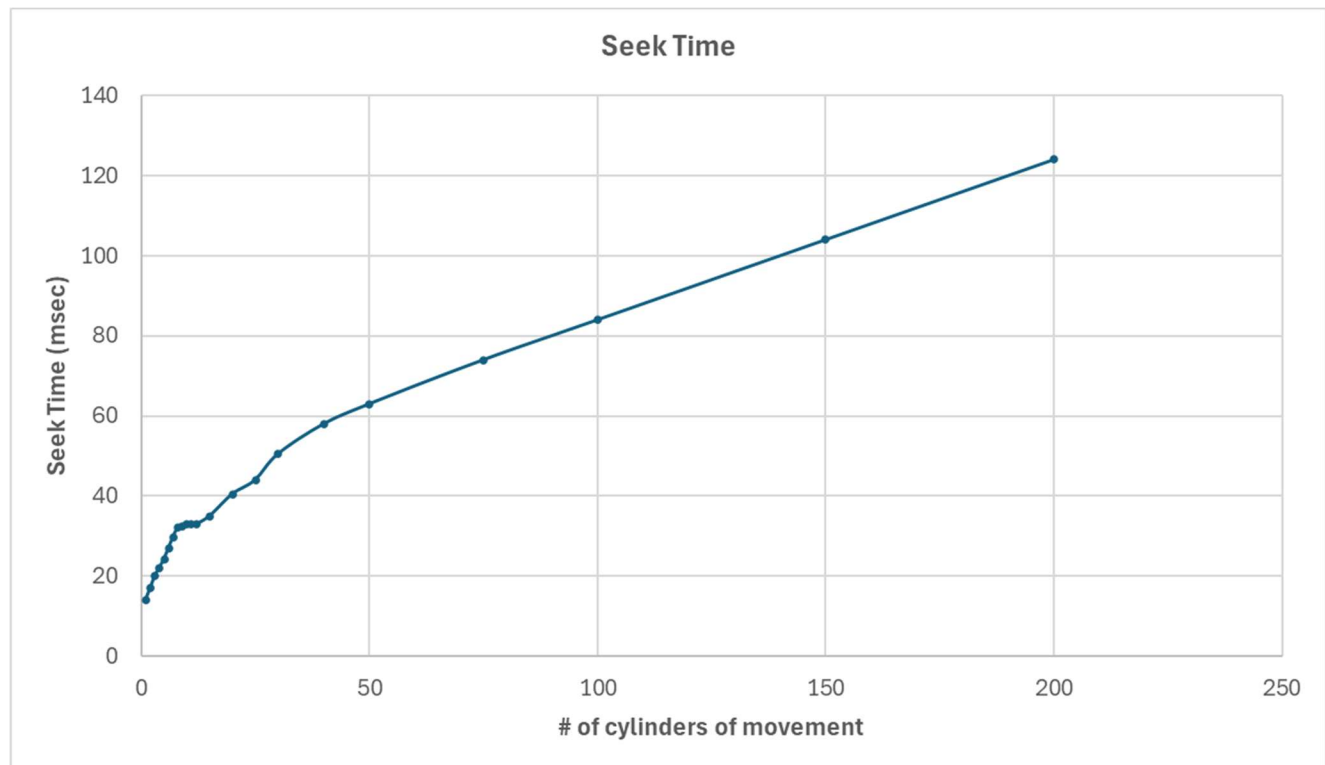
There's still a problem with the drive. When running the `write loop random` test, there are occasional errors. Discovered that when seeking more than about 20 sectors (it seems to vary) then there are intermittent errors in the `write loop verify` test. The CHS list contained: 0 0 0, 20 0 0.

Collected data on the time when RWS ready is inactive after a seek operation, `w l n` command:

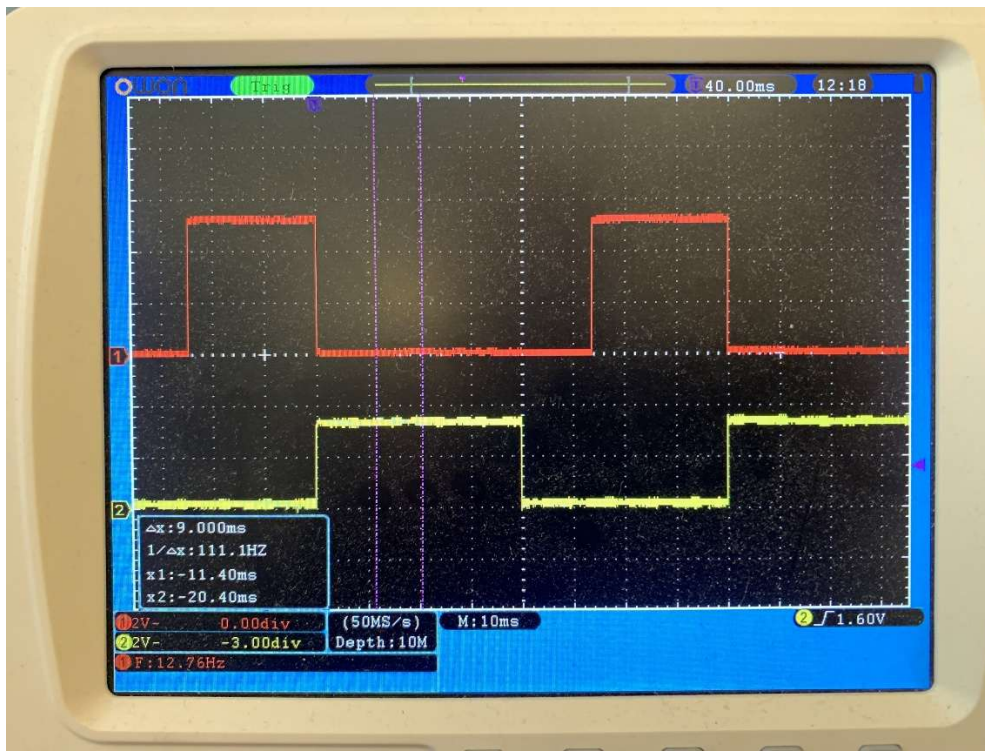
Motion Indicator Level signal, module J2 TP6:

The signal shown in CH1 (red) above is the inverted Motion Indicator Level signal.

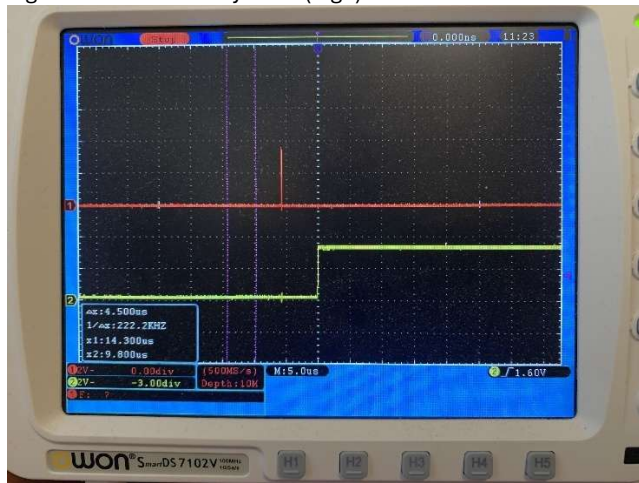
**Photo #1,**

Connected the Diablo Model 31 to the Tester. The read/write errors in the Tester appear to be related to a race condition in the Tester. The Tester asserts `BUS_STROBE_L` and shortly after checks `BUS_RWS_RDY_L` to determine if the seek operation has completed. With the Tester attached to the Diablo drive there's a 20 $\mu$ s delay from `BUS_STROBE_L` until the Diablo drive de-asserts `BUS_RWS_RDY_L`, so the Tester is checking too soon. Currently the Tester asserts `BUS_STROBE_L` and immediately checks `BUS_RWS_RDY_L`, which has not yet transitioned to the inactive state. Because of this, the Tester observes that the drive is ready before the drive is able to assert that the drive is not ready.

CH1 – GP6 software debug pulse, CH2 – `BUS_RWS_RDY_L`  
Shows that the software starts polling `BUS_RWS_RDY_L` before it goes to the not-ready state (high)

These problems can be fixed by having the Tester first observe that the command has been accepted by monitoring a latched version of the address accepted signal (BUS\_ADDR\_ACCEPTED\_L) from the drive. The Tester receives BUS\_ADDR\_ACCEPTED\_L from the drive and latches an FPGA internal signal called “address\_accepted” which can be monitored in bit 6 of the Drive Status 1 register. The Tester should detect address\_accepted prior to monitoring BUS\_RWS\_RDY\_L to determine when the seek operation is complete.

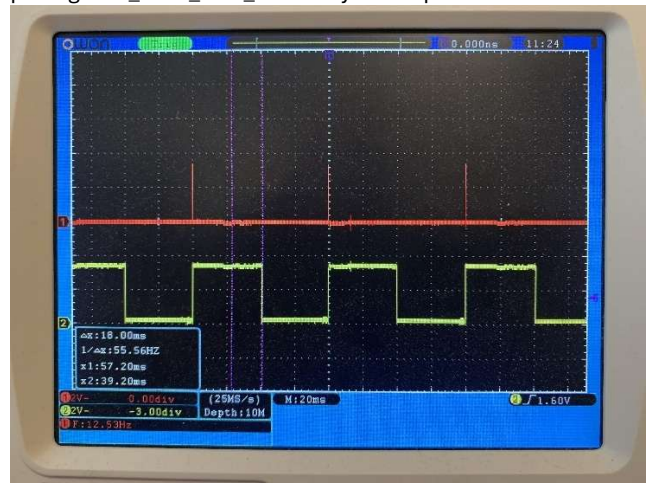
**Photo #2,**

CH1 – GP6 software debug pulse, CH2 – `BUS_RWS_RDY_L`  
A high-level view of photo #1, shows that the software starts polling `BUS_RWS_RDY_L` at every seek operation

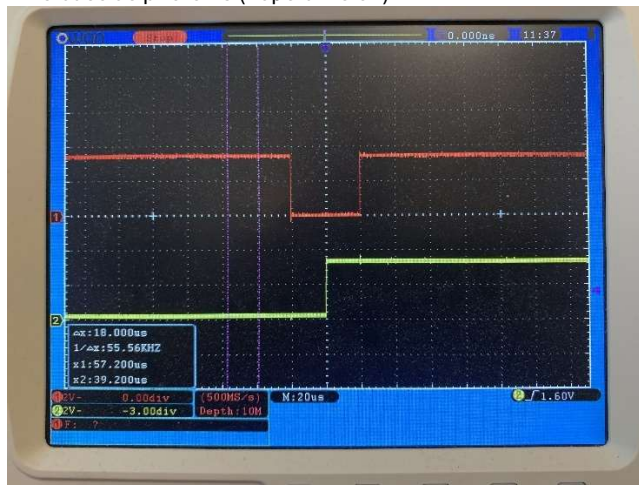
**Photo #3,**

CH1 – `BUS_STROBE_L`, CH2 – `BUS_RWS_RDY_L`  
Shows when `BUS_STROBE_L` goes active and inactive. Same time base as photo #3 (20 $\mu$ s/division)

Compared to the RK05 Emulator, the Diablo drive seems to have rather high latency to assert BUS\_RWS\_RDY\_L after BUS\_STROBE\_L is asserted. The Diablo drive also seems to have a high latency to assert BUS\_ADDR\_ACCEPTED\_L after BUS\_STROBE\_L is asserted.

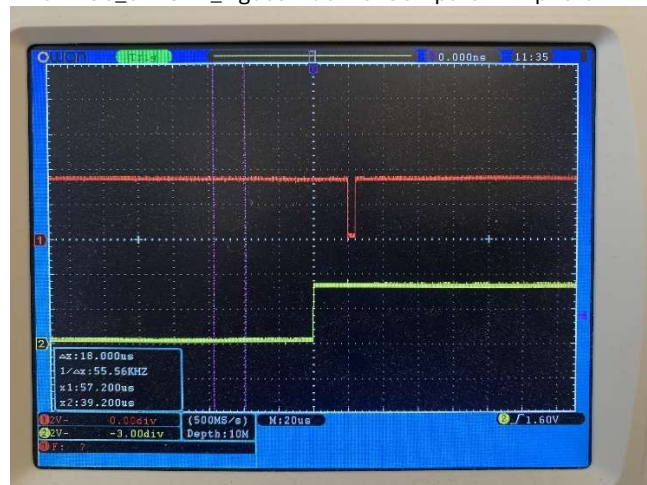
**Photo #4,**

CH1 – `BUS_ADDR_ACCEPTED_L`, CH2 – `BUS_RWS_RDY_L`  
Shows `BUS_ADDR_ACCEPTED_L` is asserted at the same time when `BUS_STROBE_L` goes inactive. Compare with photo #4
