Koni Steffan AWS Site visit

9th November 2013

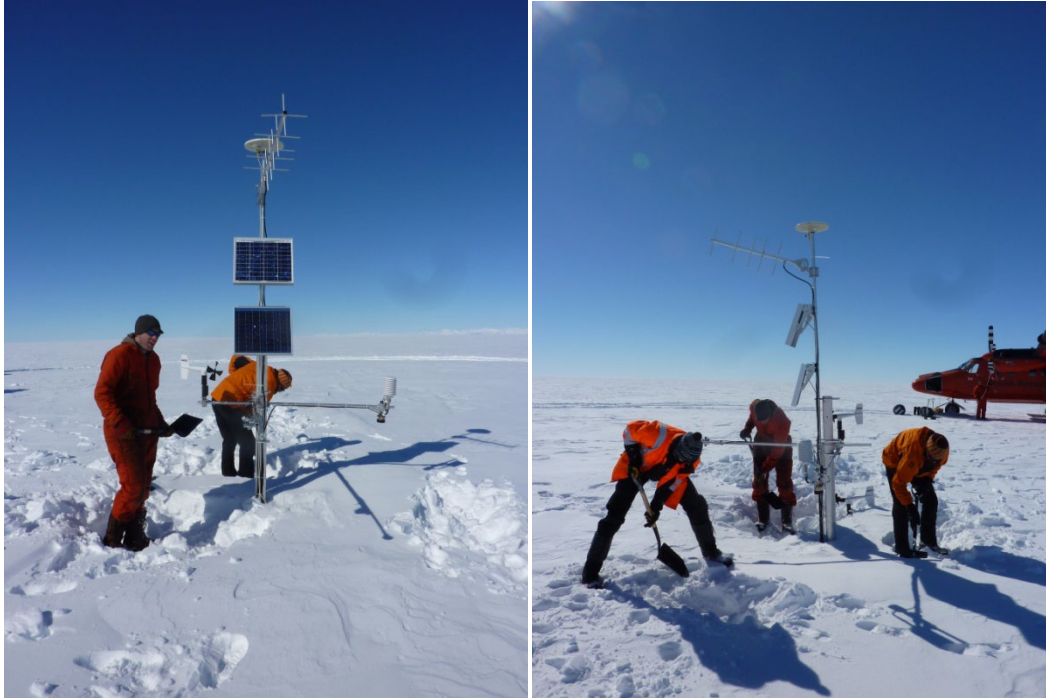
Photographs: site on arrival.

Visual inspection: The lower propvane was partially buried. The gold foil on the lower sonic ranger was visibly damaged.

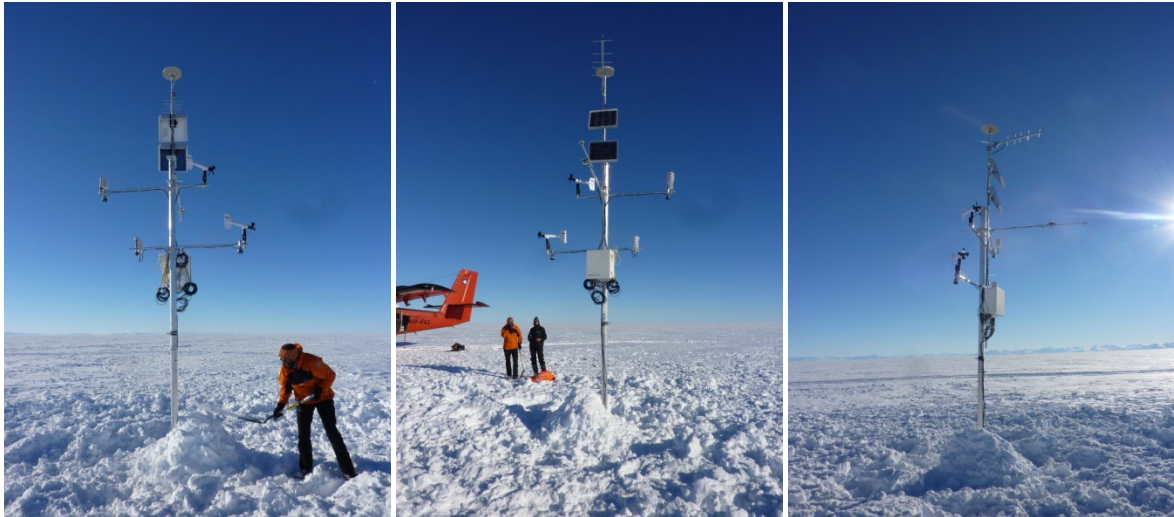
Procedure: Dug down to logger box and first battery box. Battery box was raised to surface. Logger data was downloaded from CR10X (this took about 90minutes). The cable supplied for the Trimble R7 receiver did not fit the receiver unit so it was not possible to download the data or reprogram the receiver. The damaged sonic ranger head was replaced. Continued digging to retrieve the second battery box but finally gave up as it clearly had not been raised on the last visit and the hole was already 3m deep. The cable to the second battery box was extended to enable the raise. While digging a power cable with two stripped wire ends were found. They were still connected into the logger. This cable was pulled out and discarded. The mast was raised with ease. GOES antenna aligned. The hole was backfilled. Cables and instruments checked and tidied. Battery box positioned against to the mast, to the east of the mast, below the propvanes. It was left half below the surface with snow piled on top.

Photographs: site after raise with battery box under pile of snow.

Recommendations: A new battery box and batteries will be needed for the next raise (or more cable and connectors to extend further). A cable for the Trimble R7 receiver is needed.
