Visit Report – Siemens Electrical Apparatus Ltd (SEAL)

Troubleshooting on SEAL Button Fragile/brittle fracture Issue (TR55 Green L10489.11)

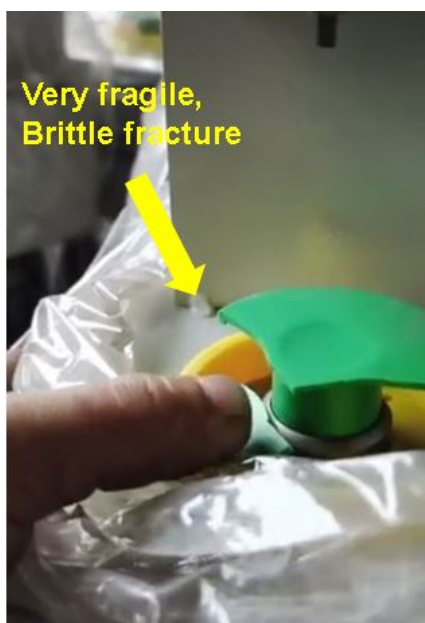
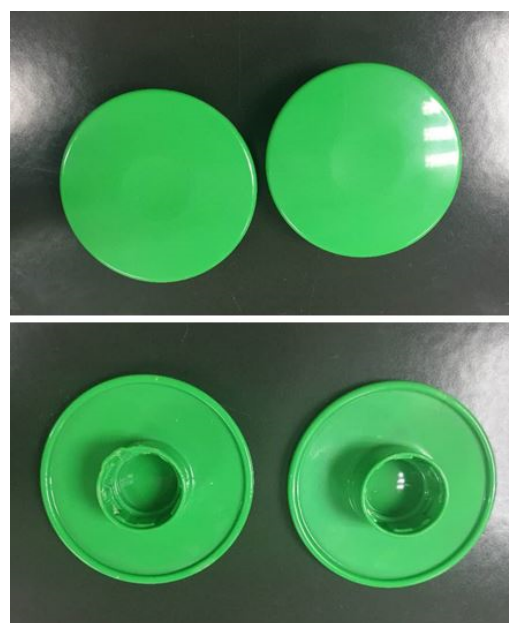
4 Part & Assembly & Defect pictures

- Very fragile/ brittle fracture were reported with SEAL's button part (TR55 green)
- Brittle fracture only happened with Green button produced before 2018, neither with newly produced blue button, nor other color button product (red, yellow, etc)
- Needs to investigate the brittle is accidental (due to processing etc.) or inevitable (due to weathering/ aging)

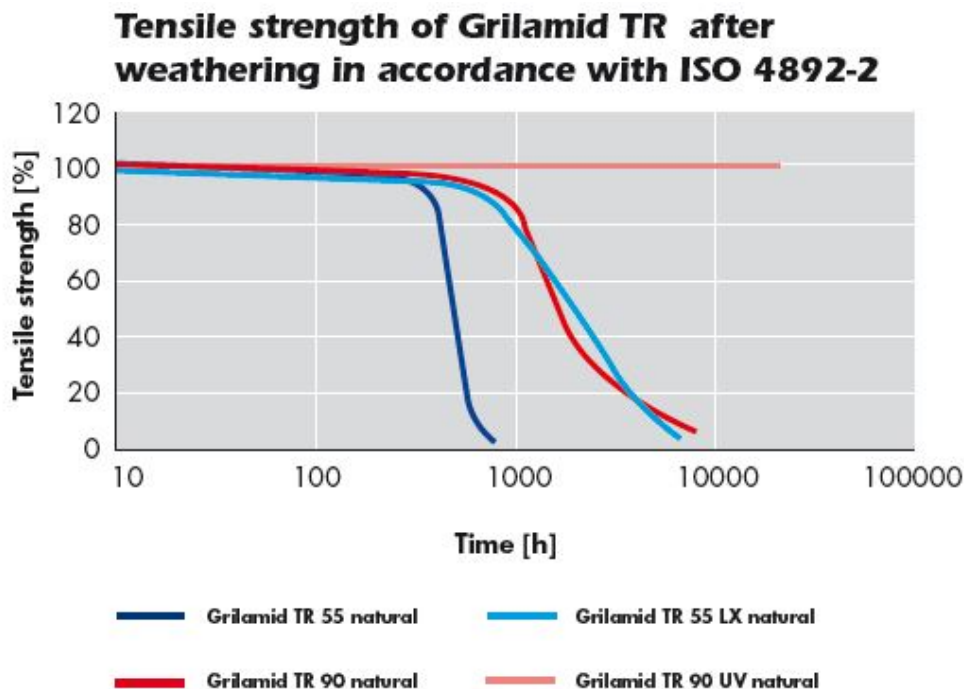
Test method: ISO 4892-2
Test specimen: ISO 294-2 3x3 mm

- TR55 are listed as f1 according to UL746C and is therefore suitable for outdoor applications
- However, will TR 55 Green show similar weathering performance as natural grade, or is it sufficient for this application?
