Visit Report

Date of visit: 18 Jul. 2023
 Date of report: 21 Jul. 2023

Plaston / CFMOTO-R2R

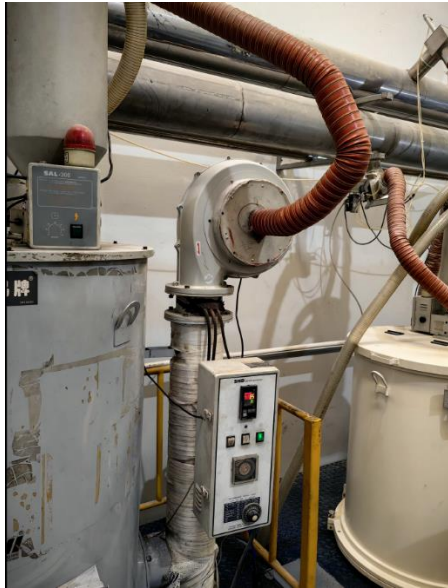
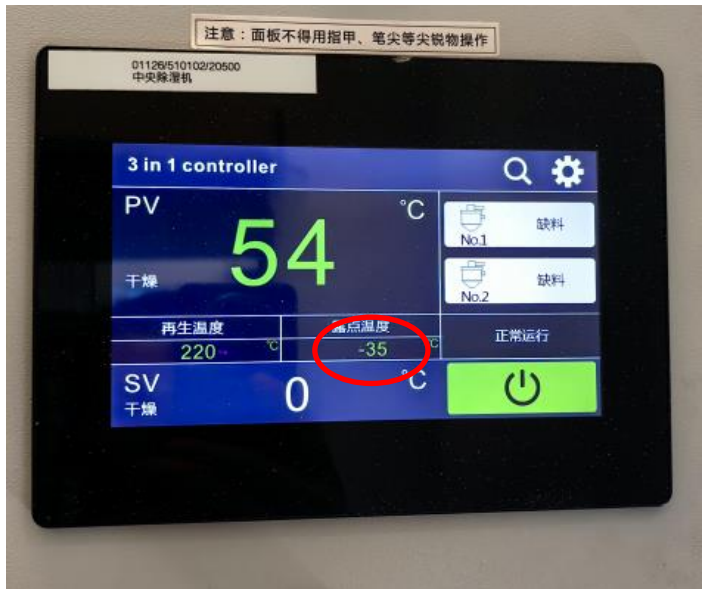
- Plaston complained >15% reject rate due to silver streaks and want EMS support them to solve the issue. Processing parameters are checked without issue.
- Central drying and central delivery system are used at Plaston. Central drying system is from SHINI which is a famous local brand. The dew point from the machine is -35°C which is sufficient to dry Grilamid TR material. And the moisture tested from the natural material is 0.013% (*By EMS Carl Fisher*). The colour MB (*adding 4%*) is dried by a hot air drier. The tested moisture content is 0.36% (*By EMS Carl Fisher*) which is over-specified and could be a risk point.

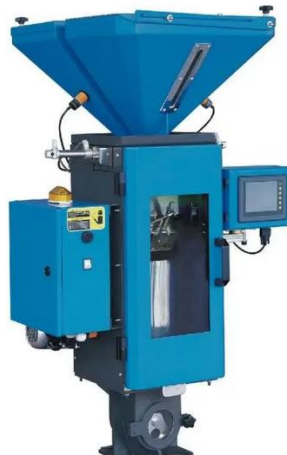
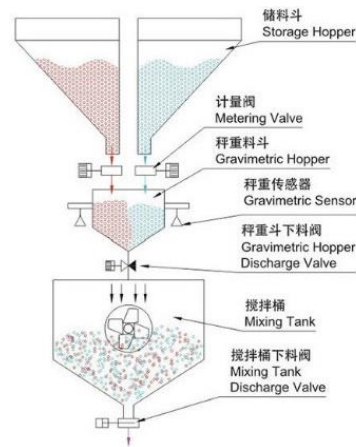
- Due to central supply system is used, the pipe is more than 20 meter long and wet air is used to convey the material which might cause the quick moisture absorption and residual of materials in the pipe. So we decide to use the manual filling of material. The defect rate is significantly reduced after changing to this process. Plaston is satisfied with the result.
- Polymer base of the MB also need to be checked to avoid any delamination which might looks similar as silver streak. Plaston will check with their supplier for details.
- The colour mixing machine (*by weight method*) is used for the part production which can solve the colour uneven issue very well. This could be a good experience for other customers especially function MBs are used.
