## Building Survey

10 High Street

Anytown

August 2023

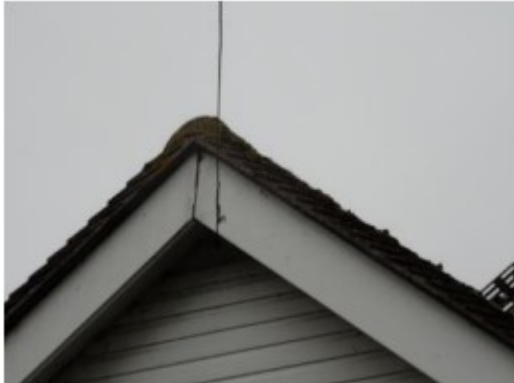
Photo 1

The roof covering is in a serviceable condition with no significant slippage or deterioration of the tiles noted. Several tiles to the left hand side of the main roof were noted to be damaged, requiring replacing in the immediate term.

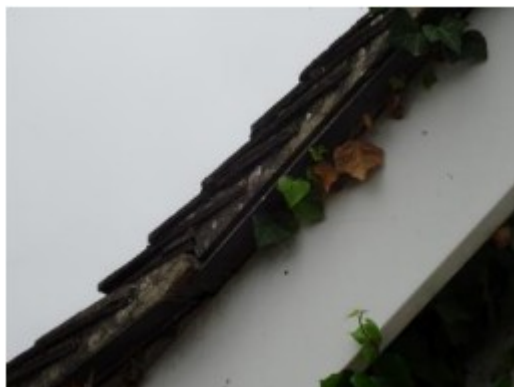
Photo 3

Where the forward facing dormer roofs abuts the main roof, tiled valleys have been formed which are noted to be relatively blocked with vegetation requiring clearing in the immediate term. It should be noted that it is necessary to keep the valleys clear of debris to prevent rainwater backing up into the roof void.
