Building Survey

10 High Street

August 2023

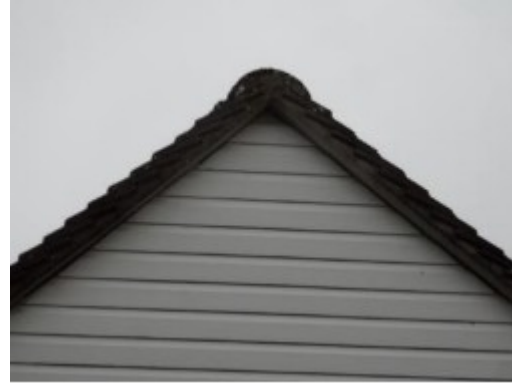
Photo 2

The bedding mortar to the ridge tiles is in good condition with the tiles firmly bedded into position.

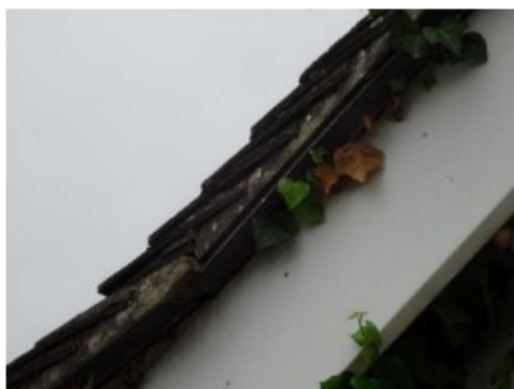
Photo 3

Where the forward facing dormer roofs abuts the main roof, tiled valleys have been formed which are noted to be relatively blocked with vegetation requiring clearing in the immediate term. It should be noted that it is necessary to keep the valleys clear of debris to prevent rainwater backing up into the roof void.
