EGLE-RRD-UpperPeninsulaEDM

**Subject: Site Assessment Report – Revision 1
5th St. Calumet Fire Site – RS
Calumet, Houghton County, Michigan
EPA Contract No.: 68-HE-0519-D0005 (START V, Region 5)
Task Order-Task Order Line Item No.: F0032-0001CF101
Document Tracking No.: 0767A**

**SITE ASSESSMENT REPORT
5th ST. CALUMET FIRE SITE – RS
CALUMET, HOUGHTON COUNTY, MICHIGAN
Revision 0**

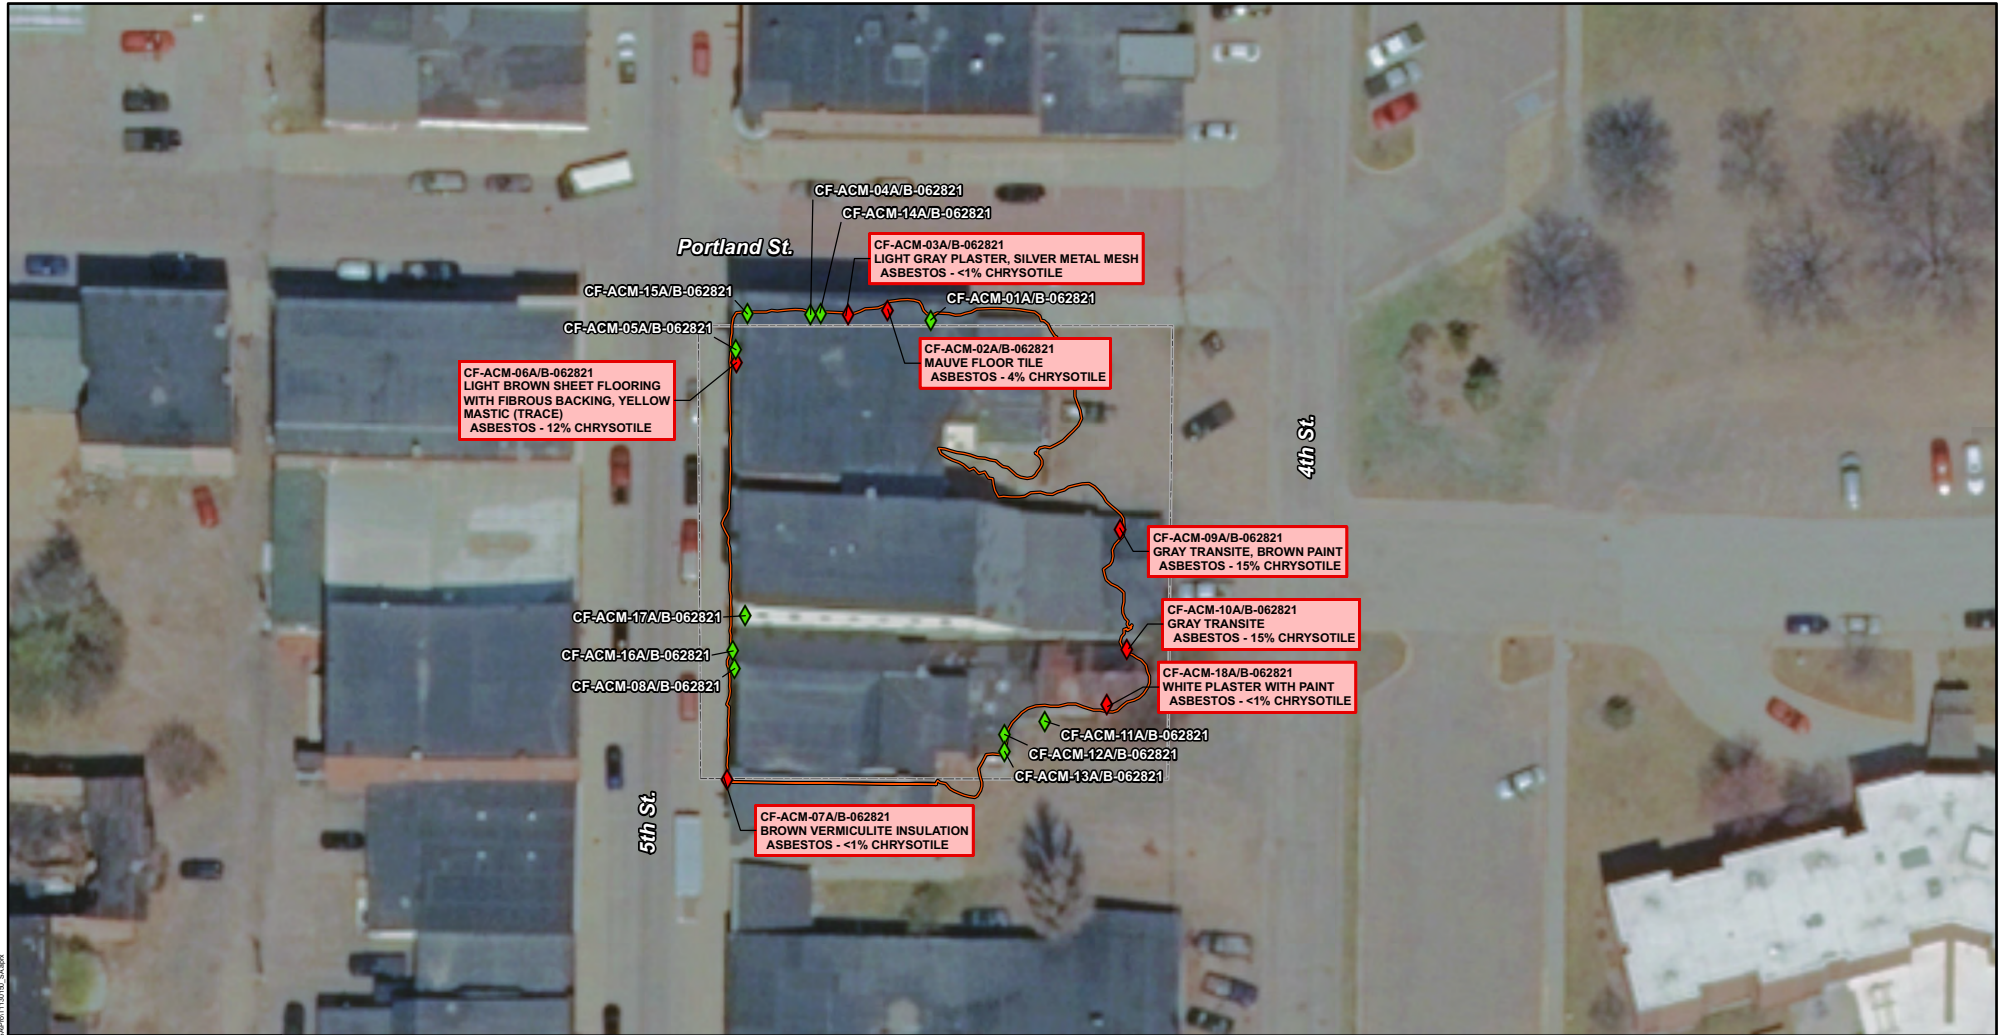
EGLE and START sample analysis detected friable chrysotile and actinolite asbestos in 20 samples. All samples collected were from the fire debris pile outside in the environment and included transite, flooring, roofing, and plaster. In addition, the observed vermiculite is presumed to be ACM. On-site friable ACM contains up to 30 percent (%) asbestos. START analytical results are depicted on **Figure 3 in Appendix A**. START and EGLE analytical results are presented in **Table 1**.

The conceptualized removal plan entails addressing a number of hazards at the site through controlled removal and disposal of the fire debris and remaining above ground structure components. **Figure 3 in Appendix A** depicts the estimated horizontal area of debris to be addressed by the conceptual removal action, **Table 2** provides the estimated debris volume, and **Table 3** provides the removal cost estimate.

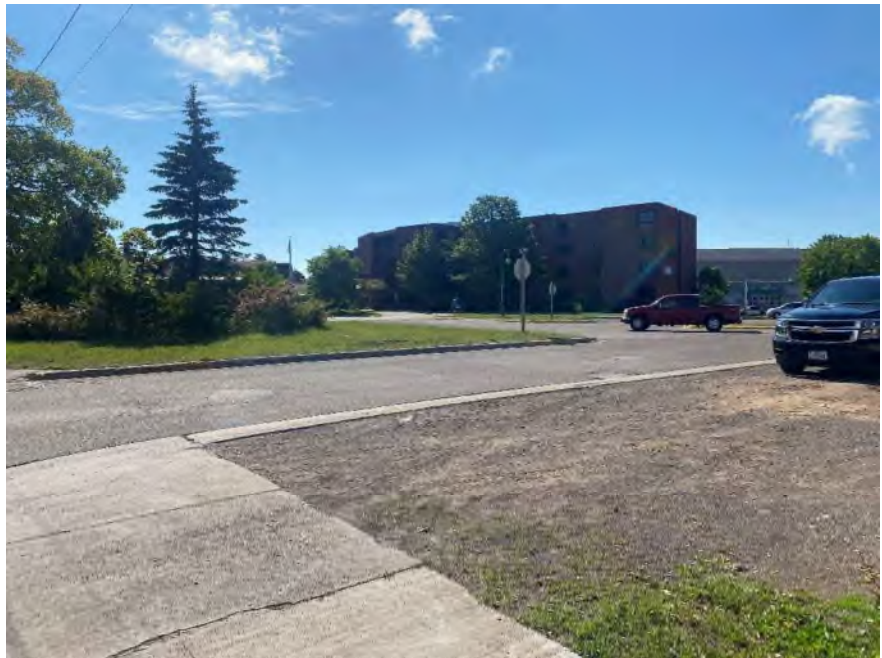
View looking east from the intersection of 4th Street and Portland Street to the public park, located east of the 5th St. Calumet Fire Site - RS.

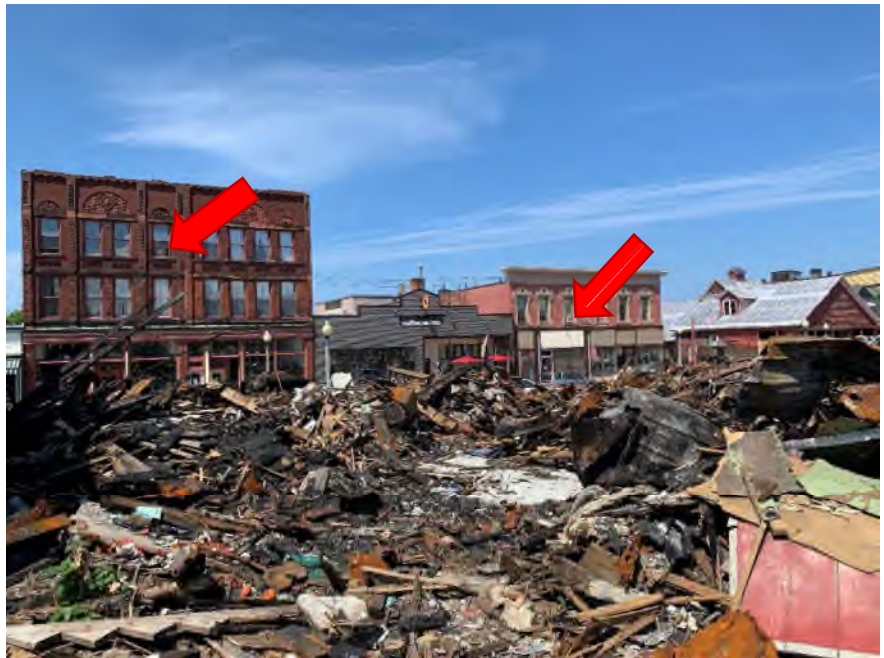
View looking northwest
across the debris piles at the
5th St. Calumet Fire Site - RS.

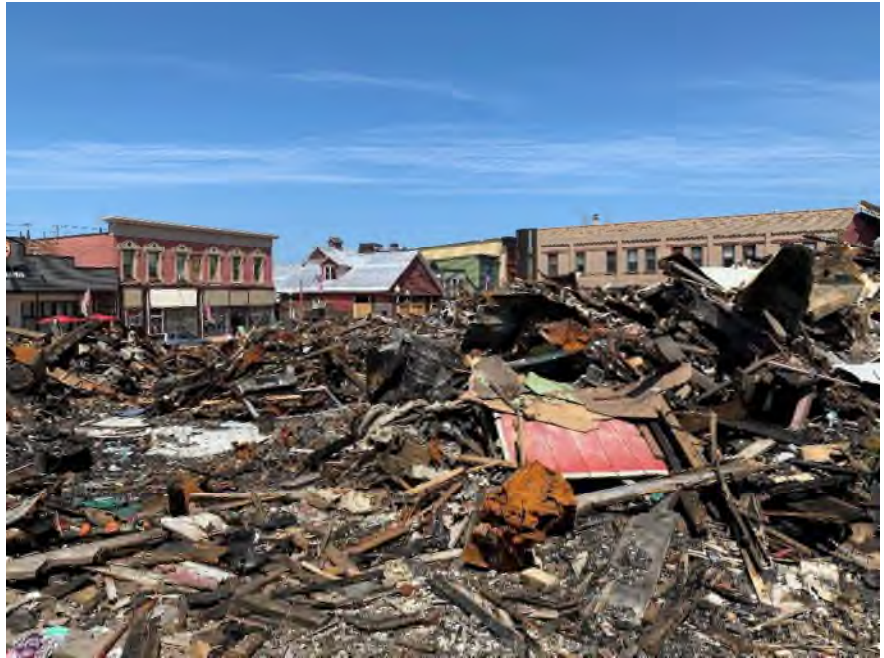
Photograph No. 6

View looking southeast at a
collapsing structure located
within the debris piles at the
5th St. Calumet Fire Site - RS.

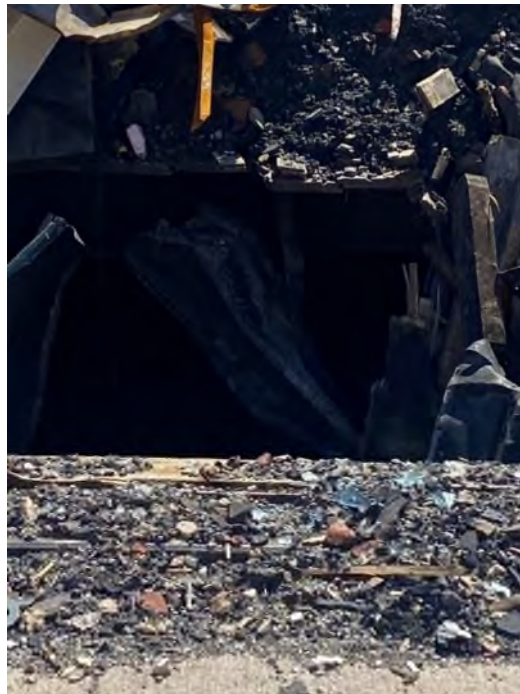
View of sorted piles of debris, which appear to have been created by trespassers along the eastern side of the 5th St. Calumet Fire Site - RS. Piles appear to be sorted into scrap metal, tools, glassware, and rock piles found in the refrigerator in the right of the photograph. Note items staged within and along the site barriers (red arrow).
