## Beckmann's Carnival in motion

– restoration work on Beckmann's Carnival is backed up by accompanying vibration measurements –

Katrin Radermacher, Daniela Hedinger, Kerstin Kracht

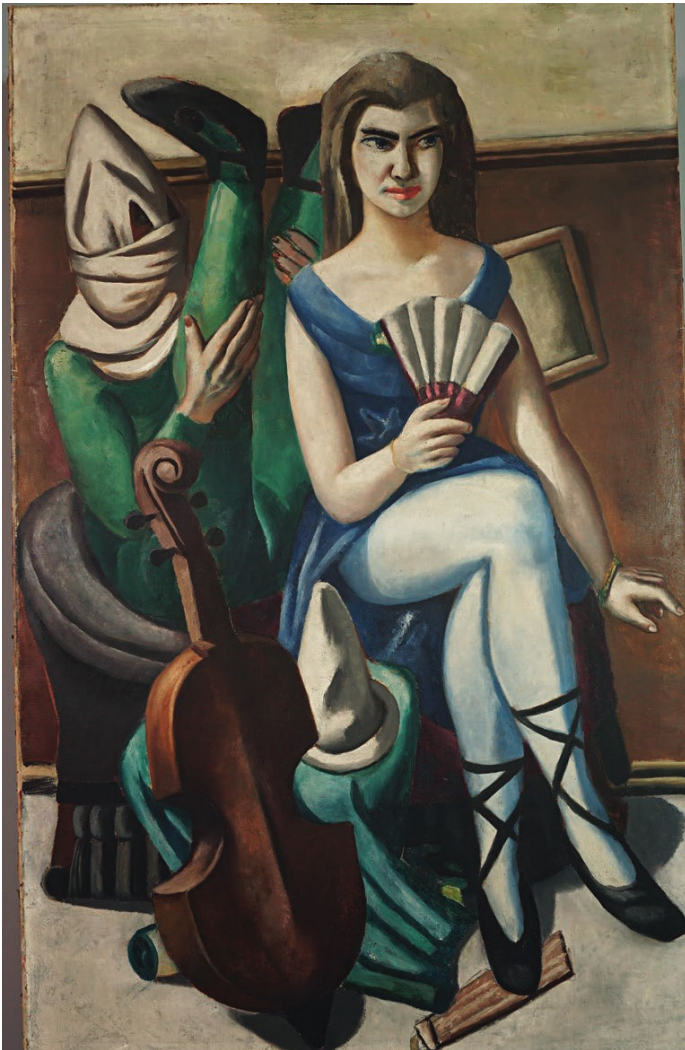
Carnival by Max Beckmann before restoration, © D. Hedinger, K. Radermacher

Why was Beckmann's Carnival chosen? On the one hand, it is one of Kunsthalle Mannheim's most important works. On the other, preliminary examinations of the painting showed that it was an ideal test case for metrological examination and answering the questions posed above. Before the restoration, this painting was a poorly tensioned portrait-format canvas, incorrectly stretched at the edges, with cracks and holes at the bottom corners and poor paint layer adhesion in places.

and weaving errors. In the area of Quappi's face, for example, some weft threads are missing. The tension was generally insufficient and uneven, the canvas sagged and flapped about as it moved and there were clear indentations (especially along the edges). The staples stretching it were at distances of up to 12 cm apart. The stretcher frame was not aligned perpendicularly before clamping but was instead shifted to the left to create a parallelogram; additionally, it is warped so that the upper right corner has moved about 1 cm backwards.

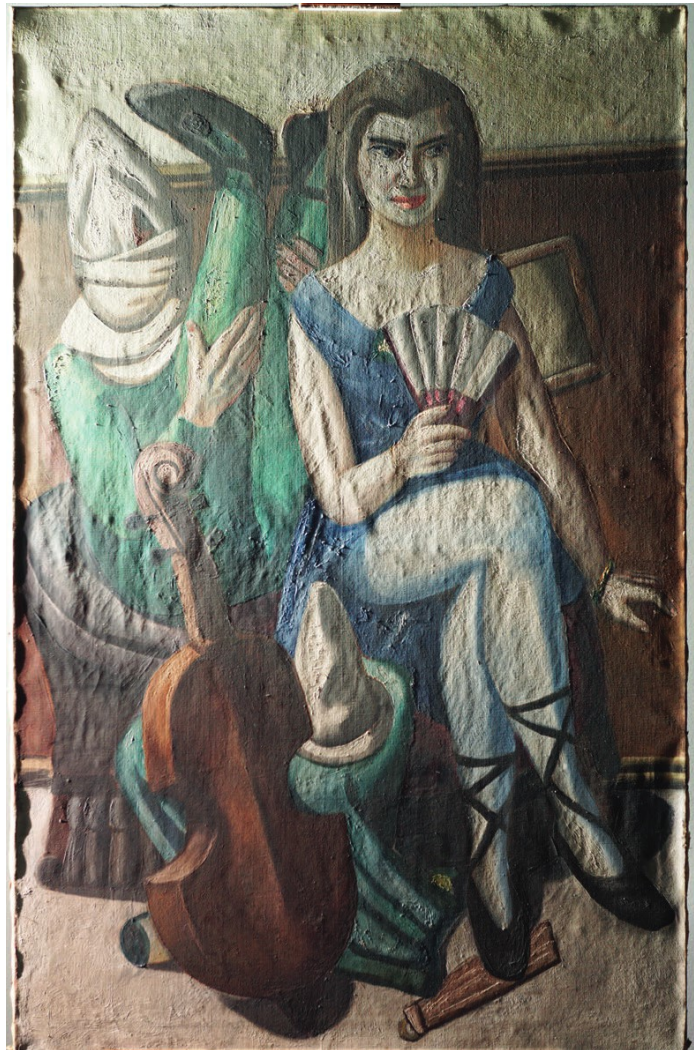
Detail, oblique light from the left, significant unevenness and departures from the plane, © D. Hedinger, K. Radermacher

First, the back of the stretched canvas was cleaned several times in multiple layers. The unevenness of the canvas was levelled several times. Smoothing out the incorrectly kinked edges where it had been stretched was done through the slow action of moderate direct moisture and weighting. Threads around the nail holes were put back in place and glued according to Heiber's method. A 65 µm thick Beva film was applied to the edges of the canvas strips (10 cm wide, washed, stretched and ironed). After alignment, the painting was first stretched by hand with pins on the restored stretcher frame. The tension of the picture support was carefully increased step by step with a collet and finally fixed in place using the existing nails (the rust had been mechanically removed from them and they had been covered with Cosmoloid) as well as blackened tacks. Using all the existing holes in the clamping edge allowed excellent uniform canvas tension to be achieved, which was also reflected in the subsequent measurements.

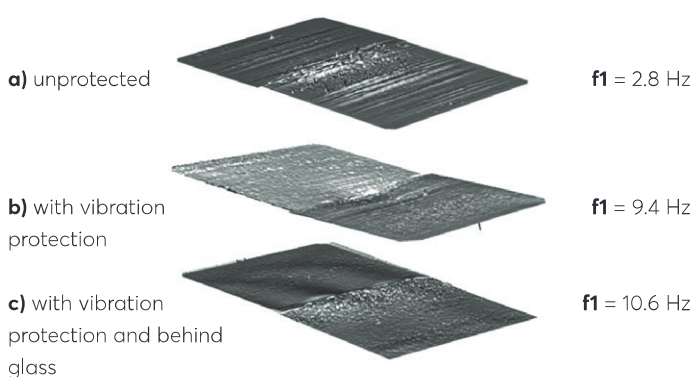
Characteristic vibration modes of the three configurations, showing the fundamental vibration frequency in each case, © Dr Kracht Vibration Management

Both the vibration protection and the glass elevate the lowest vibration frequency and reduce the amplitude of the vibration. The typical waveform of the vibration was also successfully flattened out. These three effects are all desirable because measures to reduce vibration, such as vibration insulation, require a minimum frequency. The smaller the amplitude of the vibration and the less curved the first vibration pattern is, the lower the internal mechanical stresses. However, even in configuration (c) the midsection responds with random oscillations to the excitation.

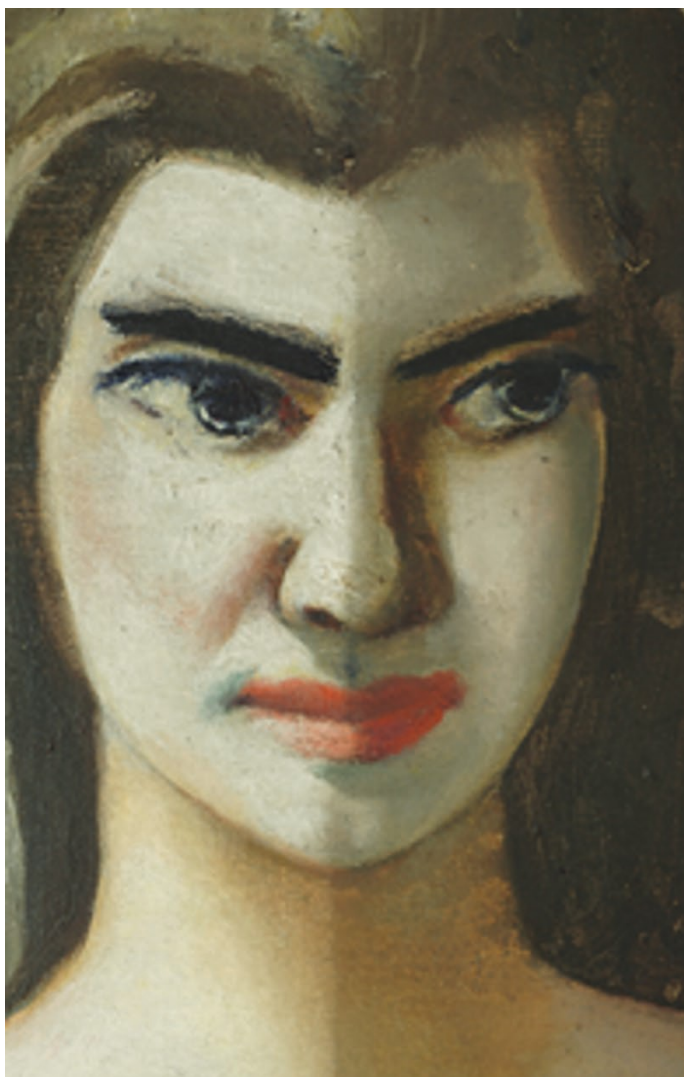
As is typical for much-travelled paintings, the paint layer had suffered friction in several places and showed various kinds of partial staining. The paint layer had, as a later addition, been given a thin coat of wax over the entire surface. The entire painting was covered with a very thick layer of surface contamination that was black, comprising finely divided particles, oily and tackily sticky. Underneath the wax was another layer of dirt, directly on the paint.

Detail of the face of Quappi during surface cleaning, © D. Hedinger, K. Radermacher

The heavily contaminated surface of the paint layer was first cleaned under dry conditions. After consolidating layers of paint that were coming loose using rabbit-skin glue and a heating spatula, the solid dirt deposits were removed from the surface with cotton swabs and (because it proved highly effective) the restorer's very own saliva. The wax coating was removed with Shellsol T and the impasto areas were brushed off with a small hair dabbing brush. The layer of dirt under the wax was again removed with saliva. Final cleaning was done with distilled water. Finally, mastic work and structuring were done with chalk mastic, followed by retouching using watercolours of the mastic, minor flaking, friction areas and numerous small round protrusion blisters in the paint layer.

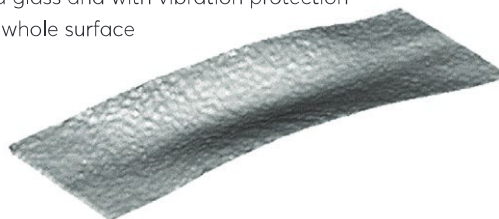
**c)** Behind glass and with vibration protection over the whole surface

Characteristic vibration waveform of the central area of the painting at the fundamental vibration frequency of 15 Hz in configuration (c), © Dr Kracht Vibration Management

The lowest characteristic vibration frequency remained the same, at 15 Hz, but the waveform measured at high resolution in the middle of the painting is smooth and flattened. In configuration (c), the amplitudes of the oscillatory response are less than 1% of the amplitudes in configuration (a) before restoration; this is primarily due to the full-surface vibration protection.

Accordingly, correspondingly thinner polyester fleece was inserted under the transverse central strut and tied in place with polyester thread. With the backing cardboard laid in place, the fleece touches the canvas very gently. Slight contact with the painted support as well as the stretching of the canvas (where still justifiable in terms of the restoration) give extremely positive effects in the vibration measurement results.

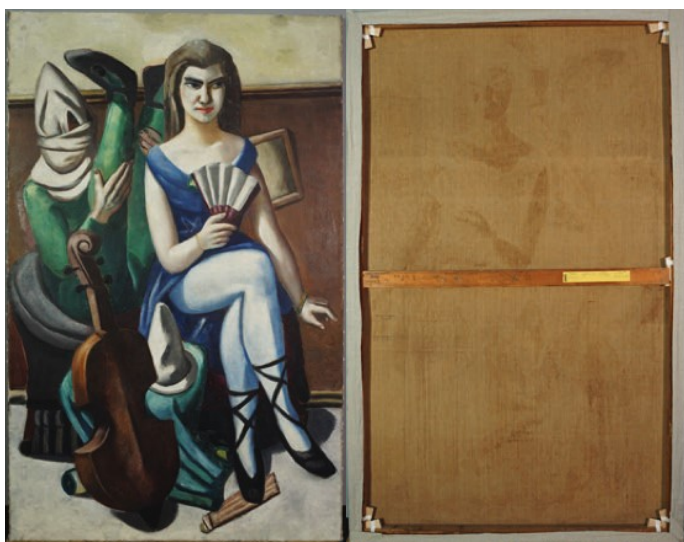
Final status, front and back, © D. Hedinger, K. Radermacher
