ES_CMT453x Series Errata Sheet V1.1.0

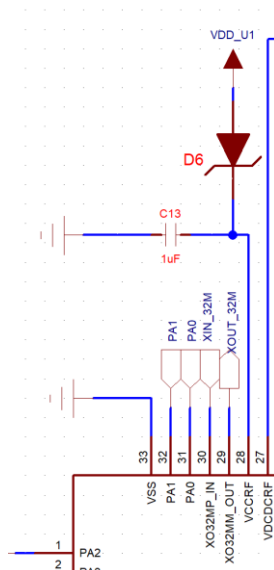
2.3 LSI issue affect wake-up

For chip version B and C, when the power supply VCCRIF over 3V, there is risk of LSI, which will lead to abnormal wake-up of the Bluetooth protocol stack.

Ensure that the power supply VCCRIF is lower than 3V. We recommend that VCC be connected to VCCRIF after a diode to reduce the voltage, as shown in the following reference figure. The recommended diode models are BAV21W, BZT52C3V6 and BAP1321.
