PBCU Maturity Plan

TRM at Umbra facilities November 16th, 2016

Prepared by: Raphaël GUILLORY, PBCU Owner

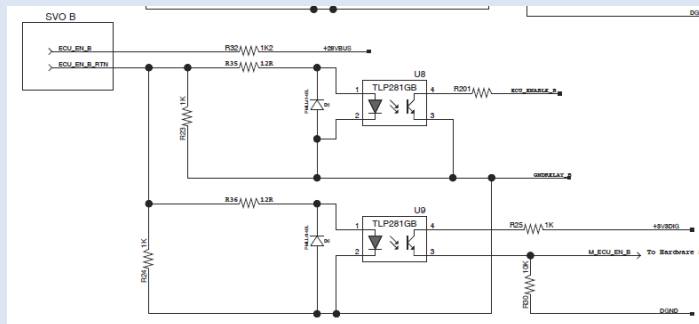
Issue : Design error on discrete interface

- On discrete interface (SVO A & B), conditioning interface is redundant (this is not a requirement).
 - ✓ The consequence is an output current in excess : 8mA
 - ✓ Requirement is : 4mA maximum

- No compliance on Airbus requirement
- Impact on interface not studied.

- ✓ Apply electronic design correction (hardware only)

- PBCU control board redesign
