**Government of India
Ministry of Mines**

**Geological Survey of India
State Unit: Tamil Nadu and Puducherry**

**A note on preliminary assessment of landslides at TNEB colony, Emerald,
Nilgiri District, Tamil Nadu**

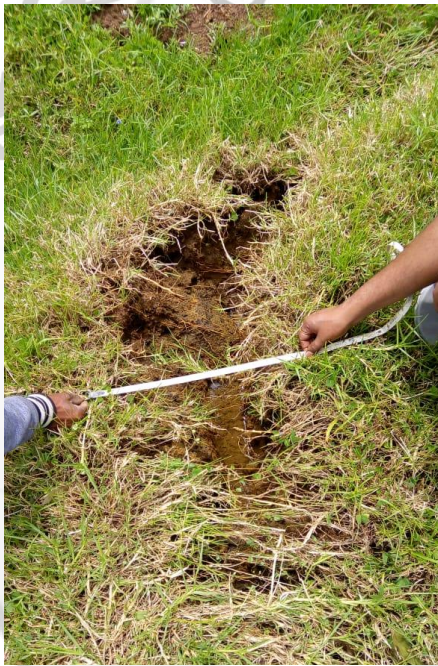
The slide is a complex type of slide, which initiated as cut slope failure and the subsequently leading to the earth flow. Ground cracks ranging from 5-10 cm were observed in the close vicinity of the slide, which also indicates chances of future reactivation, if untreated. Ground subsidence of about 1 m was observed in the slide zone. The slope forming material is mainly lithomargic clay/soil having a thickness of about 5-6 m

Fig: Ground crack observed in the slide vicinity

1. Diversion of the drainage - by Lined toe drainage
2. Benching of the slopes

3. Construction of retaining wall with weep holes

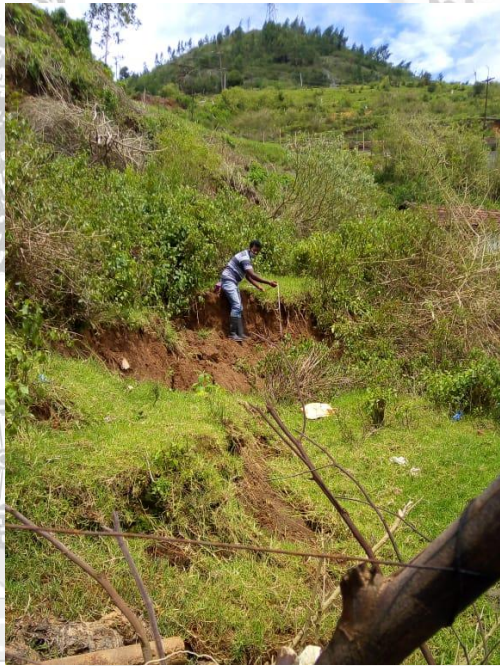
Fig. Subsidence in the slide area

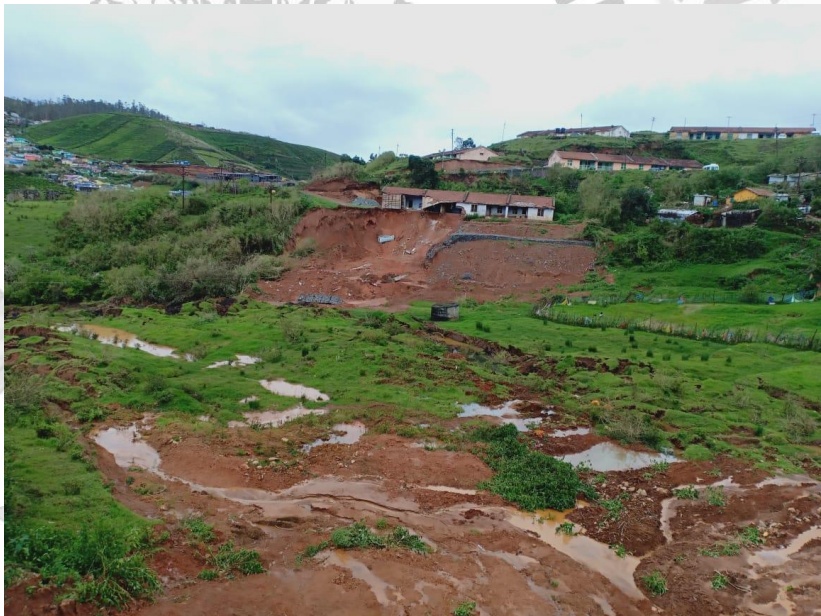
29	Triggering Factor	Heavy rainfall
30	Death of persons	Nil
31	People affected	Nil
32	Live-stock loss	Nil
33	Communication	Cracks developed in approach road to the top of the slide
34	Infrastructure	4 nos. of houses (TNEB quarters) fully damaged.
35	Agriculture/forest/Barren	Agriculture
36	Causes	1. Heavy rainfall 2. Anthropogenic activity (steep cutting of slope)
37	Remedial measures	1. Construction of retaining wall with weep holes 2. benching of the slopes 3. lined toe drainage
38	Remarks, if any	This is a complex slide. Initiated as cut slope failure, then followed by soil/earth flow.
39	Photos. Sketch of Plan & section of the slide

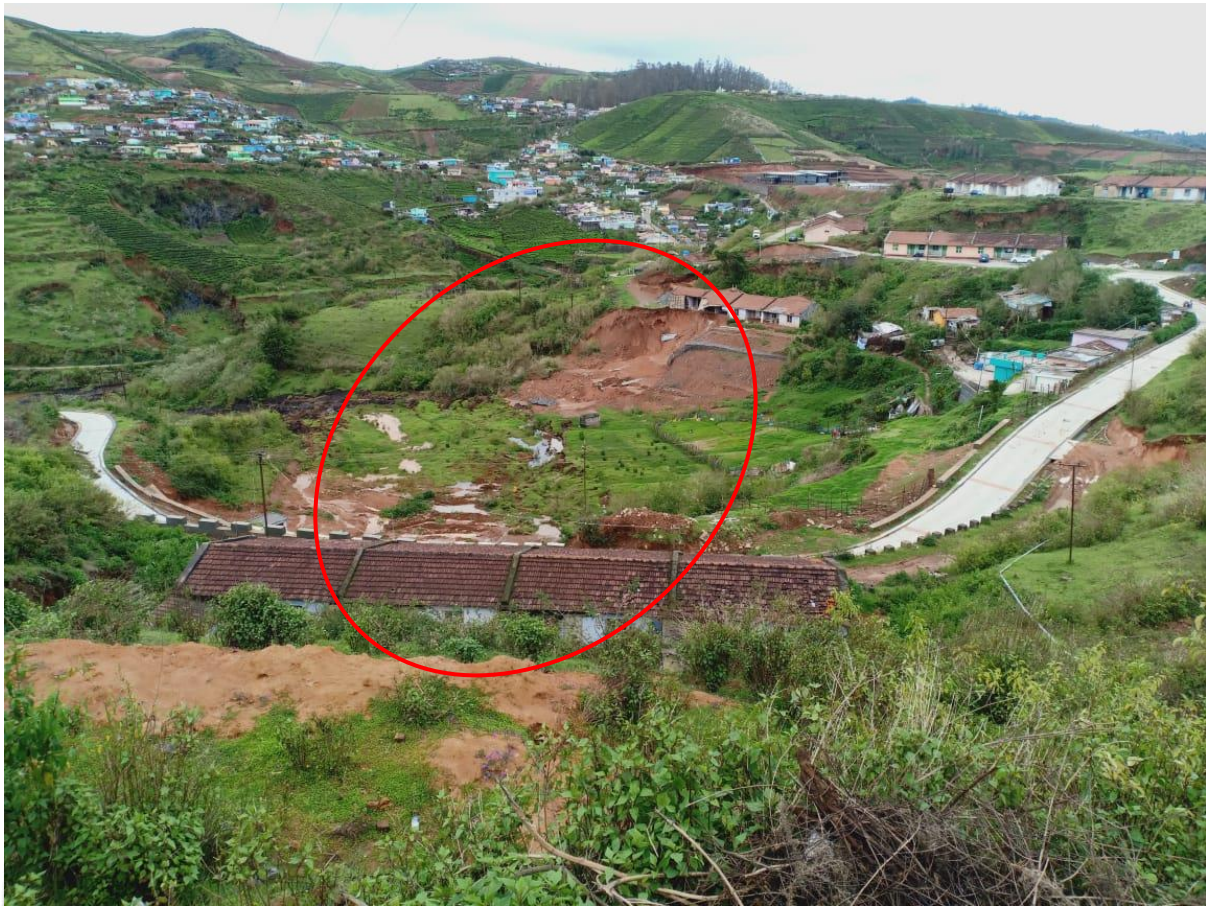
40	Summary/Abstract	An earth flow has taken place in TNEB colony, Kundah, Nilgiris on 6 th August 2020, leading to the total damage to 4 nos. of houses. the slide is a complex type, which initiated as cut slope failure and the subsequently leading to the earth flow. Ground cracks were observed in the close vicinity of the slide, with are indications of chances of future reactivation, if untreated. The slope forming material is mainly lithomargic clay/soil having a thickness of about 5-6 m. Suitable remedial measures in the form of benching ogf the slope, followed by provision of retaining wall with weep holes and lined toe drainage has been suggested for the slide.

Fig: Panoramic view of the slide area
