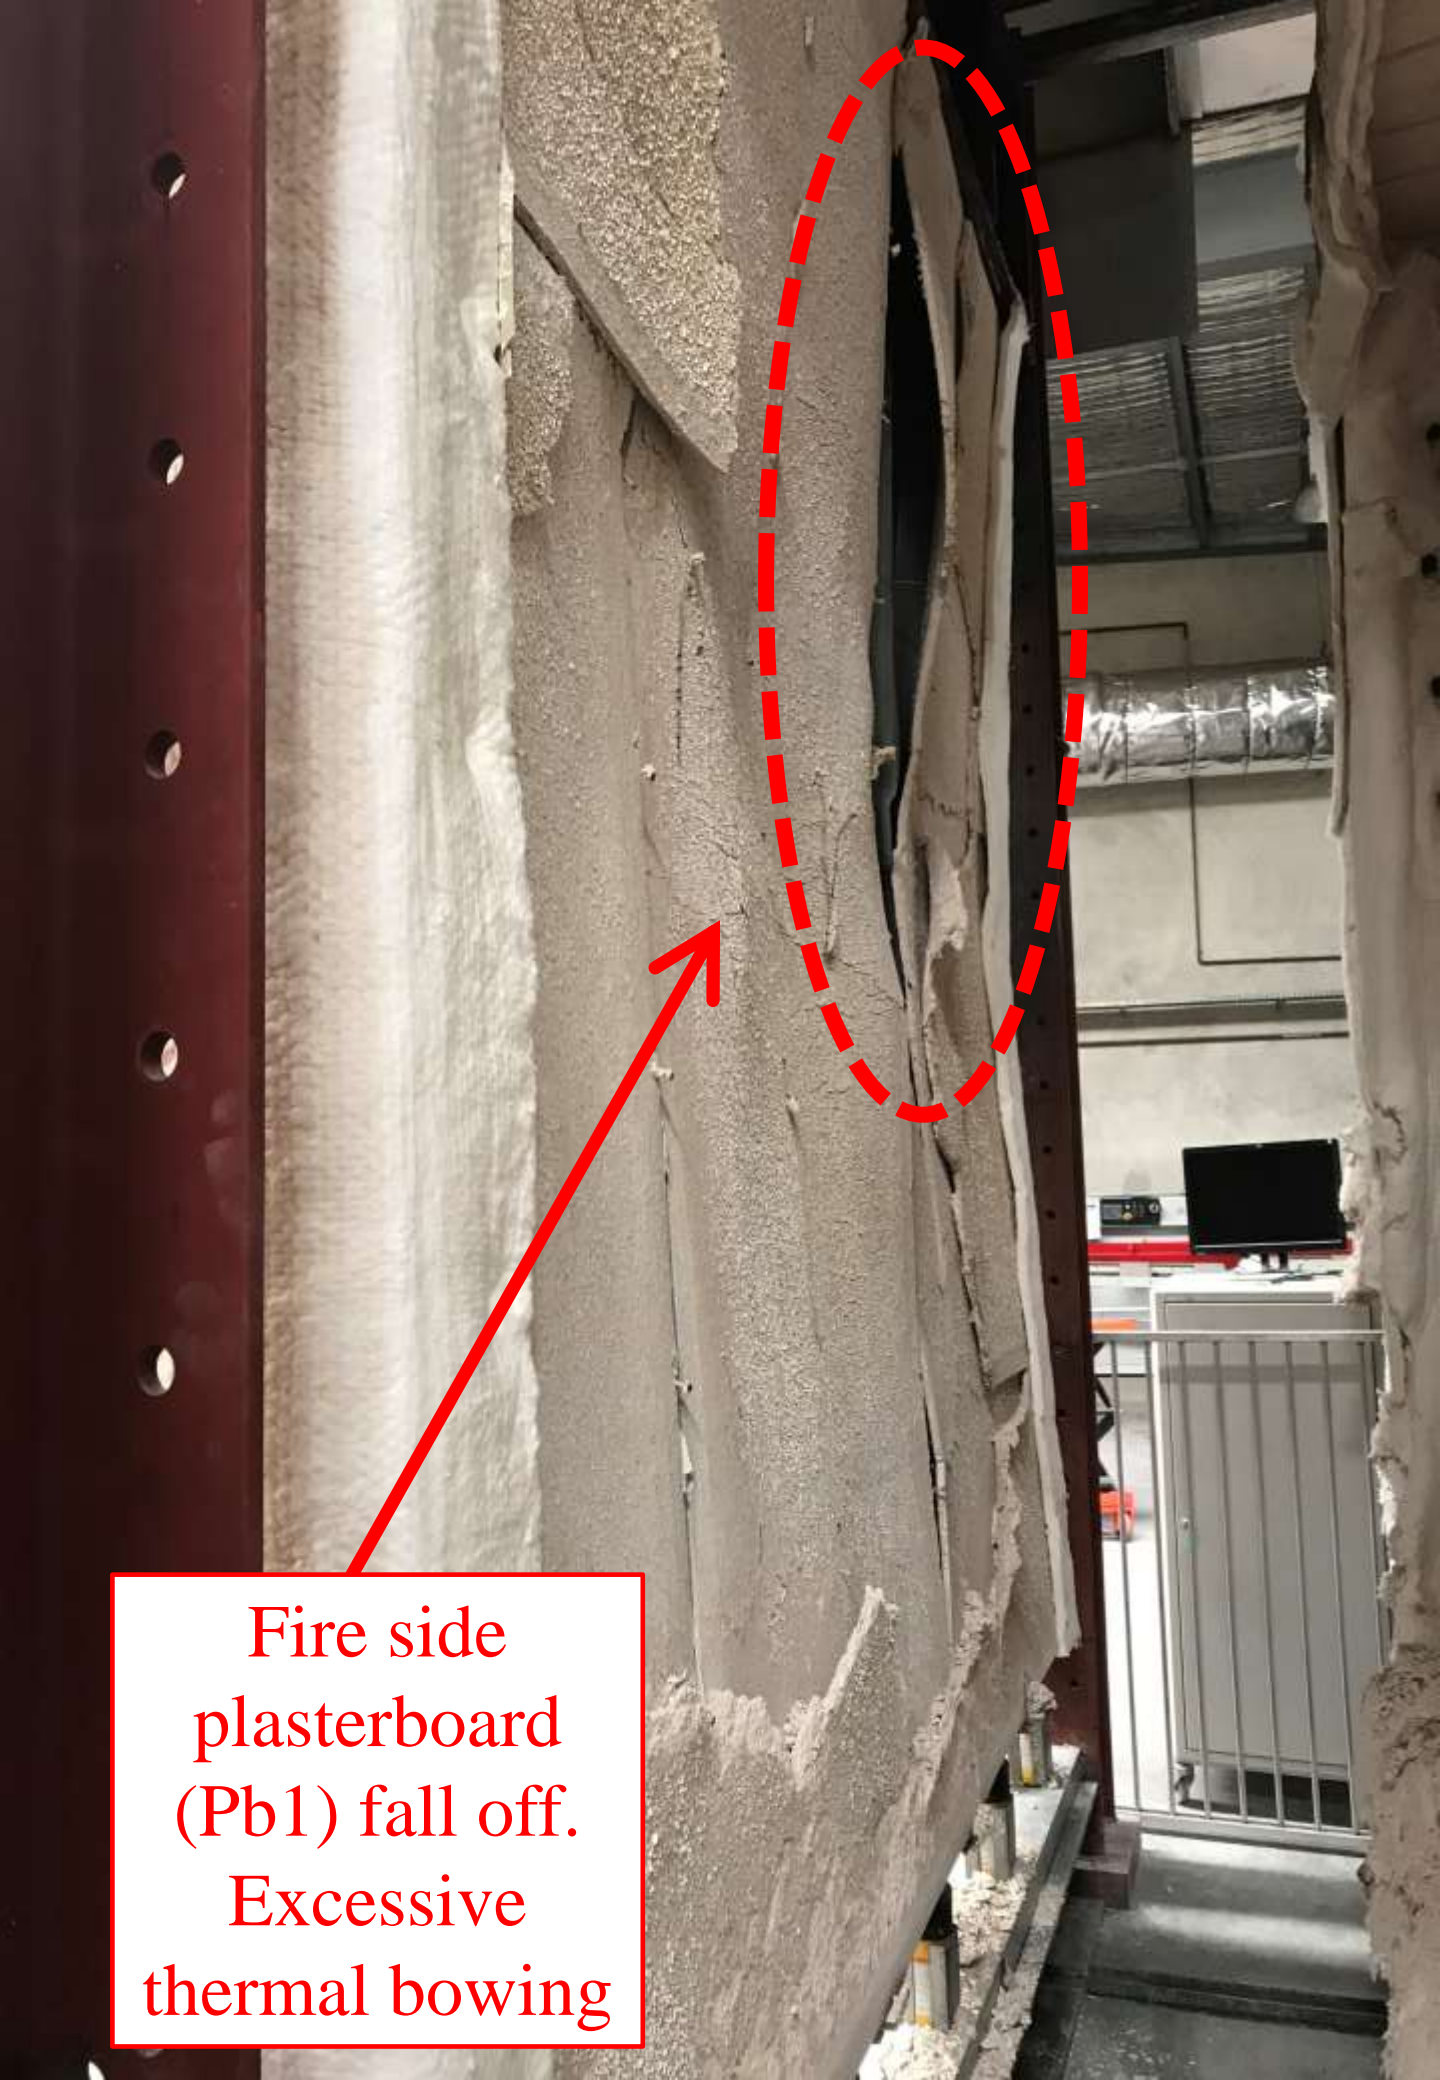
Fire side  
plasterboard  
(Pb1) fall off.  
Excessive  
thermal bowing
