Building and Timber Pest Inspection Report

Inspection Date: Thu, 20 Jul 2023

Property Address: 67 Ferris St, Annandale NSW 2038,
Australia

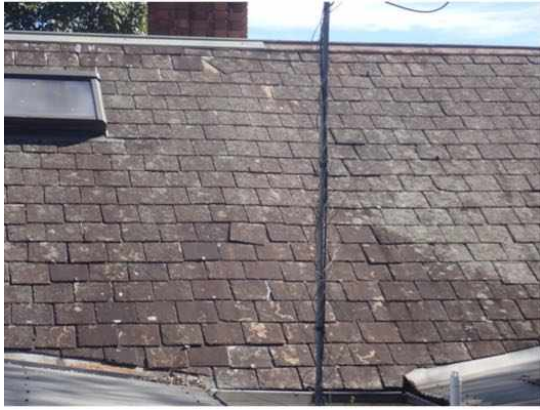
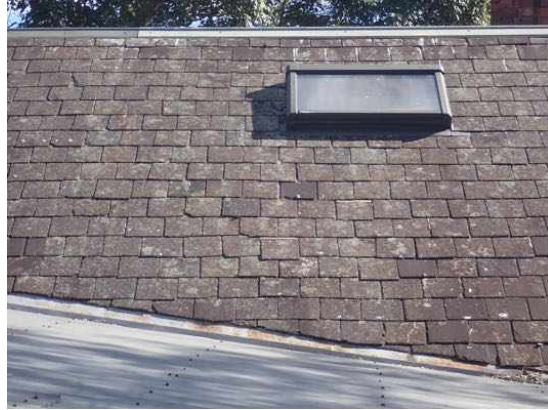
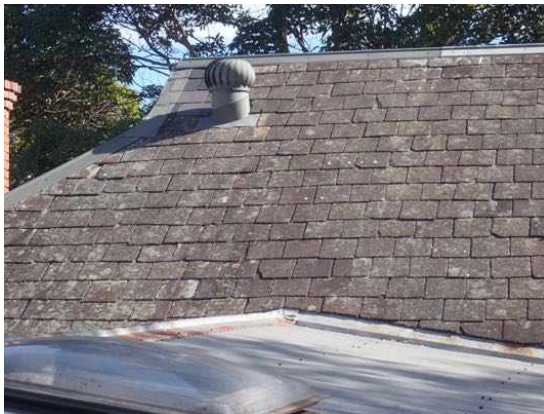
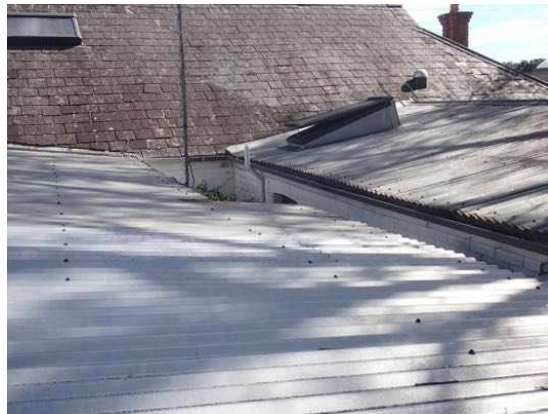
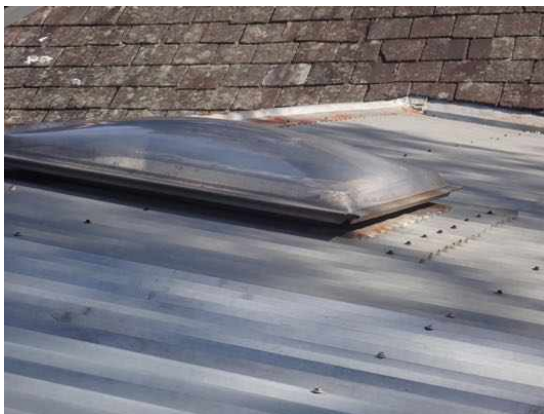
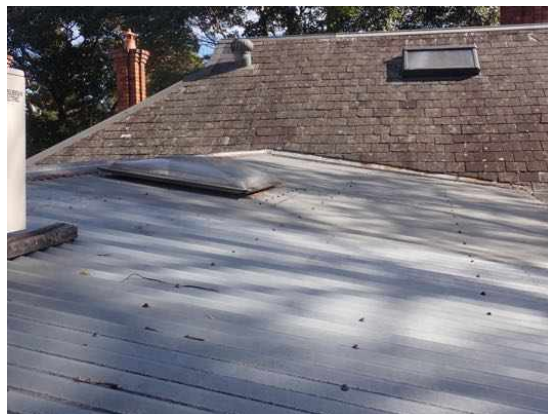
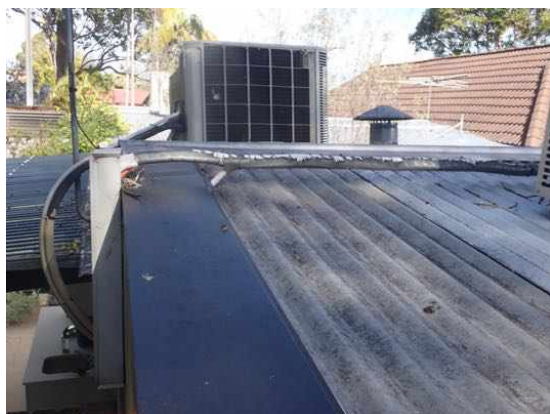
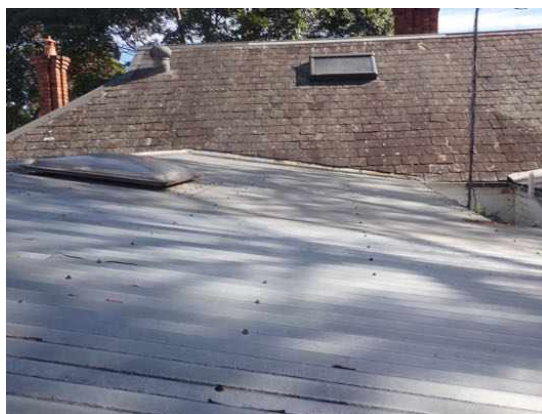
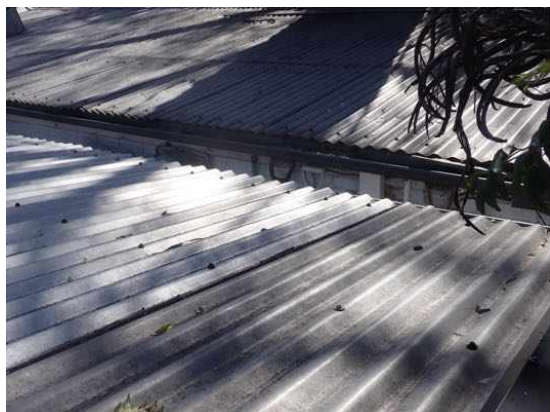
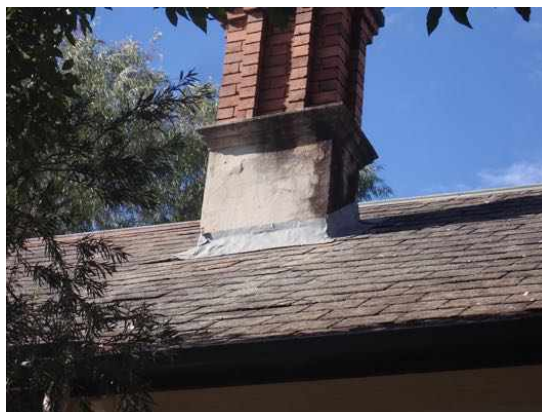
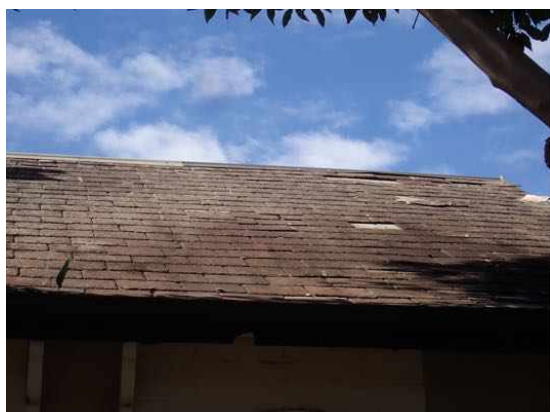
Building:	Main Building
Location:	Roof Exterior
Finding:	External Roof Coverings & Plumbing
Information:	The New South Wales area experiences major weather events annually. These periods of storms and torrential & driving rains from certain angles can overwhelm residential roofs, waterproofed areas, skylights, flashings & guttering causing water ingress into properties that other wise would not happen in normal rain conditions. Therefore no guarantee can be given against any future roof leak.

All roof coverings & plumbing, flashings, exterior guttering, box gutters and downpipes, even with gutter guard products installed, should remain free of all debris and possible blockages. Any areas of missing guttering replaced. Blockages may lead to pooling, accumulated water overflows, possible water ingress and the associated damage to adjoining building elements.

- Areas of corrosion, patched areas of flashing and installed sealant should be replaced.

- Areas of weathered or water damaged timber trims should be replaced.

- Areas of aged / damaged slate tiles should be replaced.

At the time of the inspection all visible internal ceiling areas appeared dry with no signs of any water ingress or staining. All internal ceiling areas should be monitored during weather events.

- Improving ventilation, the installation of mechanical ventilation (whirly bird fans) is recommended to improve/ optimise roof void airflow and to manage moisture & temperature levels through out the property.

A further inspection by a Licensed Roofing contractor is recommended to go over the complete roof covering and advise on the extent of replacement/ repair & maintenance items.

Regular inspections & maintenance of all roof coverings & plumbing should be conducted.

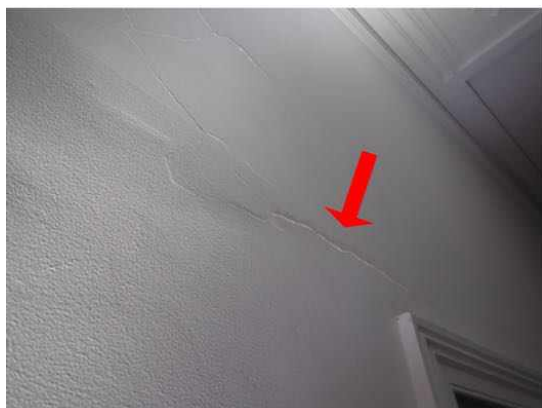
Finding 3.02

Building:	Main Building
Location:	Masonry Walls
Finding:	Cracking - Masonry - Damage Category 2 - Noticeable (up to 5mm)
Information:	Localised cracking was evident to sections of the internal masonry walls

This type of cracking is common to properties of similar age and type. Such causes may include age, general wear and tear, expected building movement, general expansion/contraction of building materials in different weather conditions.

Monitoring of all cracking should be conducted frequently. Always contact a building inspector should cracks widen, lengthen, or become more numerous.

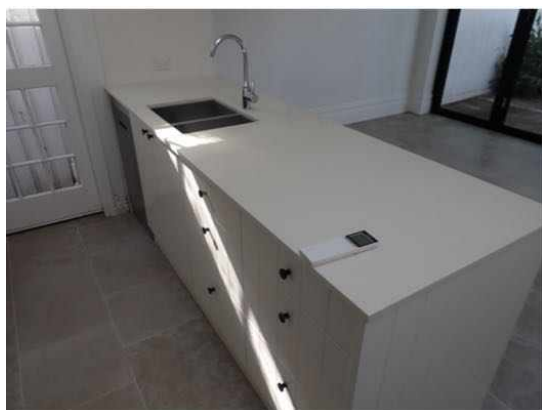
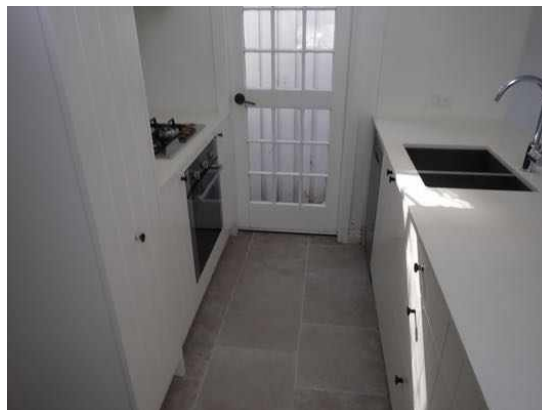
Building: Main Building
 Location: Doors & Windows
 Finding: Door & Windows - Servicing
 Information:

The doors & windows generally were found to be in serviceable condition, areas of weathering, binding / jamming were noted, with some fixtures/ locking & weather seals in need of serving.

Building: Main Building
 Location: Internal Joinery
 Finding: Internal Joinery - Condition
 Information:

The internal joinery including kitchens, bathrooms & wardrobe units were generally found to be in aged but usable condition.

- Water damage was noted to sections of the kitchen & laundry joinery.

- Note any aged/ deteriorated sealant & grout should be replaced.

A licensed builder can advise further on the extent of replacement of any old/ aged cabinetry at the owners discretion.

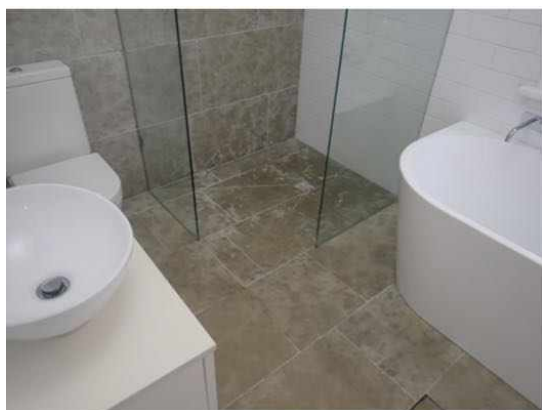
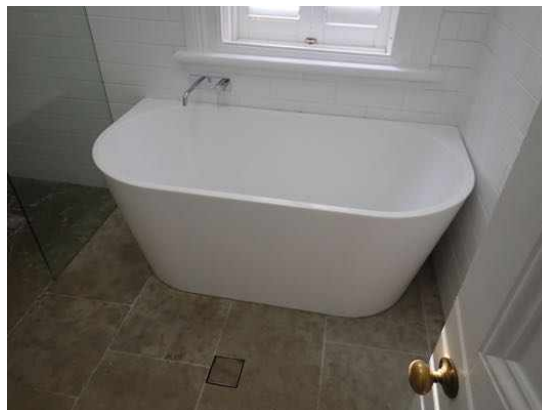
Finding 3.05

Building:	Main Building
Location:	Wet Areas - Waterproofing Membranes
Finding:	Water Proofing Membrane - Certification
Information:	Internal Water Proofing Membranes, are crucial in preventing water ingress into the property is important to know that the Membrane System used is to Australian Standards and has been installed correctly.

No guarantee can be given against waterproofing membrane failure. If any leaks, water staining, peeling or bubbling of the paint become evident to any adjacent walls or ceilings below a licensed builder or waterproofing specialist is recommended to investigate further.

Any aged/ deteriorated sealant & grout should be replaced, Improved ventilation is recommended to all wet areas. Replacement of all old/ existing wet areas should always be factored in.

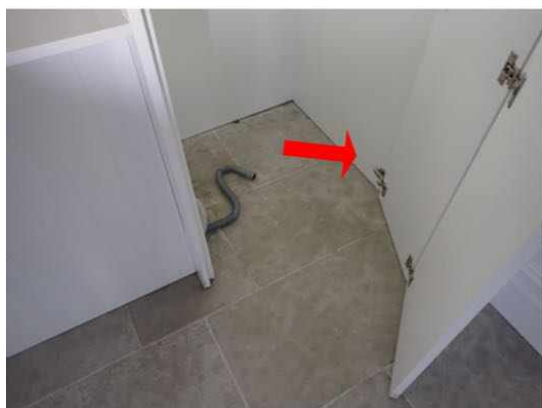
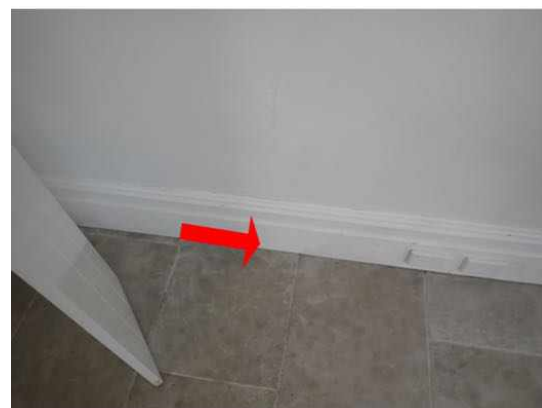
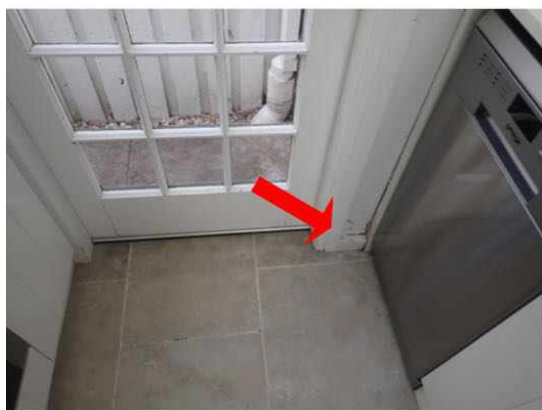
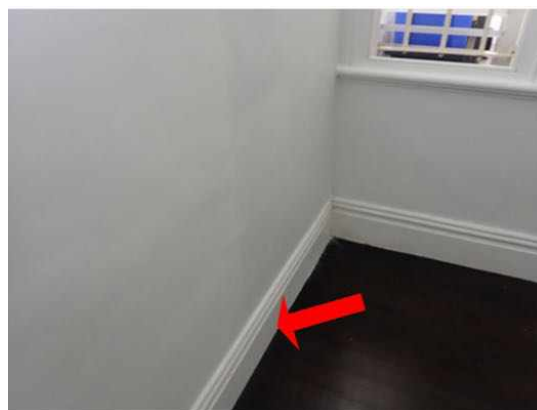
Finding 3.06

Finding: Masonry Walls - Moisture Levels

Information: At the time of inspection, most areas of the lower ground floor masonry walls appeared dry with normal (low) moisture readings detected in the tested areas and no visual signs of any rising or lateral damp evident. High moisture levels (damp) were evident to sections of the second bedroom & left side rear living room wall, with damage noted to the timber skirting.

A licensed damp proofing specialist is recommended to advise further on sealing solutions of all ground floor walls.

Installation of a new DPC may needed in the affected sections of the walls, along with improved subfloor ventilation & ground/ stormwater drainage.

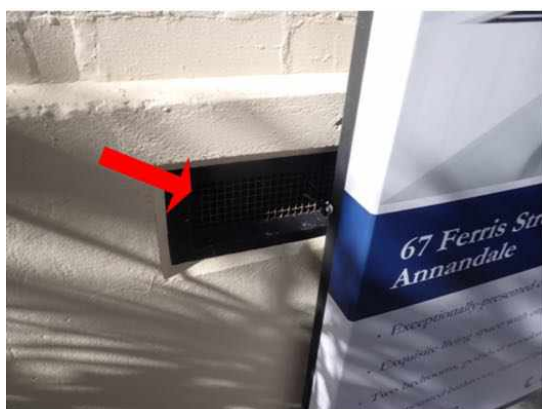
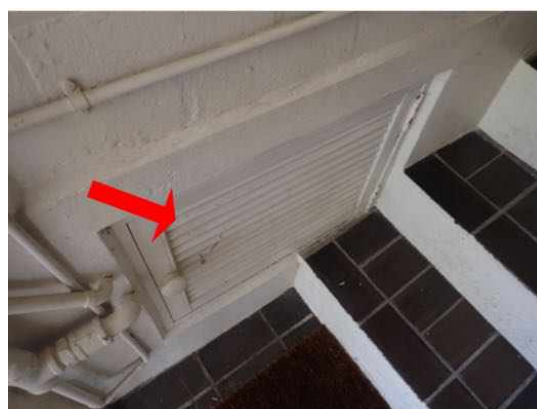
Finding 3.07

Building: Main Building
 Location: Subfloor
 Finding: Subfloor - Maintenance
 Information: With 'subfloor' type construction, good ground/ stormwater drainage & ventilation/ air movement is crucial in maintaining dry conditions, preventing rising damp and/ or secondary damage such as wood rot and pest activity.

- Subfloor vents were noted to the front of the property.

- Improving ventilation, the installation of mechanical ventilation (ducted fans in the subfloor & roof void) is recommended to improve/ optimise subfloor airflow and to manage moisture levels through out the property.

Subfloor areas should be monitored ensuring moisture levels, drainage & ventilation remains adequate.

Further inspection by a licensed builder is recommended to provide access to all areas for regular pest inspections & maintenance.

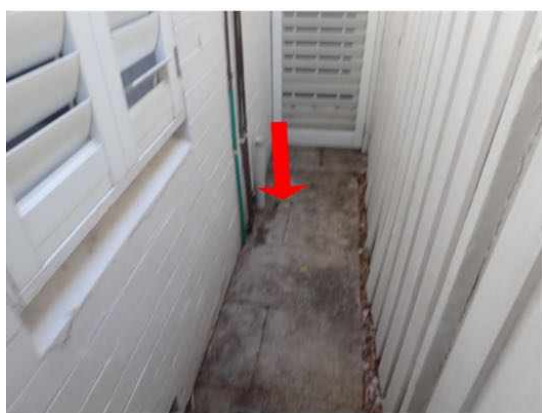
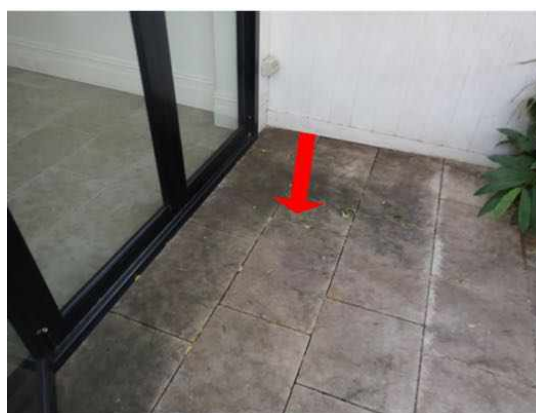
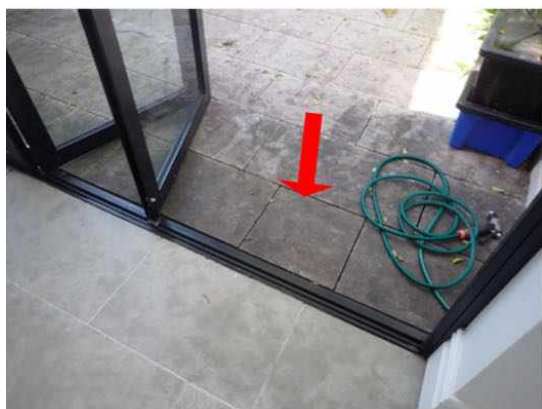
Finding 3.08

Building: Main Building
 Location: External Drainage
 Finding: Stormwater Drainage - (maintenance)
 Information: Storm water drainage points were noted to the sides and rear of the property.

It is important that water does not lie against the base of walls; surrounding paths and ground levels should be sloped to drain water away from walls creating potential for subsequent water damage to associated building elements, all external stormwater drainage should be monitored, licensed plumber can advise further on regular maintenance solutions.

These areas should be monitored during rain events to insure water flow is adequate.

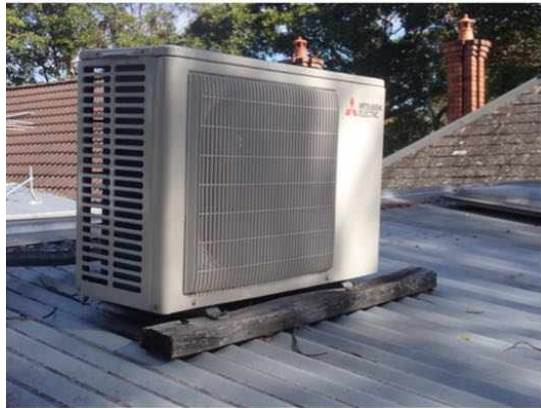
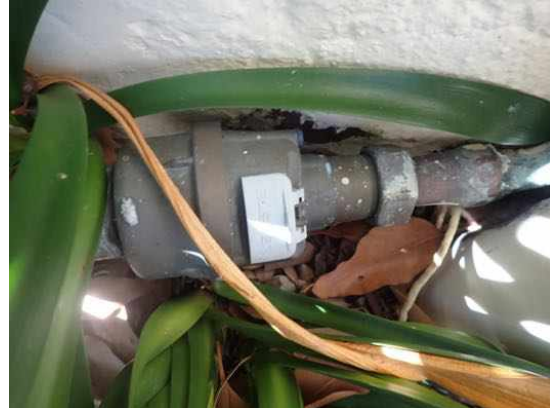
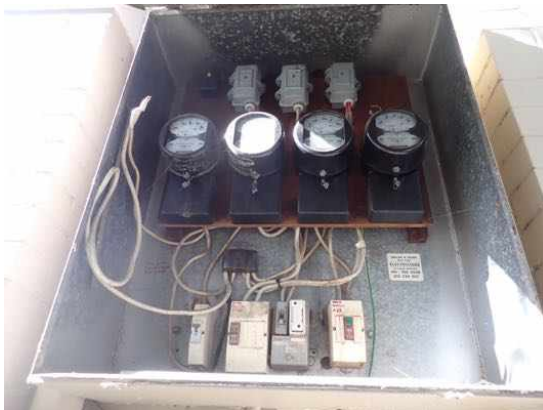
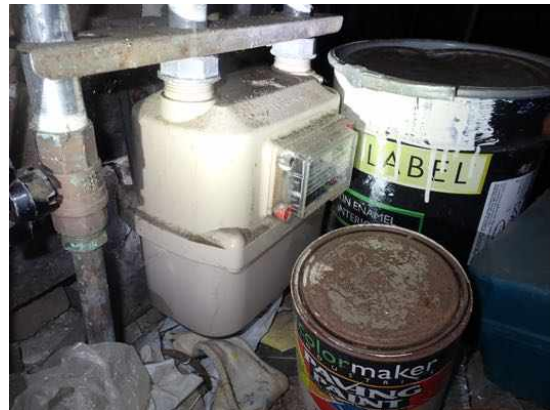
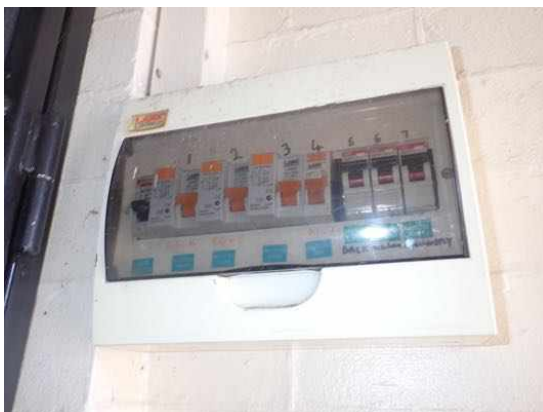
Finding 3.09

Building: Main Building
 Location: Services
 Finding: Services - Maintenance
 Information: Refer to the original building documentation or service/ maintenance manual for electrical, hydraulic, mechanical, drainage, water storage and/or any special item information.

It is recommended that a Licensed Electrician and a Licensed Plumber check over any newly purchased property with the new owners to avoid any electrical or plumbing problems in the future and to instruct new owners on proper use, care and maintenance of all electrical, plumbing and any other elements to prolong their life time and safety.

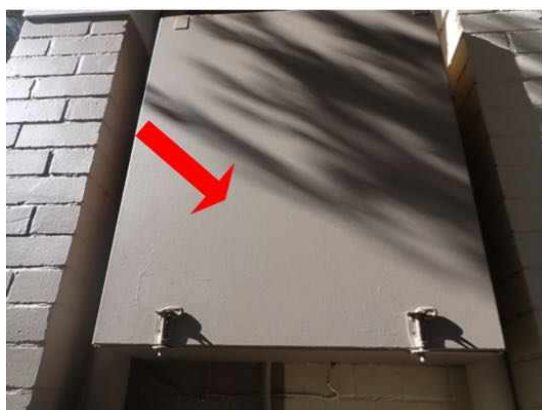
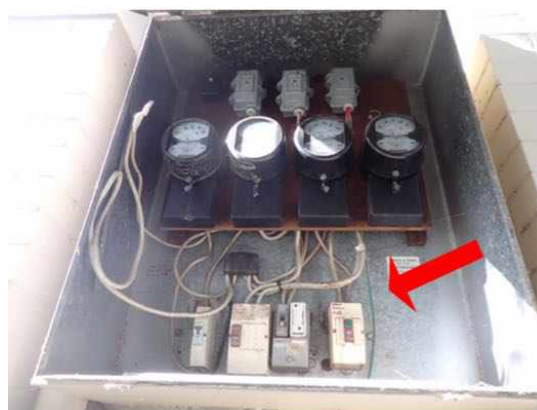
Building:	Main Building
Location:	Mains Board
Finding:	Termite Management System - no evidence of installation
Information:	The application of a post-construction chemical termite barrier is highly recommended for all properties.

A durable notice should be placed in the switchboard unit to indicate current termite barriers. At the time of inspection, it appeared as though no termite management system has been installed.

A further invasive inspection by a licensed termite treatment specialist is recommended to advise on management & treatment solutions.
