**INVESTIGATION REPORT ON SERIUOS INCIDENT TO M/s GLOBAL  
VECTRA HELICORP LTD. AS350B3E HELICOPTER VT-RRH AT  
PANCHTARNI ON 10.07.2023**

**INVESTIGATION REPORT ON SERIOUS INCIDENT TO M/s M/s GLOBAL VECTRA  
HELICORP LTD. AS350B3E HELICOPTER VT-RRH AT PANCHTARNI ON  
10.07.2023**

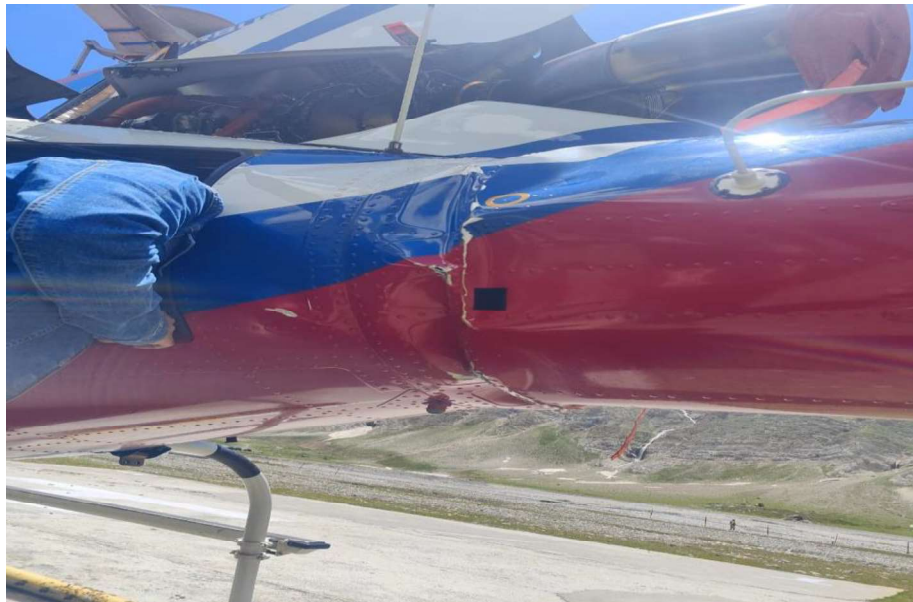
- Skin folding and damage on the tail boom near to the tail boom to fuselage junction attachment.
- Dents on the main fuselage LH side near to tail boom to fuselage junction attachment.
- Slight noise from tail rotor drive shaft bearing No. 4 during rotation of main and tail rotor drive system.
- Rub marks on tail skid due to rubbing on ground.
- Slight oil on transmission deck below MGB to Engine coupling housing.

Tail booms seems bent slightly downward. However tail boom to fuselage attachment bolts are secure and intact.

*Fig-1: Damage at Tail boom to fuselage junction*

Parts to be changed	Parts to be checked	Parts to be repaired
Right Window fairing	LH and RH Aft beam	Tail Boom rear Cowling
Reinforcement shims	LH and RH Skids	Rear left door
LH Aft skin	Forward, Tube Crossbar

left skin of the intermediate fuselage	Aft, Tube Crossbar
Tail Boom Assembly	LH, RH Landing gear shock absorbers

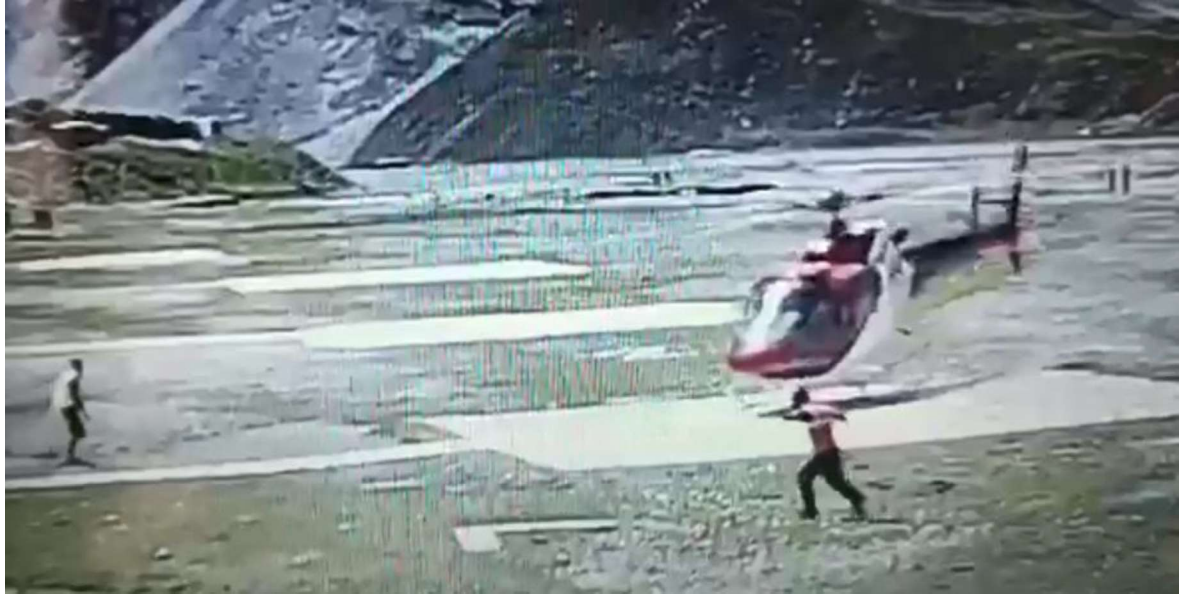
*Fig 3: Abnormal contact of helicopter with the helipad surface*

The PIC was maintaining a high rate of closure and low collective pitch setting on approach, and on entering the helipad the collective pitch was raised rapidly for carrying out the landing. This caused the cautionary audio gong for likely power exceedance to come on, and same was heard by the PIC. Thereafter PIC rapidly lowered collective pitch resulting into a bounce and hard landing.
