FINAL INVESTIGATION REPORT ON

**INCIDENT OF GEAR-UP TOUCH DOWN TO
M/s PAWAN HANS LTD DAUPHIN SA 365 N3 HELICOPTER
REGN. VT-PHO AT GUWAHATI ON 24.07.2019.**

O/o Dy. Director General of Civil Aviation (ER)

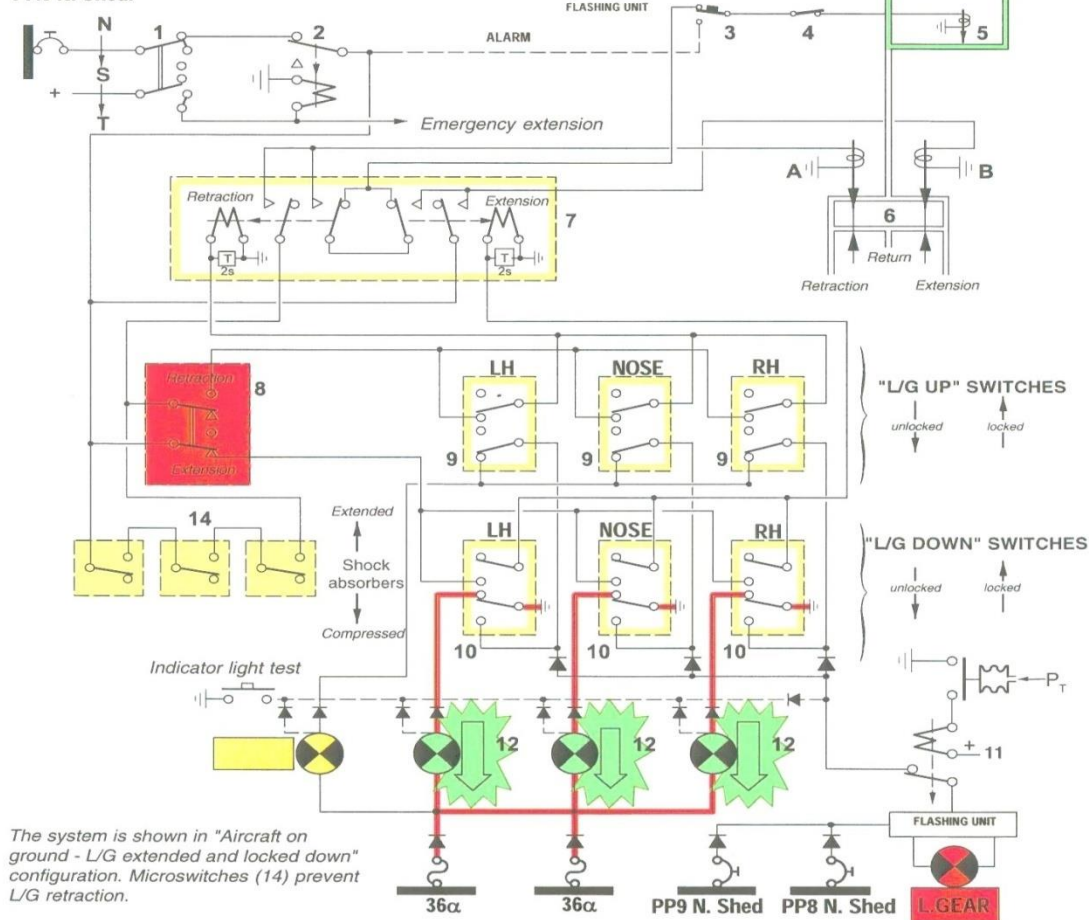
Landing Gear Retraction / Extension Control System Schematic Diagram

1.6.6.2. Control System Description: When the 3 position switch, in the cockpit, is selected to DOWN position, power is made available to bypass solenoid valve (5) which closes the pressure line (which otherwise was a return line to tank causing NIL pressure in the system called “NO CALL FOR POWER”) causing the system to pressurise up to 140 bar. (This state is called “CALL FOR POWER”).

The three position switch when selected to DOWN position also energises the extension relay (7) causing Retraction/Extension solenoid valve (6) to energise relay (B) and open extension valve and fluid to pass to the upper chamber of the actuator and to open the UP mechanical lock and closes the UP LOCK micro switches in all three L/G actuators and also push the actuator DOWN. This state of UP LOCK (closed) and DOWN LOCK (closed) provides AMBER indication in the cockpit to state that the L/G is in OPERATION. Max permitted time is 7 (seven) seconds before which the L/G's must be extended and locked. While the actuator moves down under pressure and at the end of the travel the DOWN mechanical LOCK closes and DOWN micro switches opens and disconnect circuit to AMBER light (amber light extinguishes) and provides contact to GREEN lights to illuminate permanently till switch put to retraction or battery switch is selected to OFF, in the cockpit. Simultaneously, the DOWN lock micro switches provides circuit to EXTENSION relay (7) to close and thus to close the EXTENSION VALVE (6) to close and also to OPEN the bypass valve (5) to open to facilitate the system pressure to return to tank making zero pressure “NO CALL

FOR POWER” in the system. By pass valve opens after a time delay of 15 sec by a time delay unit to ensure positive mechanical lock.

Similarly the retraction process also takes place involving same components in opposite direction. However, an important feature is provided in the retraction system and that is the SAFETY MICRO SWITCHES provided on the landing gear casing and one NOSE CENTERING MICRO SWITCH.

When the three position micro switch in cockpit selected to UP position, the power will not be reached to retraction relay (7) and to retraction valve (A) in (6) unless the all the three SAFETY MICRO SWITCHES are closed (the shock struts are NOT compressed and aircraft load is NOT supported on landing gears, NOT on ground but extended and either in air or on jacks) and the NOSE CENTERING MICRO SWITCH is opened (nose wheel centred.)

An another provision given is to caution the cockpit that the L/Gs are NOT EXTENDED by means of a RED FLASHING LIGHT (L.GEAR) when the aircraft speed is less than 55 kts. This is achieved by means of a bellow fed with P1 pressure to close contacts and to make circuit to flash the light warning that the aircraft is about to land but the L/Gs are still in retracted position- CAUTION.
