**Final Investigation Report of Propeller strike while landing incident to
M/s National Flying Training Institute, Diamond DA 40CS aircraft,
VT-NFC at Gondia Airport on 23.11.2021**

GOVERNMENT OF INDIA
OFFICE OF DY. DIRECTOR GENERAL CIVIL AVIATION (WESTERN REGION)
INTEGRATED OPERATIONAL OFFICE COMPLEX, SAHAR ROAD
VILE PARLE (E), MUMBAI-400099

Final Investigation Report of Propeller strike while landing incident to M/s National Flying Training Institute, Diamond DA 40CS aircraft, VT-NFC on 23.11.2021 at Gondia Airport.

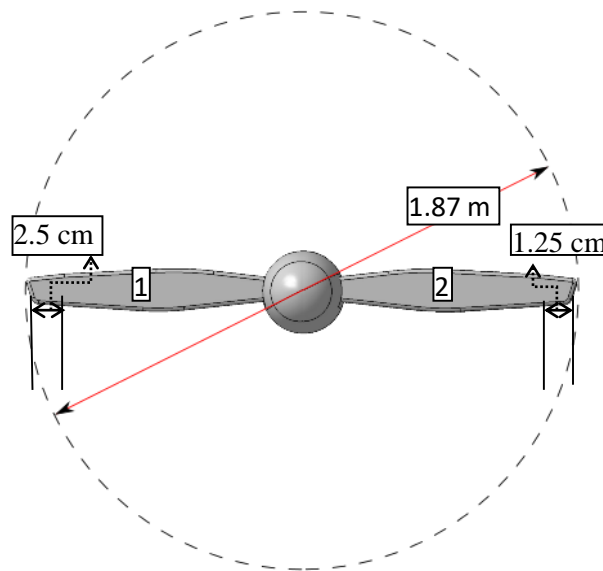
Fig 1: Representing the extent of tip damage on propeller blades

The aircraft while landing at RWY 04, touched the runway initially on its nose landing gear. Due to the nose down attitude of the aircraft, the propeller hit the runway surface while landing. During this impact, the tip of the blades (1 and 2 as shown in fig 1) got curled inside by 2.5cm and 1.25cm respectively. The tail skid was found to be intact with no scratches.

Three markings as a result of the propeller strike were found on the runway near the point of first touchdown. No significant dent/markings could be observed in the first instance of propeller touching the runway surface. In the second and third instance, the propeller strikes created significant cut marks on the runway surface. From the propeller tip damage, it could be inferred that during the first instance, the #2 blade (refer fig 1) would have slightly crazed the runway surface. In the second instance, the #1 blade (refer fig 1) made a significant cut on the runway and it is evident by the inward curl of about 2.5 cm at the tip. In the third instance, the #2 blade (refer fig 1) made a less significant contact and the tip got an inward curl of 1.25 cm.

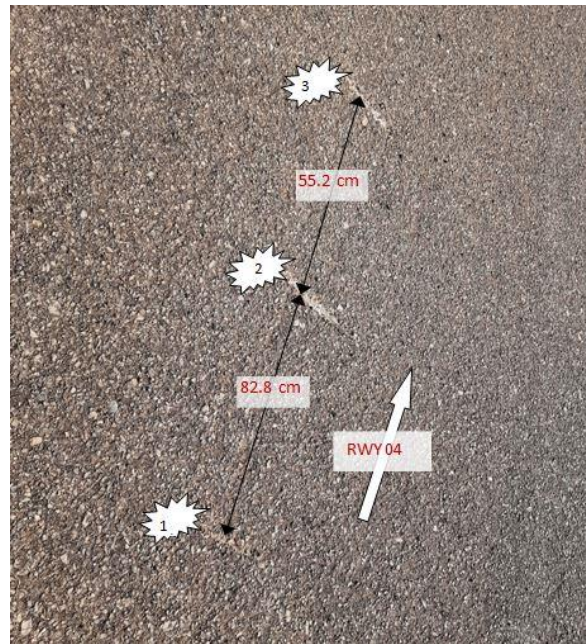
During landing on RWY 04, the propeller of the aircraft touched the runway thrice, thereby making scratch/cut marks on the runway surface. Fig 2 depicts the marks made on the runway, by the tip of the propeller blades. The consecutive distance between the first, second and the third markings were 82.8 cm and 55.5 cm respectively (refer fig 2). Only a light scrape mark could be observed in the first instance of propeller blade hitting the runway surface. In the second and third instance, the propeller blade tips made significant contact with the runway surface, thereby creating cut marks on

the runway surface. The depth of cut is deeper in the second instance in comparison with the third instance.

Fig 2: Depicting the propeller strike marks and their spacing on RWY 04

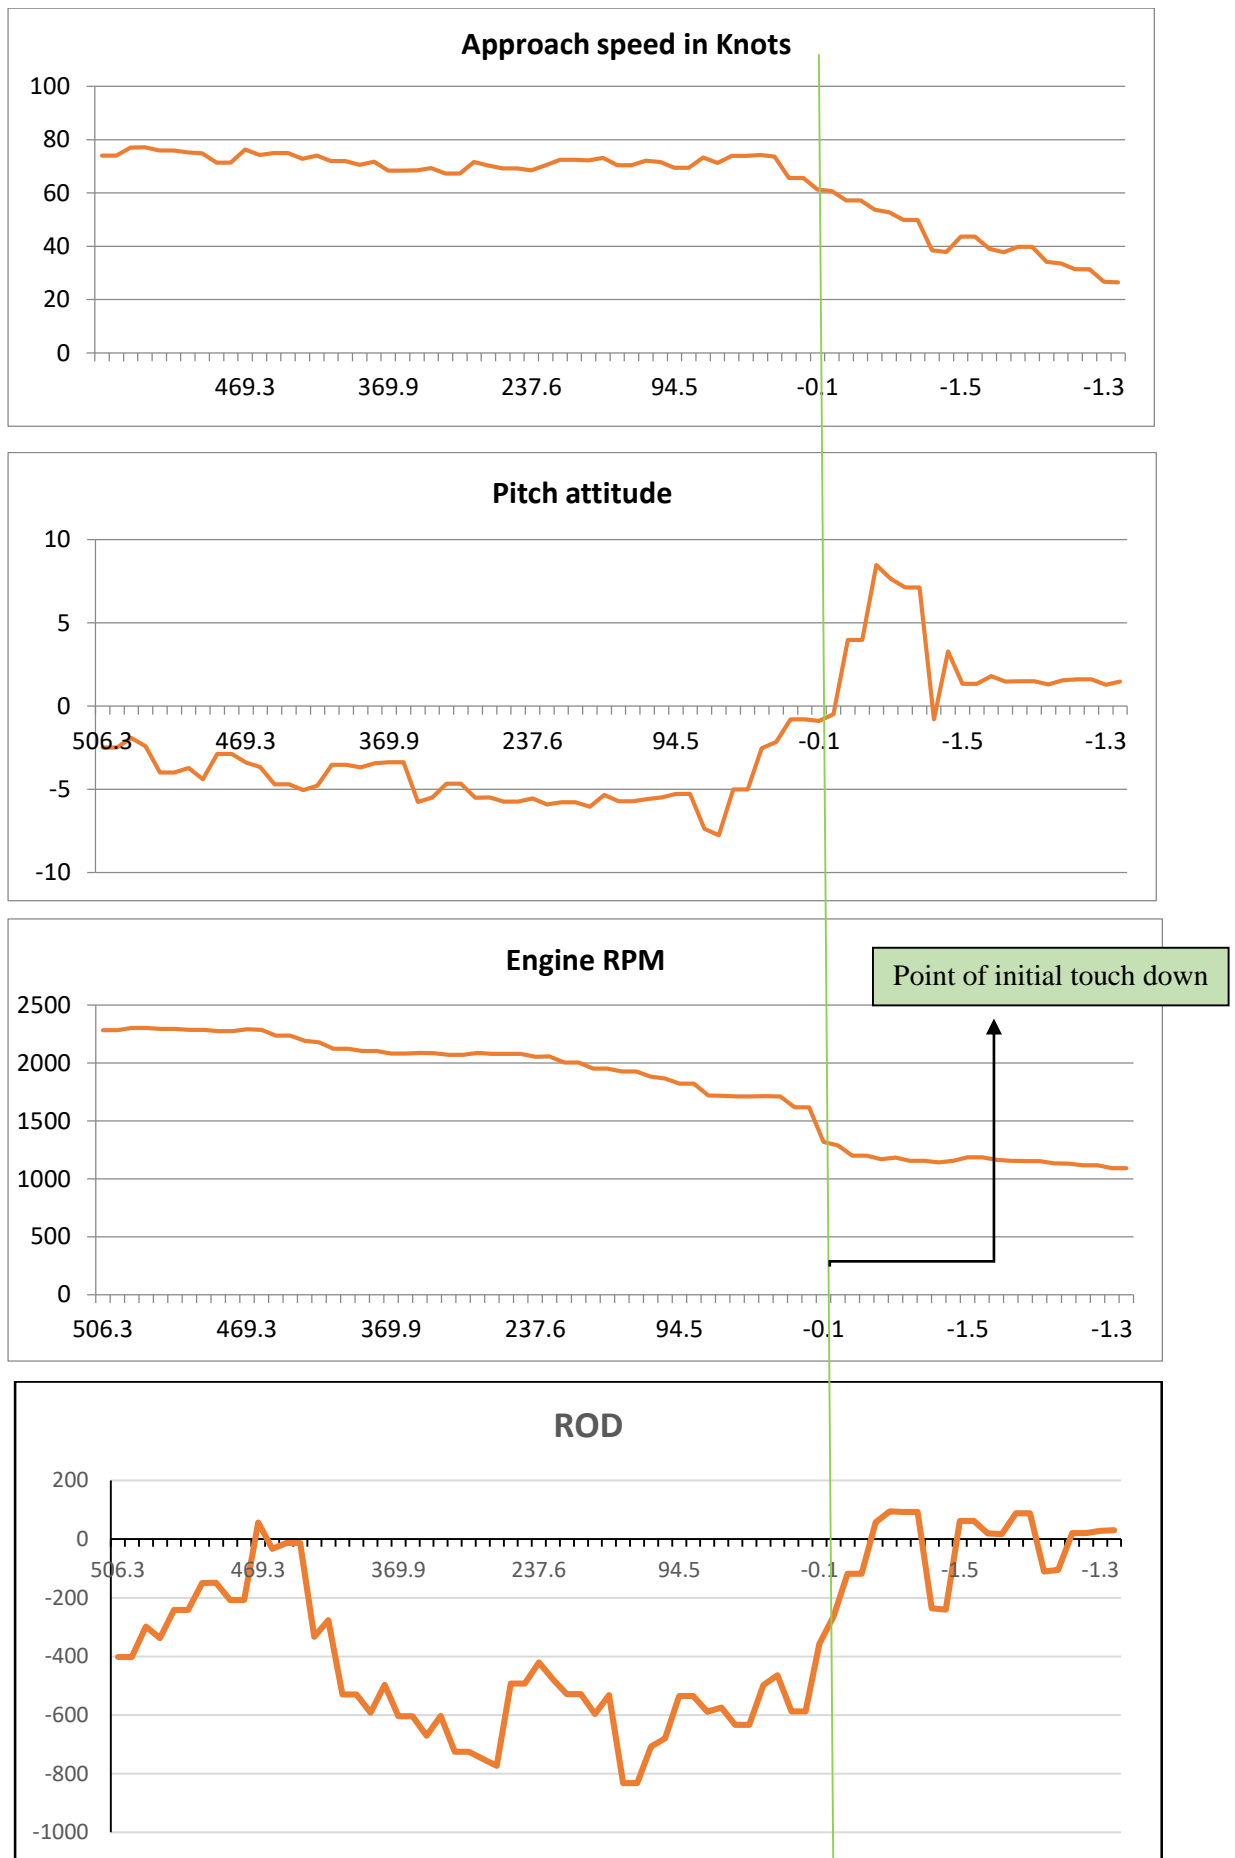
The aircraft is not fitted with DFDR or CVR units. However, the aircraft is equipped with a Garmin based software system (G-1000) which logs and stores critical flight and engine data, which are displayed in the PFD. The parameters are recorded at an interval of one second (sampling rate). About 62 parameters can be recorded by the system. The aircraft is not equipped with Radio Altimeter (Radalt), which indicates the exact height of the aircraft from the runway elevation. Hence the elevation of RWY 04 (987.5 ft) was taken as reference to calculate the height of the aircraft from the pressure altitude. The pitch, engine RPM, approach speed and the sink rate of the aircraft against height of aircraft (from 500ft plotted along x-axis) is graphically presented in Fig.3.

Fig 3: Depicting the pitch attitude, Engine RPM, Approach speed and ROD w.r.t height of A/c from 500ft RA

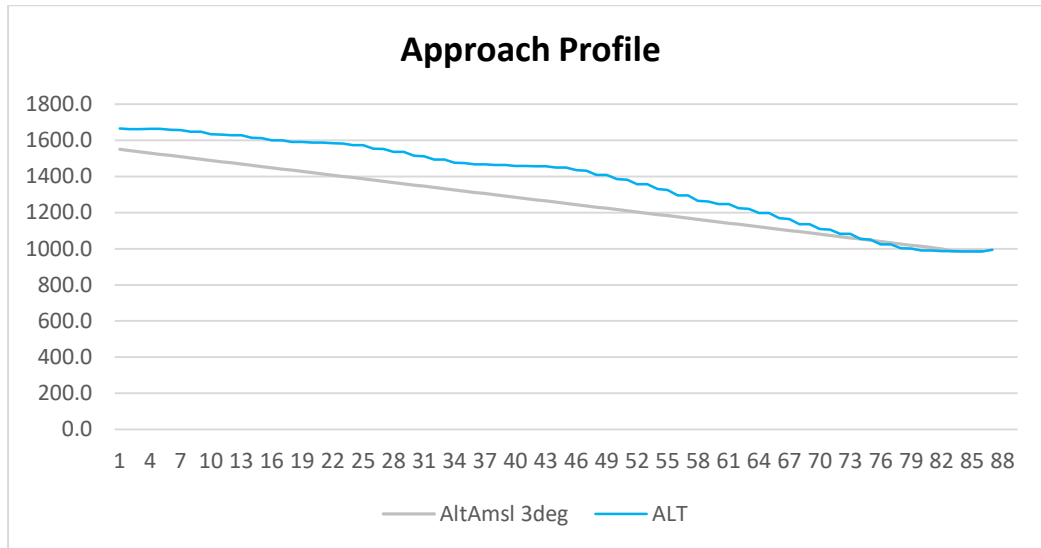
Fig 4: Approach profile path of the aircraft

- The grey line (in fig 4) shows the ideal 3-degree glide path. The blue line is the actual path followed by the aircraft during the approach till touchdown (height in AMSL). The approach angle of the aircraft maintained was higher than the ideal 3-degree glide path.

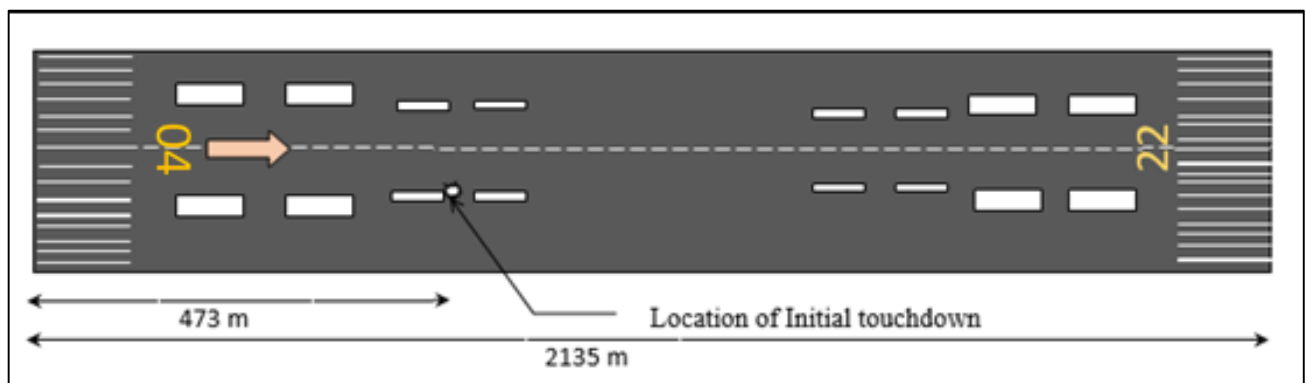
The trainee had landed the aircraft after the aiming point and in the touchdown zone, slightly right from the runway centerline. From the threshold of RWY 04, the initial point of touchdown was around 473 meters, slightly right to centerline of RWY 04. The propeller strike marks were found at a distance of 6 meters, to the right from the runway centerline. No distinct rubber marks made by the tires could be seen on the runway surface.

Fig 5: Pictorial Representation of RWY 04/22 locating the point of touchdown
