**FINAL INVESTIGATION REPORT ON INCIDENT
TO M/S OPEN SKIES AVIATION PVT. LTD.,
MAULE MT-7-235 AIRCRAFT VT-MAT, WHILE
LANDING AT BARAMATI AIRPORT ON
12.03.2018.**

| 5. Date of incident | | : 12.03.2018 |
| 14. Type of Incident | | : ARC: Abnormal Runway Contact |

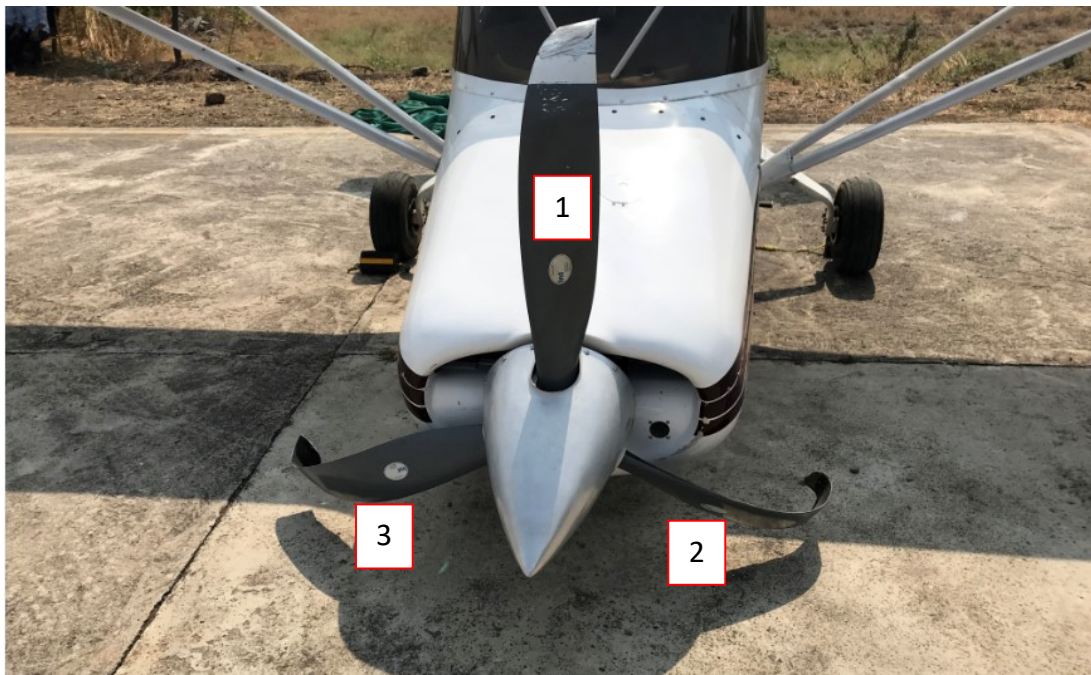
Picture 1 - All the three propeller blades (1, 2 &3) strike runway and bent inwards

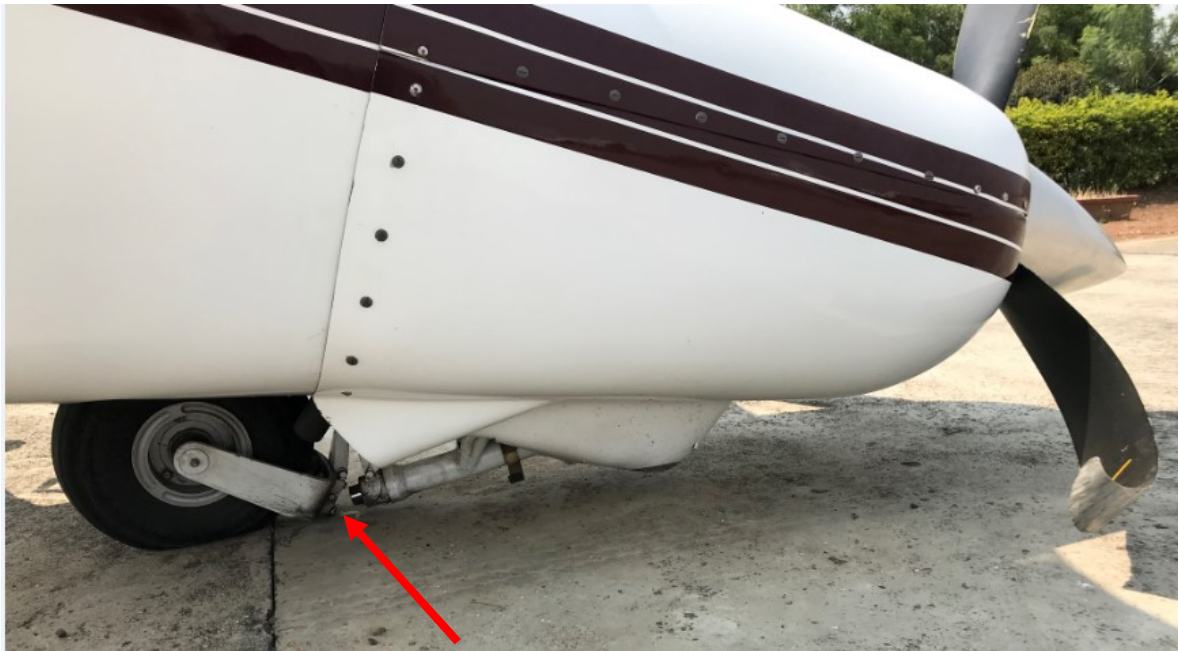
Picture 2–Nose Landing Gear collapse and the oleo strut shear off

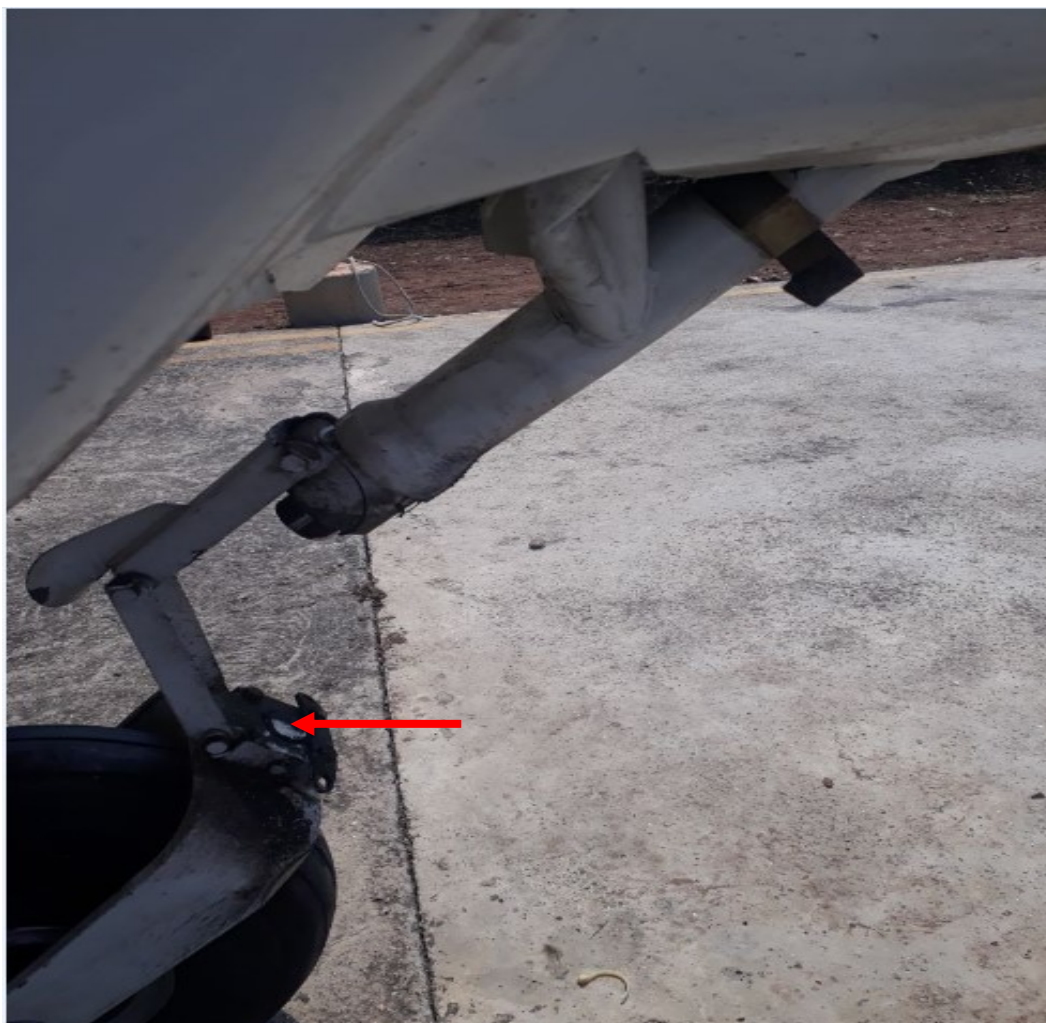
Picture 3 – Nose Landing Gear Oleo strut shear off from the lower attachment of torque link

- j) The pilot's improper landing flare caused the aircraft land and bounce into the air. Further with the incorrect bounce recovery technique when the aircraft touchdown on runway again with high impact on the NLG resulted into the nose wheel oleo strut shear off from the lower attachment point of the torque link.

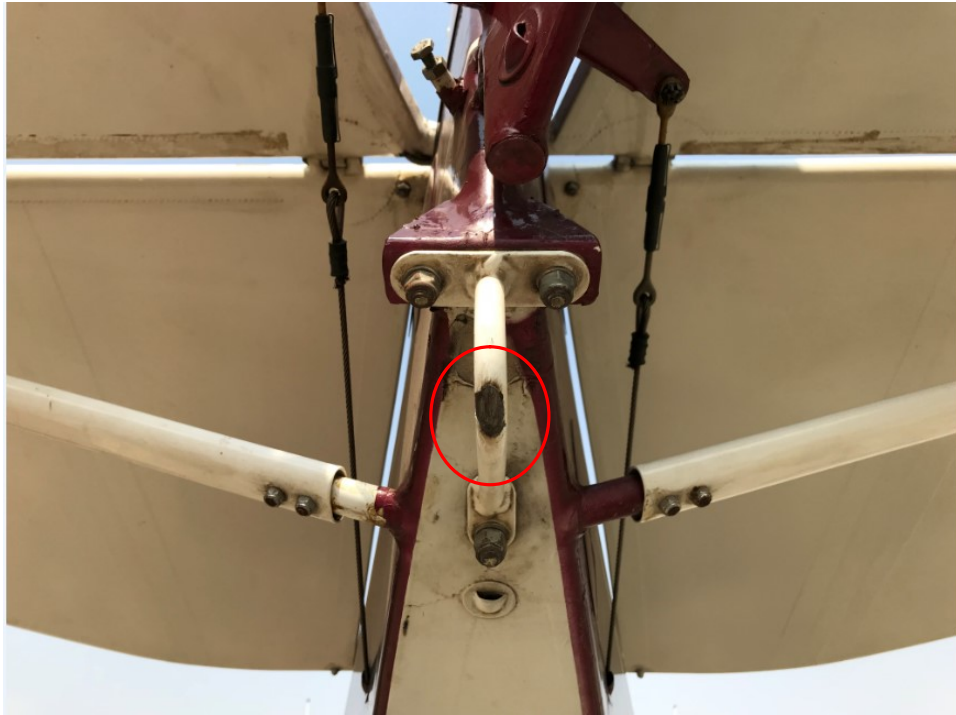
Picture 4–Tail (mooring) rubs off during touchdown

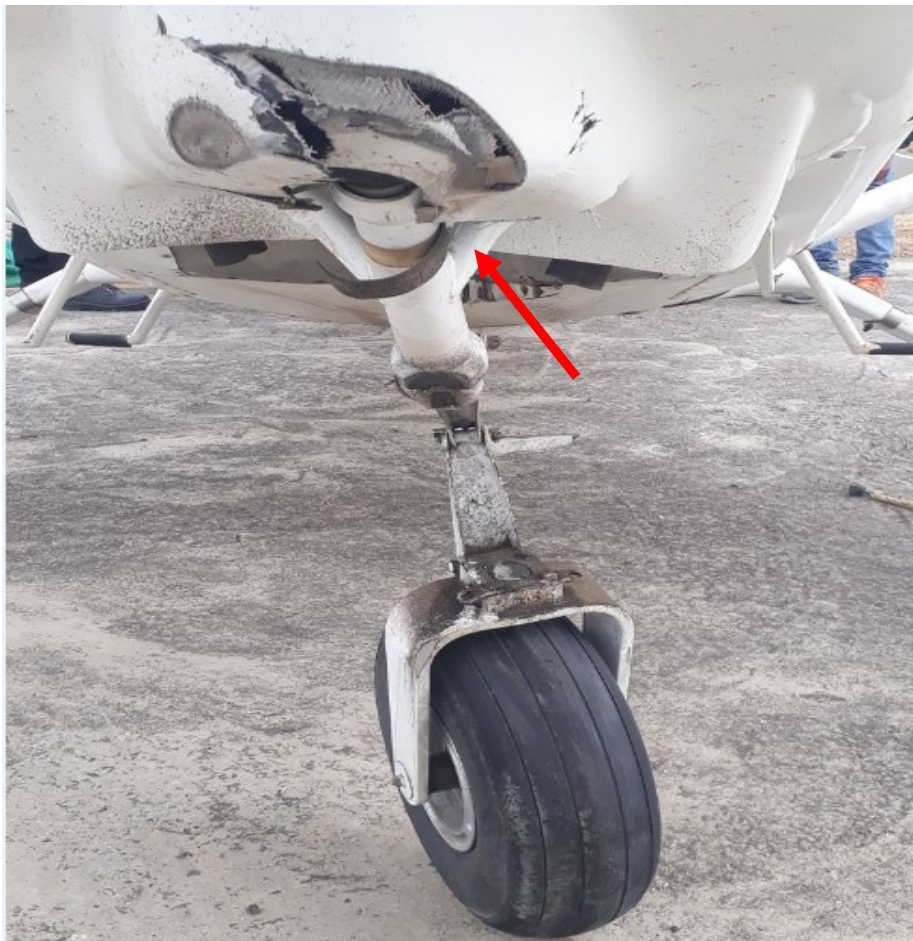
Picture 5 – Bottom portion of the engine cowling damage

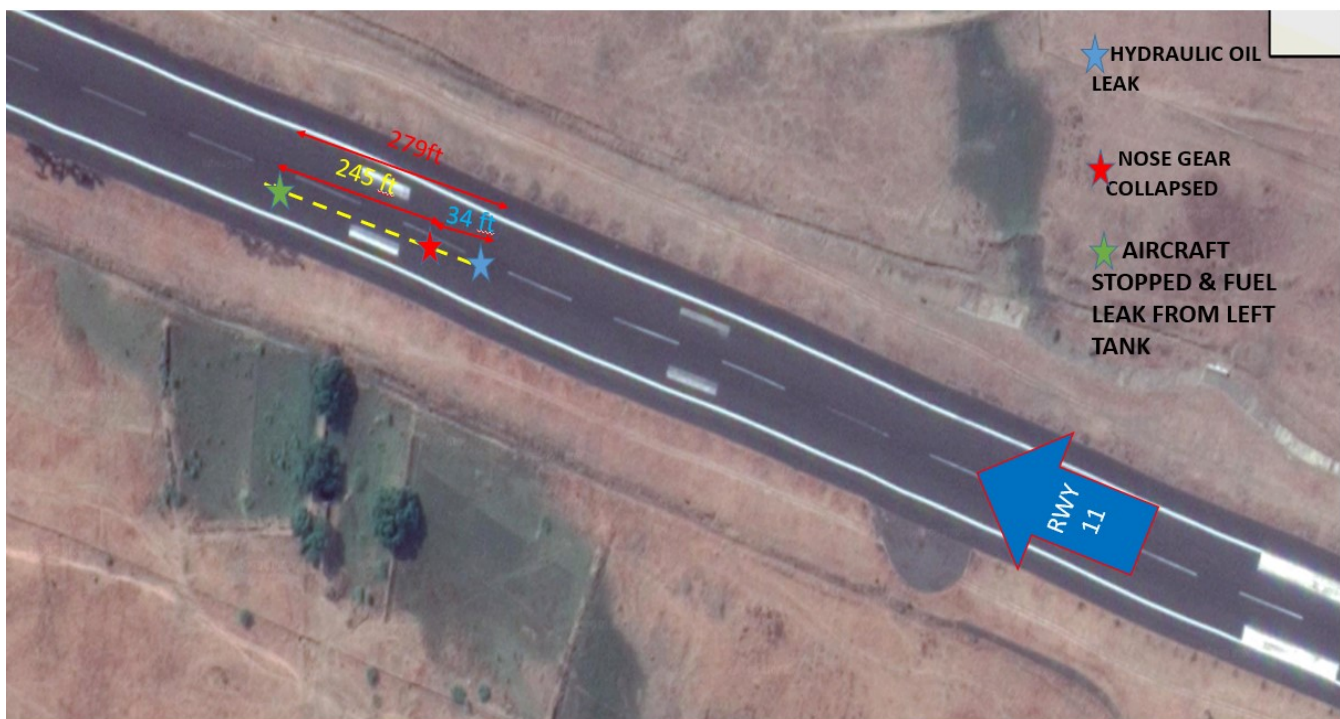
Picture 7 – Pictorial drawing

"A" – The distance from hydraulic oil leak on impact to the Nose Landing Gear collapse is 34feet.

"B" -- The distance from the Nose Landing Gear collapse to the aircraft stopped point is 245feet.

"C" -- Distance from the start of the impact to stoppage of aircraft is 279feet.

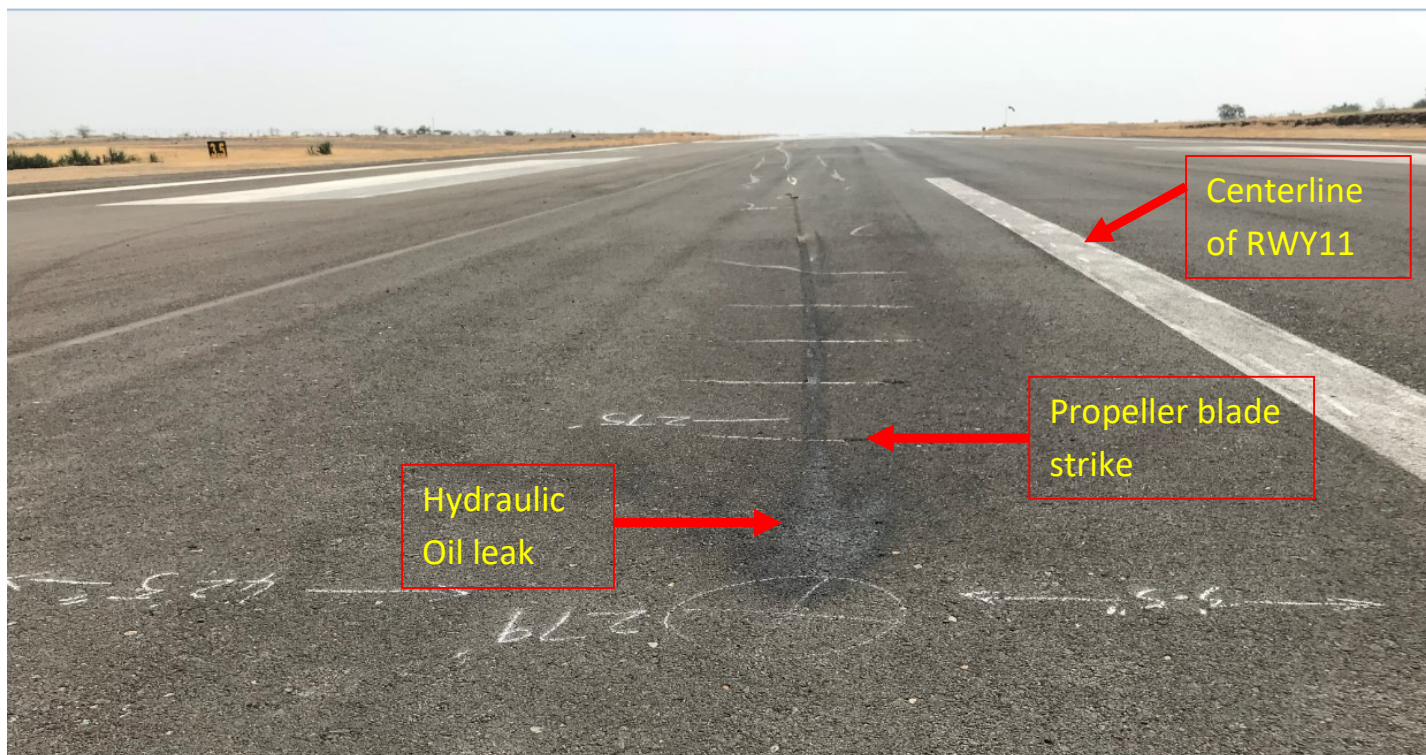
Picture 8 – Hydraulic Oil leak & Propeller blade strike

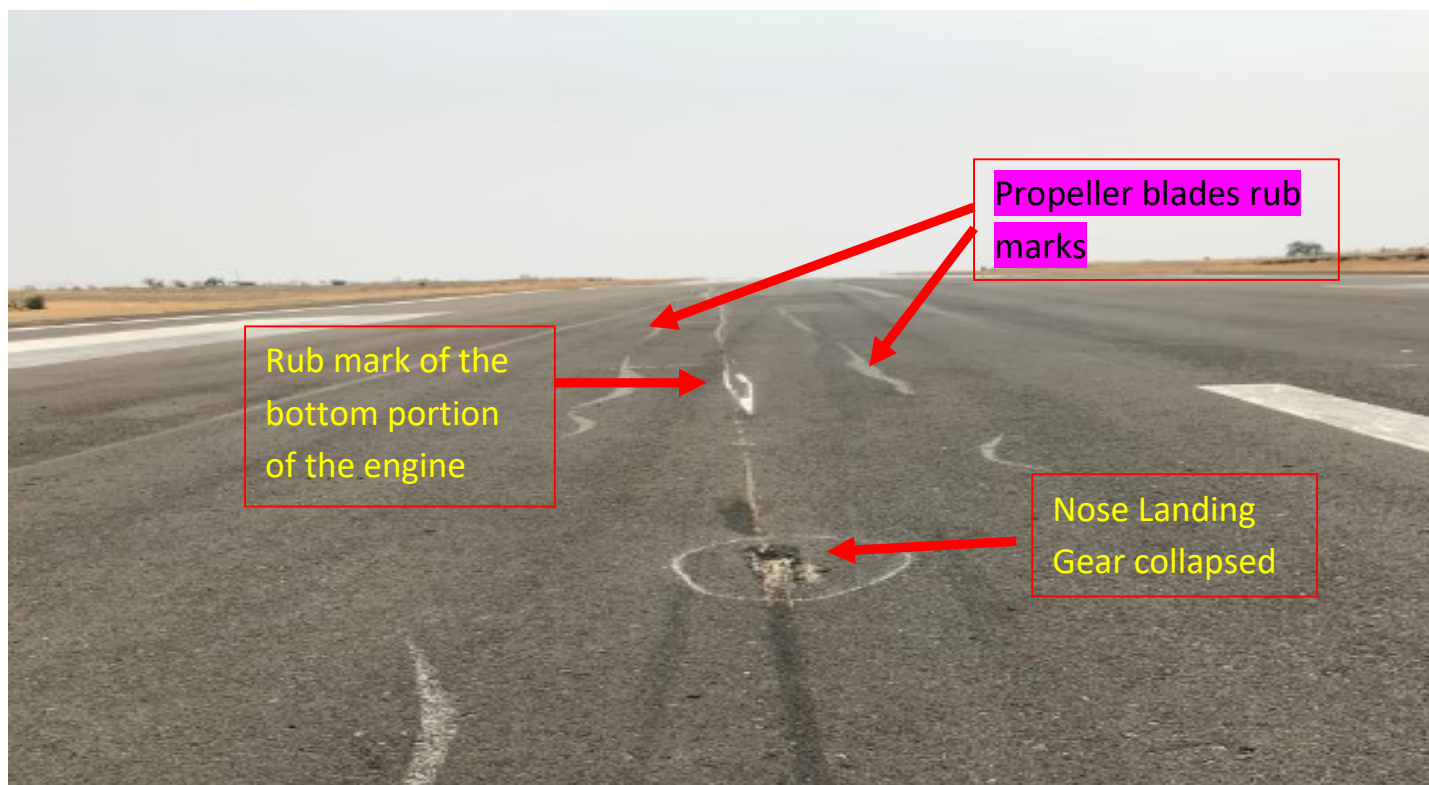
Picture 9 – Nose Landing Gear Collapse & rub marks on the runway

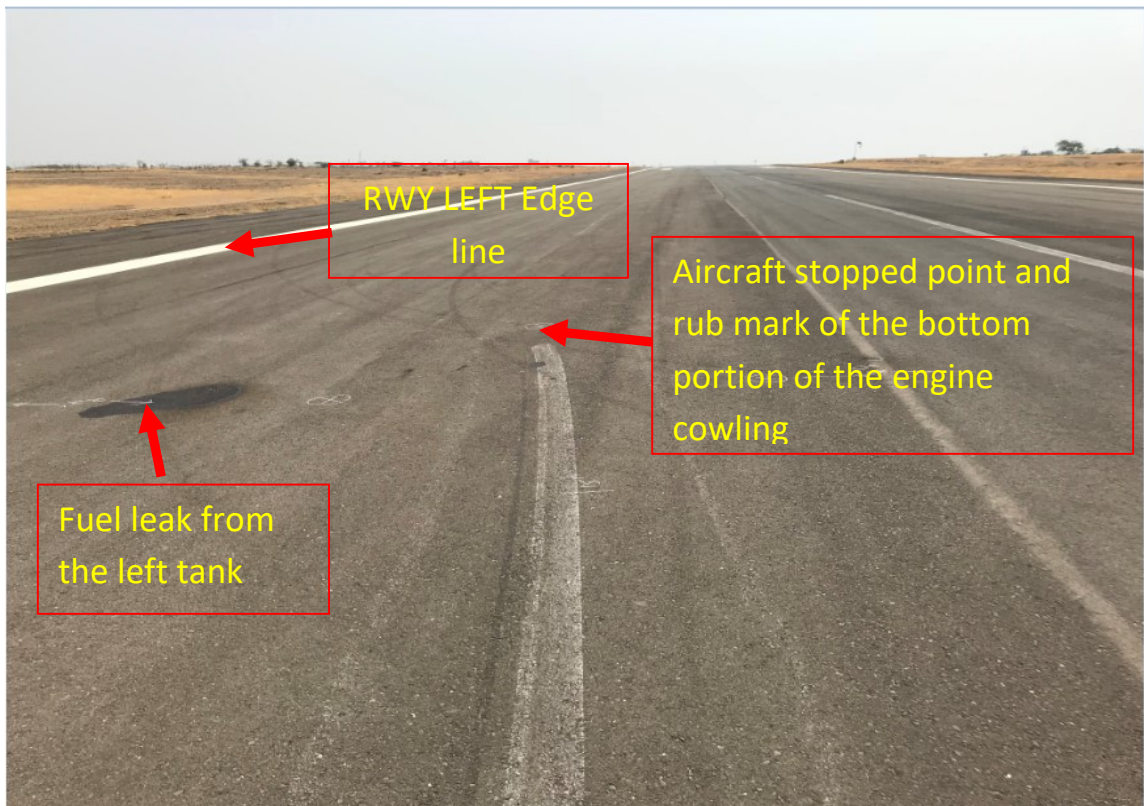
Picture 10 – Fuel leak from left tank and aircraft stopped point with rub mark

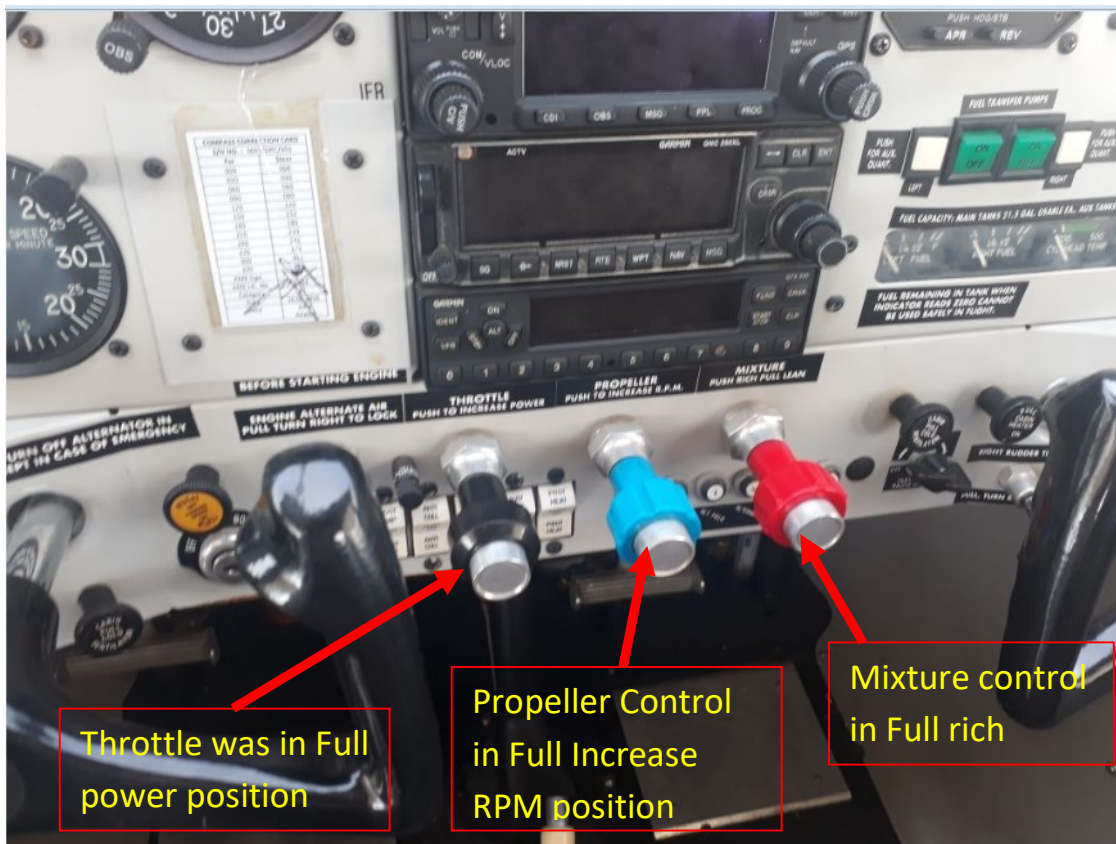
Picture 11 – Throttle, Propeller & Mixture control Position

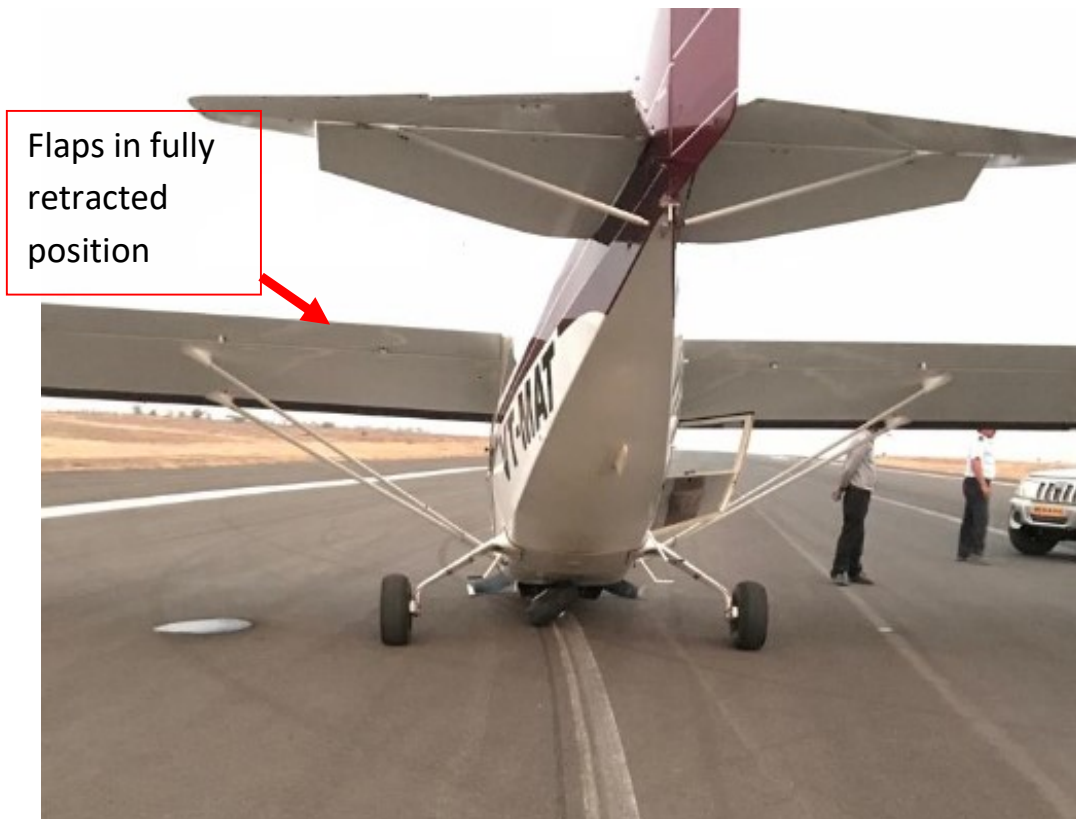
Picture 12 - Flaps in Fully retracted position

During the post incident investigation, the flaps were found fully retract condition (Ref: Picture 12). This implies that the pilot has used 0° flaps during landing, which is recommended as per the Para 3.3 of Airplane Flight Manual (ref: 1.18.6) only under gusty crosswind conditions. However, the weather was calm as per the report. Further the movement of the flaps was checked for any stuck in position but found to be in satisfactory condition.

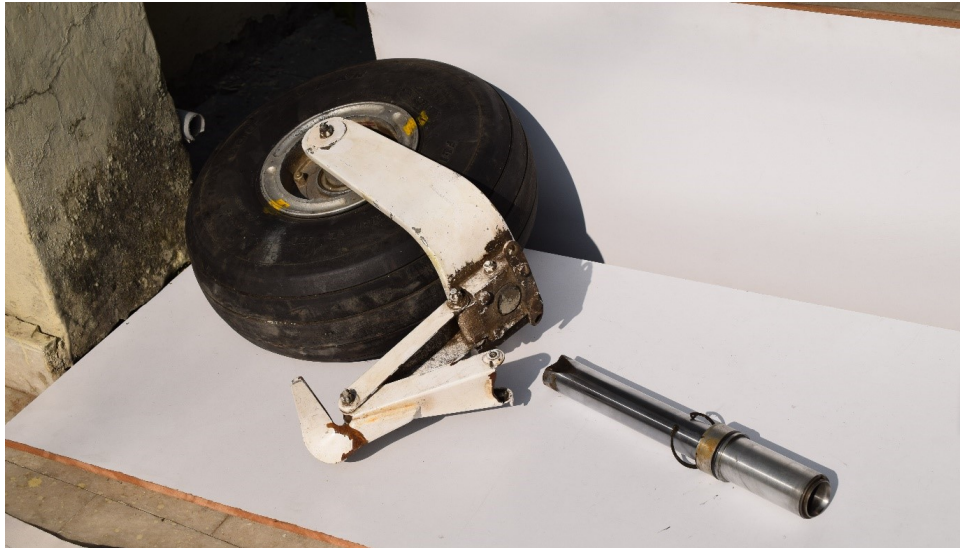
Photograph 13 - Detached nose wheel

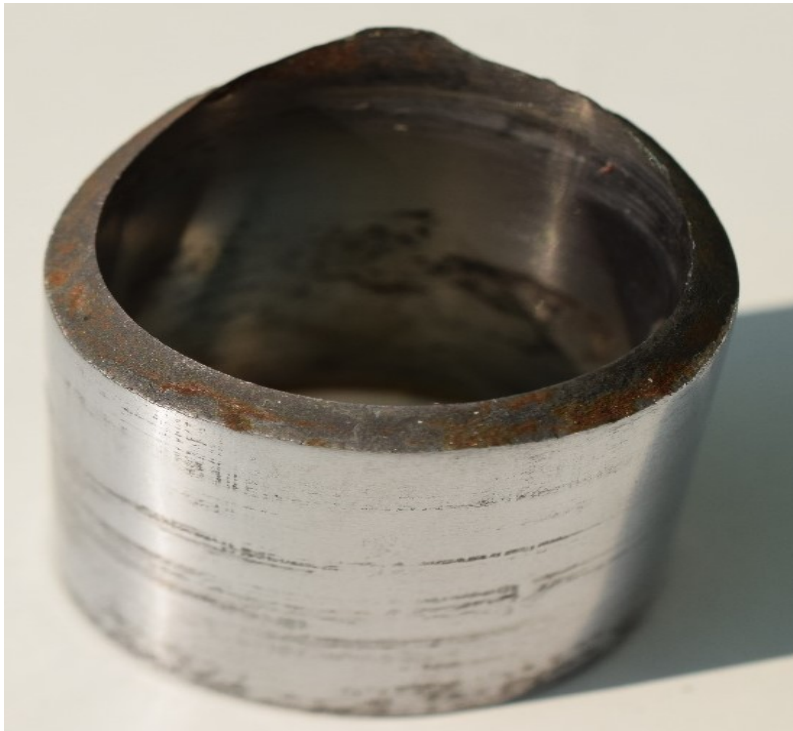
Photograph 14 (b) - the broken part of the strut tube

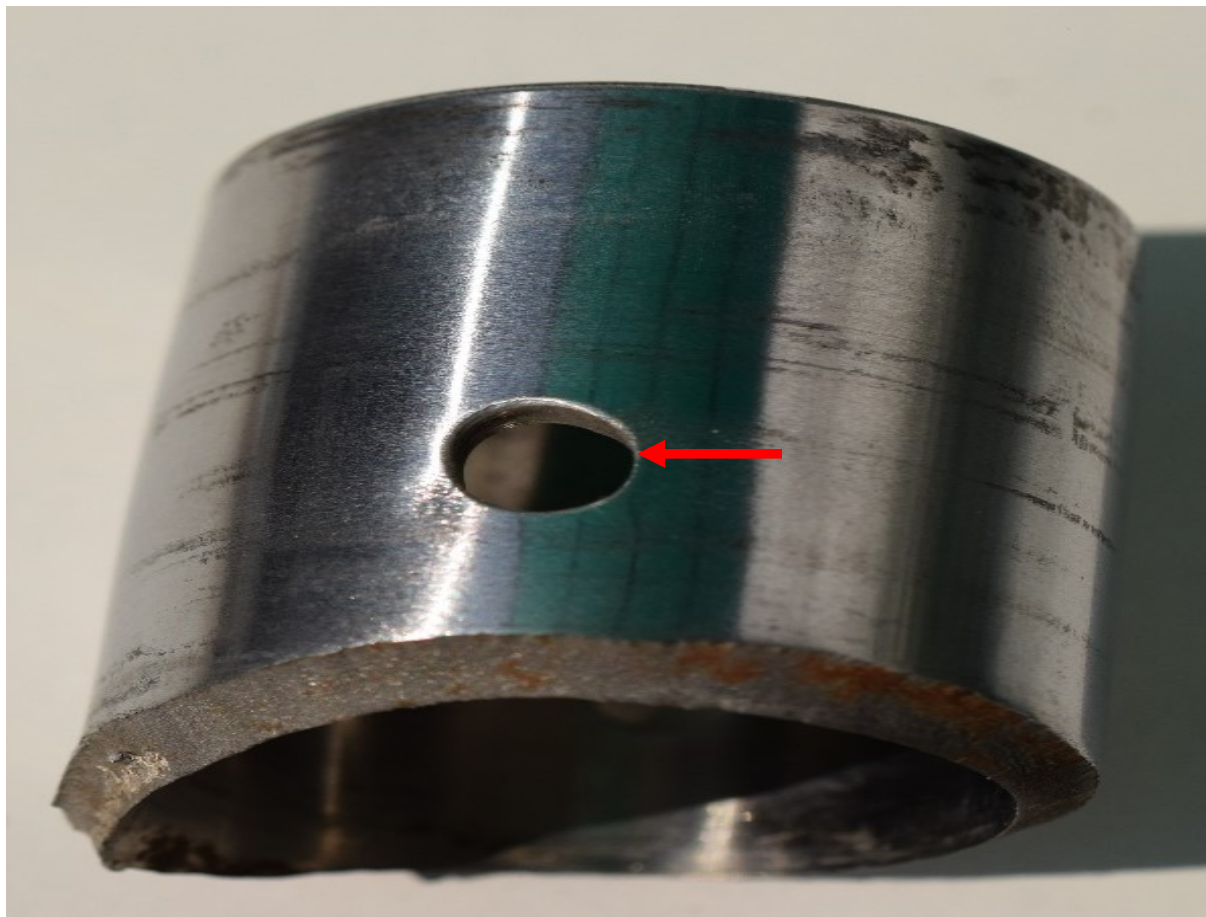
Photograph14 (c)-the strut tube found slant and fibrous and the hole of the tube found to be oval shape

During detailed examination of the detached nose wheel, the fracture surface of the strut tube found slant and fibrous and the hole of the tube found to be oval shape,

which indicates that load exceeds the strength of part, which may be caused due to impact or overload during landing.

- q) The laboratory examination report of the failed part confirms that, the fracture of the NLG oleo strut may be caused due to impact or overload during landing.
