REPORT ON INCIDENT TO TELANGANA STATE
AVIATION ACADEMY CESSNA-172R AIRCRAFT VT-CAM AT
BEGUMPET AIRPORT ON 06.04.2021.

SYNOPSIS:

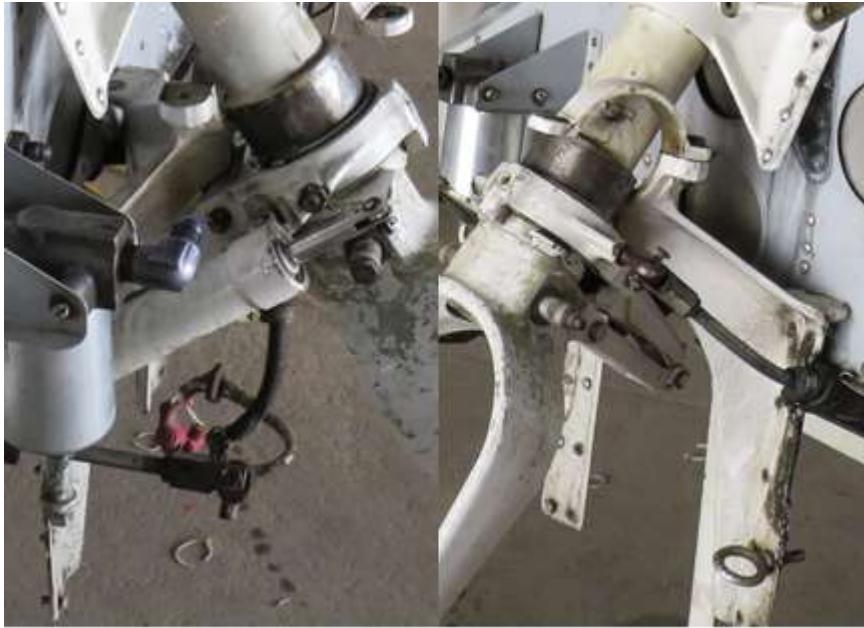
Fig.1. Damage of nose landing gear.

The nose landing gear assembly has come out of the top support assembly breaking attachment bolt, the orifice assembly piston support came out from its position.

- xii. The collapse of the nose landing gear was due to the heavy impact during the landing on nose.
- xiii. The aircraft veered to the right and stopped on the runway in a nose down position.

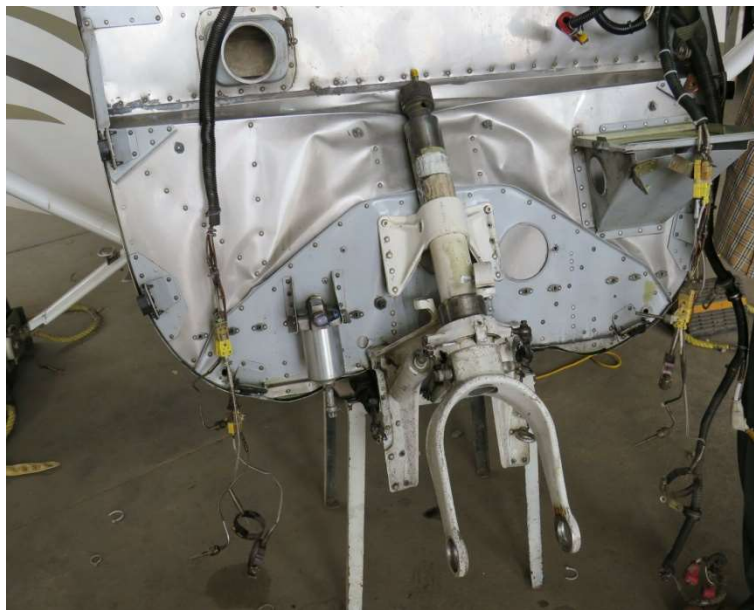
Fig. 2 Damaged orifice assembly piston support

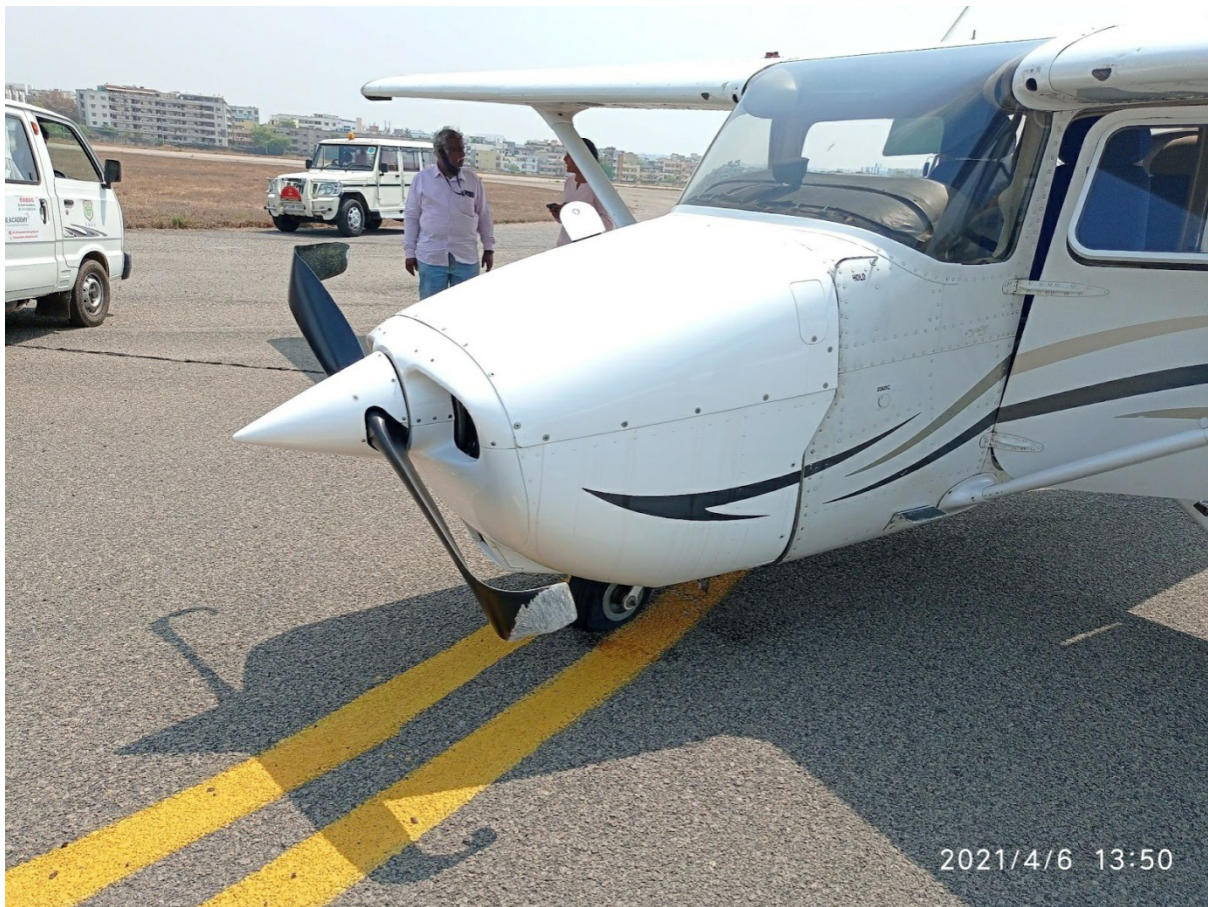
Both propeller blades exhibited impact damage and the blade tips were bent rearward (See Figure 3).

Fig. 3 Propeller blades bent rearward & damaged

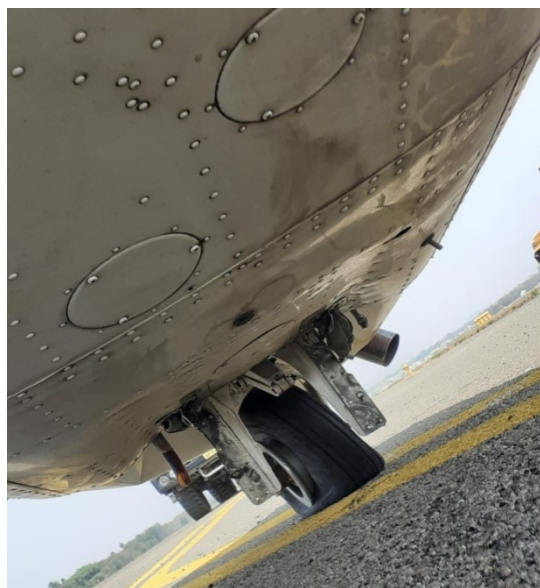
There were minor wrinkles observed on the bottom surface of the fuselage (See Figure 4). The complete fire wall was damaged.

Fig. 4 Damage to bottom surface of the fuselage

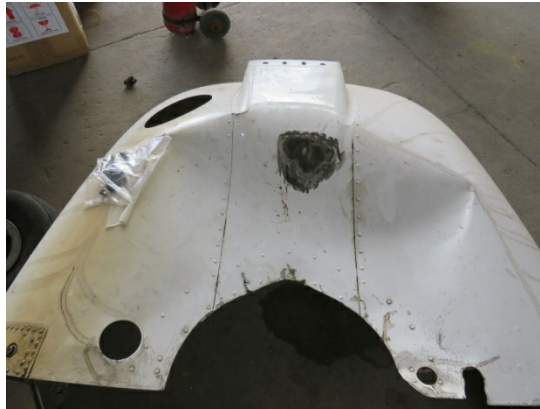
Nose cowling of the aircraft received dents.

Fig. 5 Dent on nose cowl

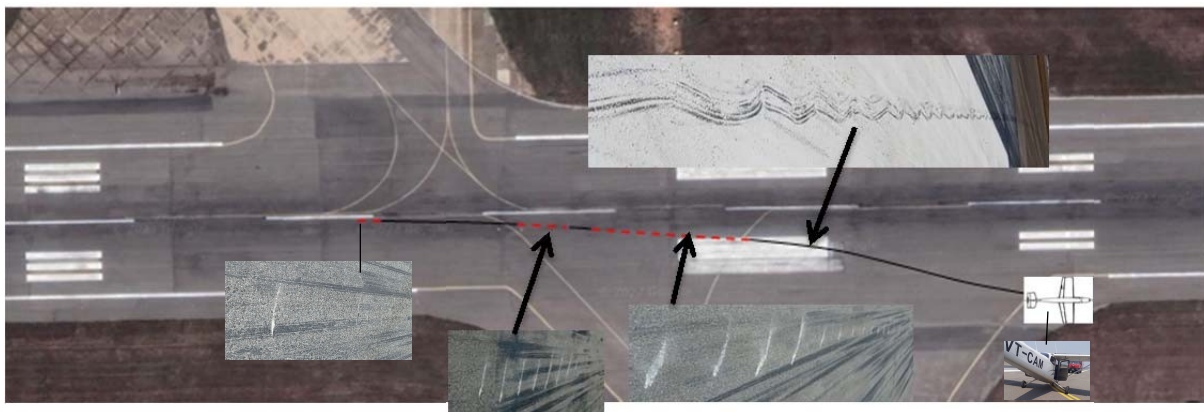
Fig. 7 Wreckage plot

The aircraft approached from RWY 09. Based on the propeller strike markings on the runway, it is indicating that the first point of contact of the propeller blades from the threshold of RWY 09 was 721 feet. The damage on the runway from the propeller blade strike with one hit followed by a second propeller hit marking a distance of 4 feet. After 12 feet from the second strike of the propeller, there were continuous propeller hit markings on the runway for about 196 feet. The damage on the runway surface from the propeller blades strikes were observed on the RHS of the Runway Centerline. The aircraft had moved 312 feet further where only tyre markings were observed on the RHS of the Runway Centerline, indicating suspected engine power loss.

The aircraft moved forward for approximately 787 feet and finally stopped at 77.7 feet to the right of the runway centerline. The tyre mark was found. (See Figure 7 wreckage plot).
