**GOVERNMENT OF INDIA**

**FINAL INVESTIGATION REPORT ON HARD LANDING INCIDENT TO M/S TATA SIA  
AIRLINE (VISTARA) AIRBUS A320 AIRCRAFT VT-TTM WHILE OPERATING FLIGHT UK-  
913 (SECTOR: DELHI-INDORE) ON 09.08.2021**

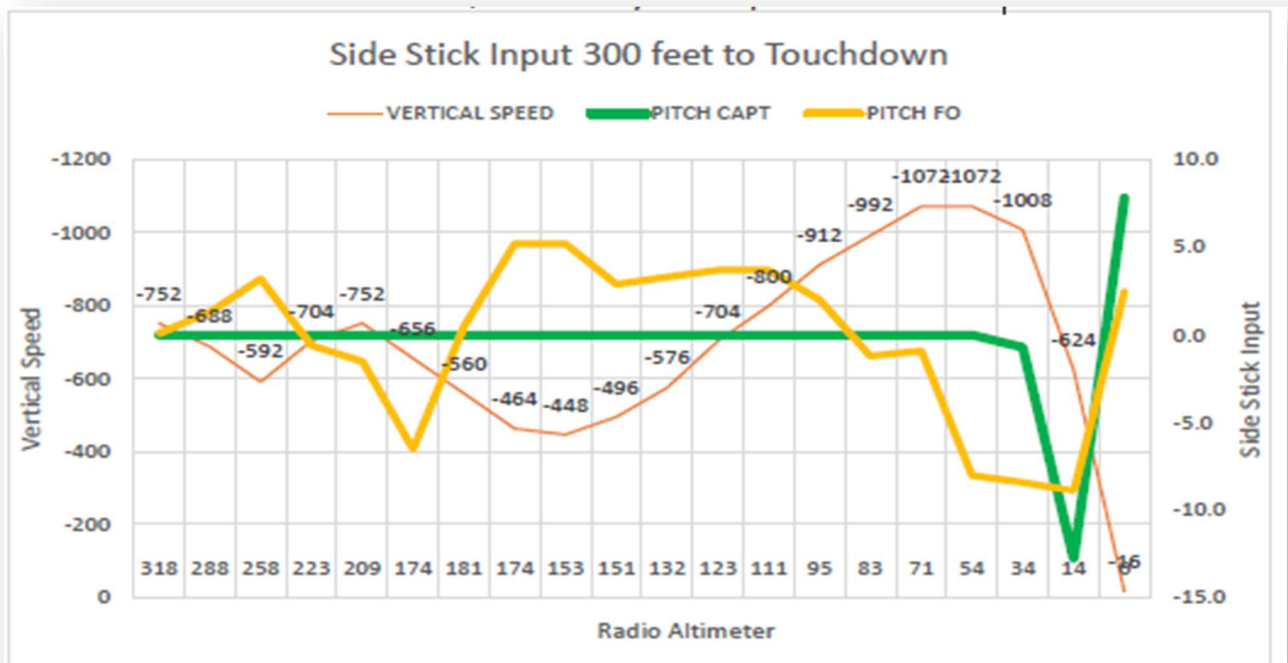
(a) Graphical representation for vertical speed along with the both cockpit crew side stick inputs are given below. It shows continuous pitch input was given by co-pilot which resulted in high rate of descent of 1072 fpm at 54ft RA. PIC gave a pitch input only after 34ft RA and resulted in dual input.

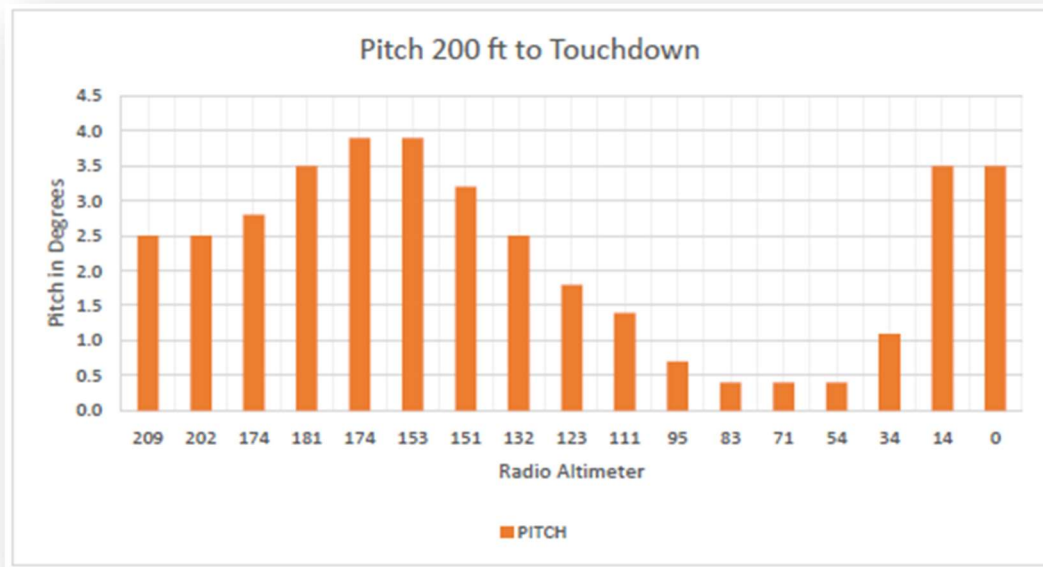
**(b)** Graphical representation for pitch attitude with radio altitude is given below. It shows the aircraft pitch was decreased to 0.4 degree at 54ft RA. The aircraft touched down with a pitch of 3.5 degrees.

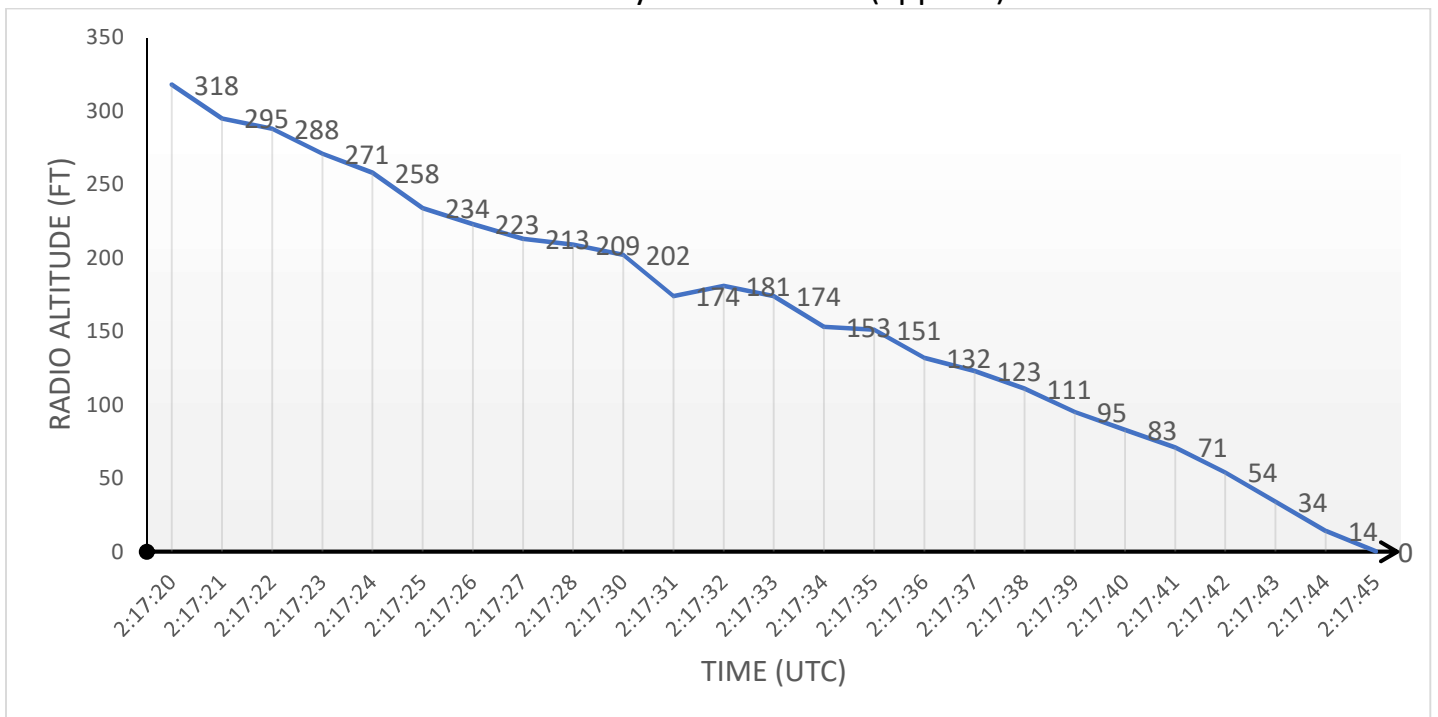
**(c)** Graphical representation for radio altitude with time is given below. The flare was short and lasted only 4 seconds (approx.) before touchdown.
