**DIRECTORATE GENERAL OF CIVIL AVIATION**

**FINAL INVESTIGATION REPORT ON LEFT HAND WING  
SHARKLET DAMAGE INCIDENT TO M/s AIR ASIA A320  
AIRCRAFT VT-ATB AT BAGDOGRA AIRPORT ON 15.02.2019**

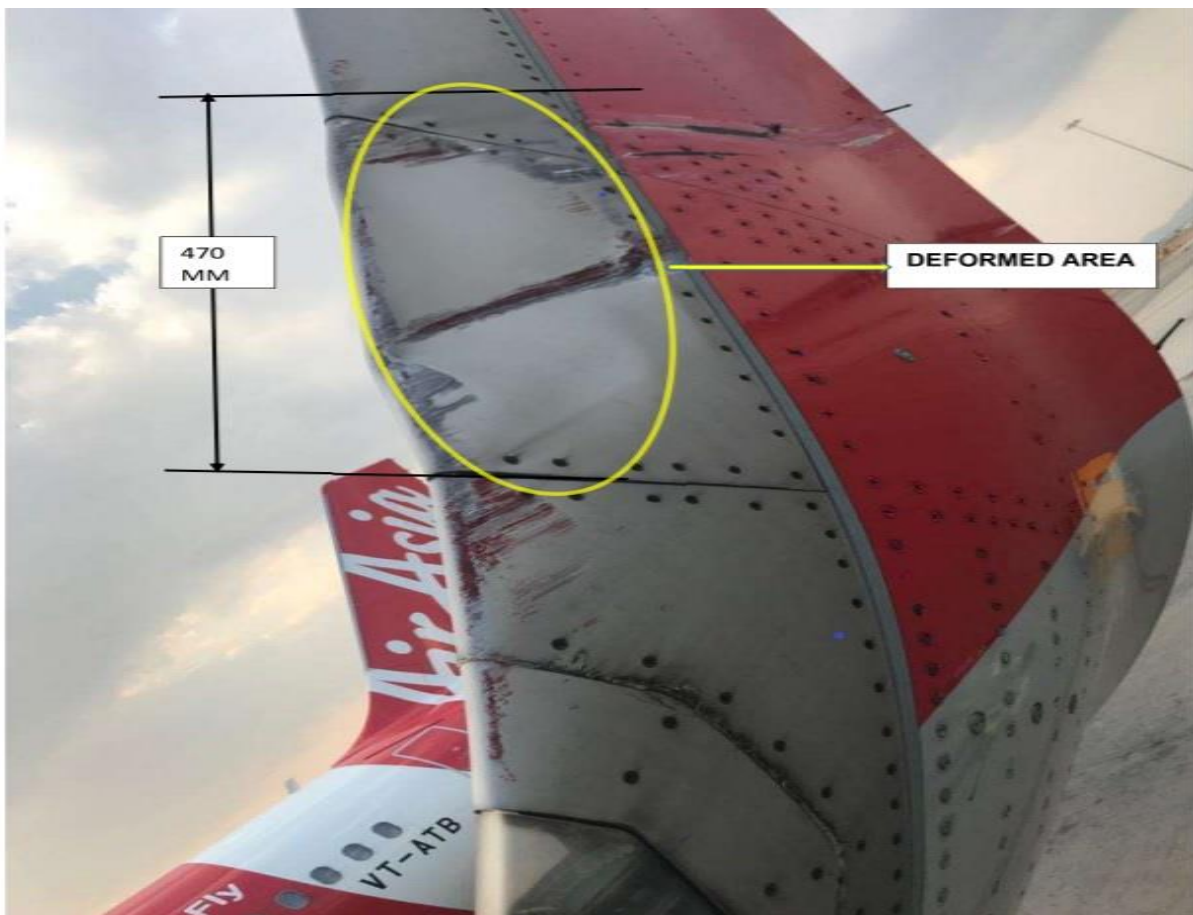
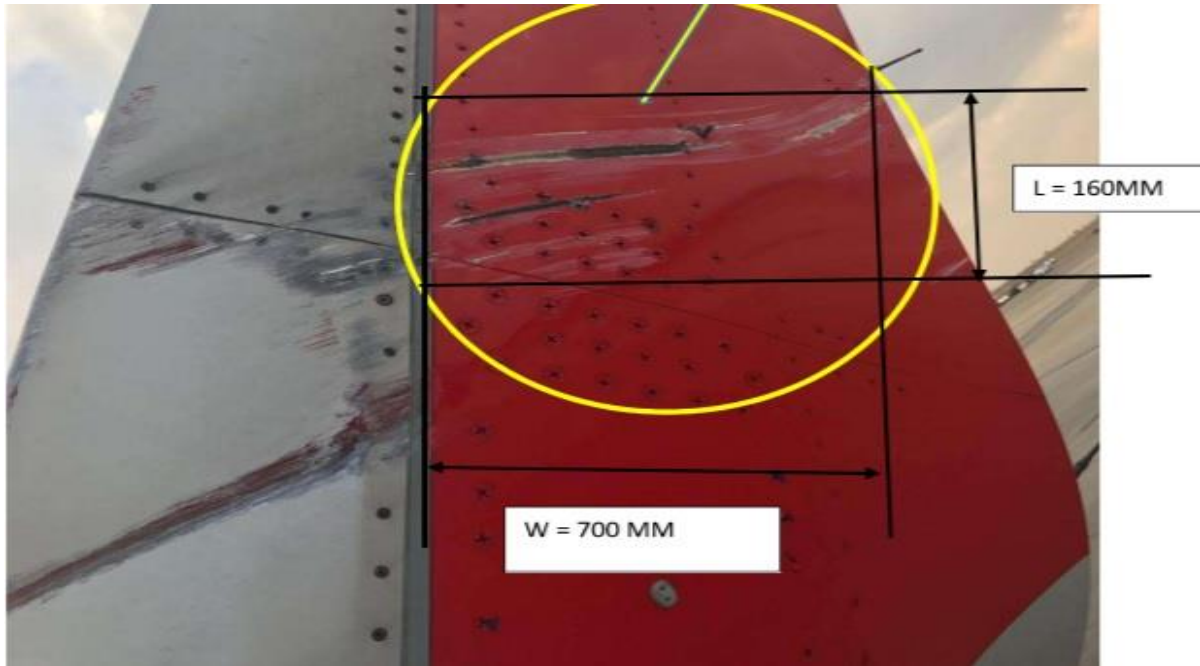
## 1.3 Damage to Aircraft: Aircraft received minor damage to LH wing Sharklet.

Aircraft LH wing sharklet hit the blast pen wall while aircraft was negotiating 180 degree turn for lineup and takeoff from non-designated place. The LH wing sharklet got damaged

and replaced by serviceable one after the incident. The blast pen wall on side of the runway got damaged. Deformation and scratches were observed on the shraklet and damage dimensions are given in para 1.3.

The damaged LH wing sharklet was bearing serial No. KAA10409 and was pre-fitted with aircraft at the time of delivery and confirmed from Aircraft Inspection Report VT-ATB. The damaged sharklet was removed from the aircraft as damage was beyond the permissible limit. The damaged sharklet was replaced with serviceable sharklet.

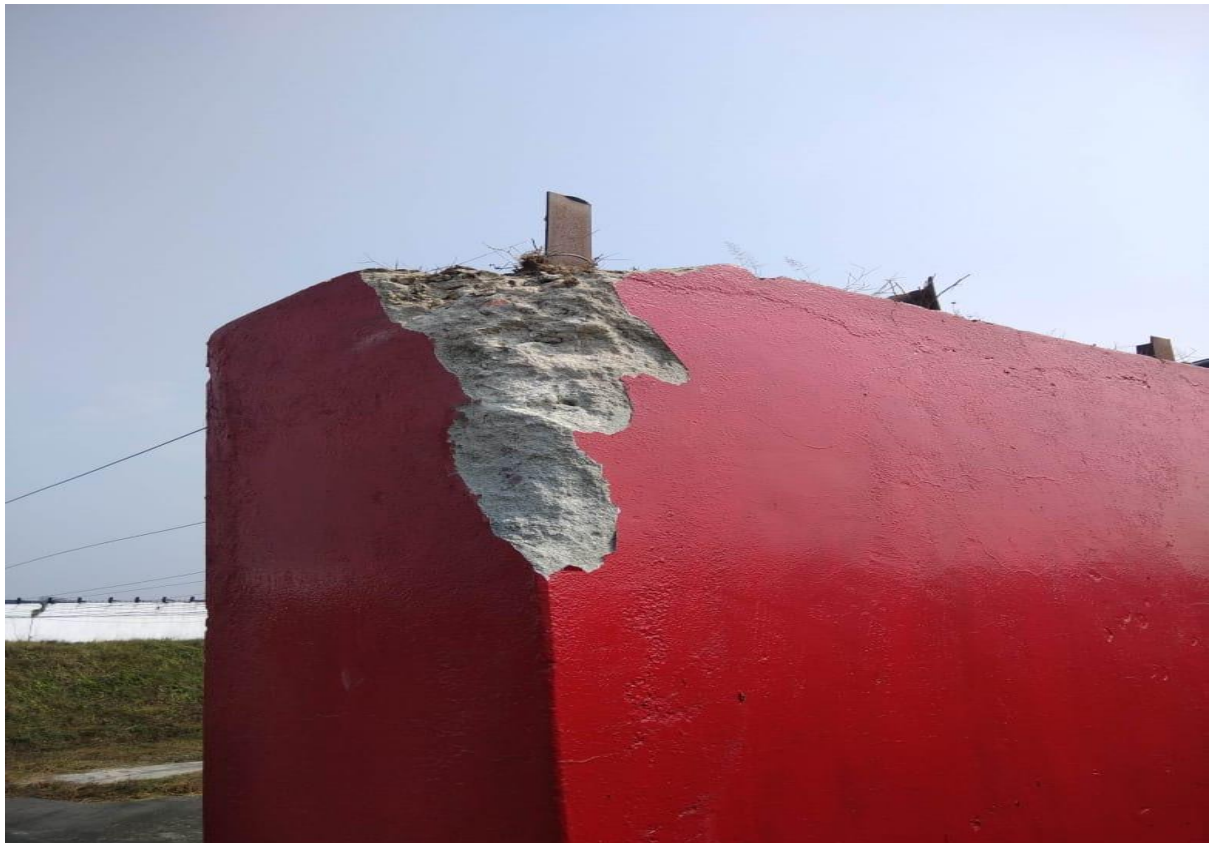
**1.4 Other Damages:** Blast pen wall surface at Bagdogra airport adjacent to runway 18/36 received minor damage.

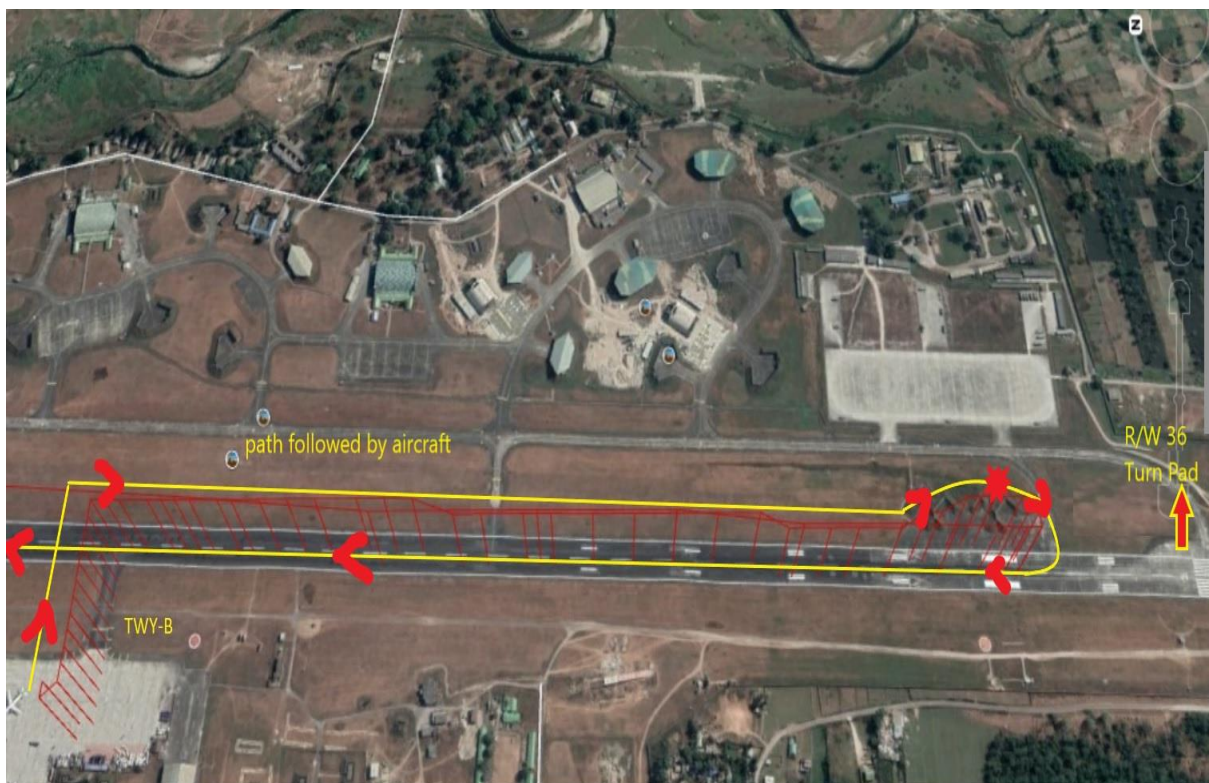
The DFDR readout analysed in M/s Air Aisa (India) Ltd. FOQA monitoring tool i.e AirFACE and aircraft location coordinates were superimposed on Google Earth (AirFACE software is having a provision for doing so and a .kml file gets created to show the path followed by the aircraft) and found that, aircraft negotiated its 180° turn well before the runway 36 threshold point. While completing turn, aircraft LH wing sharklet hit the blast pen wall and got damaged.

The path followed by the aircraft during taxi and lineup is as under:
