**GOVERNMENT OF INDIA  
O/o, DIRECTOR AIR SAFETY, WESTERN REGION,  
NEW INTEGRATED OPERATIONAL OFFICE COMPLEX,  
SAHAR ROAD, VILE PARLE (EAST), MUMBAI**

**FINAL INVESTIGATION REPORT ON INCIDENT TO**  
**M/s REDBIRD FLYING TRAINING ACADEMY PRIVATE LIMITED,**  
**TECHNAM P2008JC AIRCRAFT, VT-RBC ON 15.06.2021 AT**  
**BARAMATI AIRPORT**

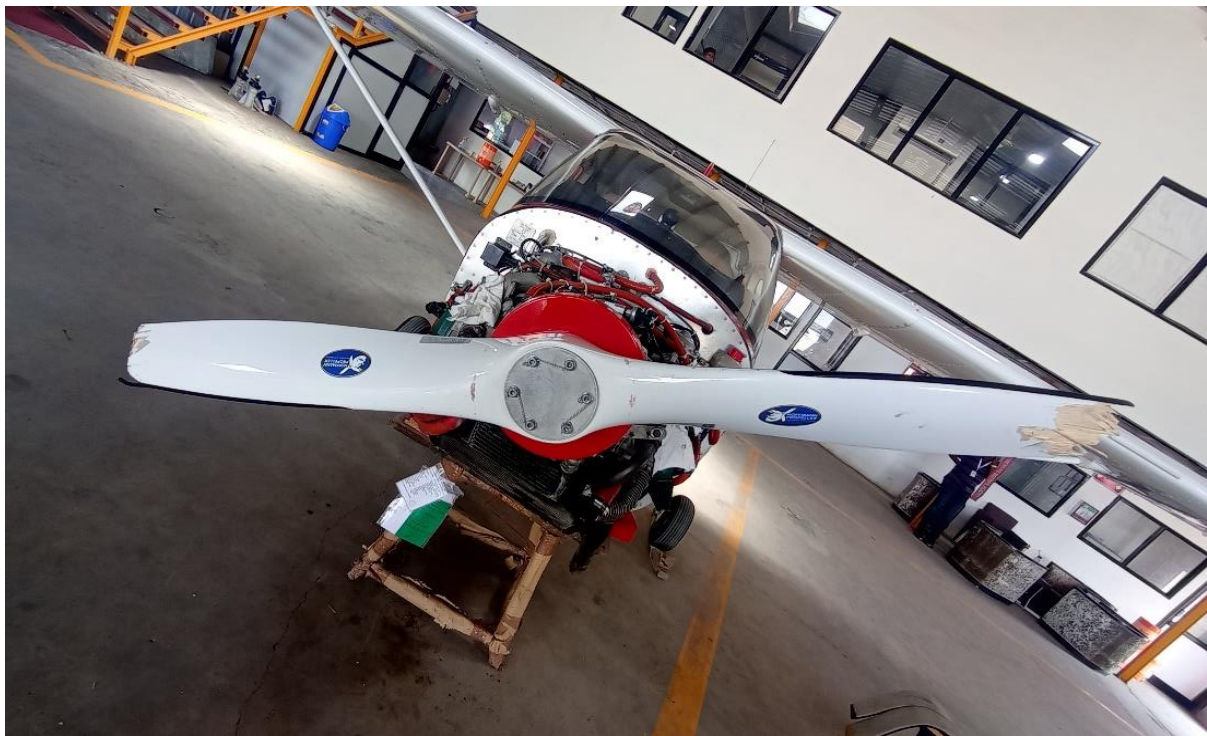
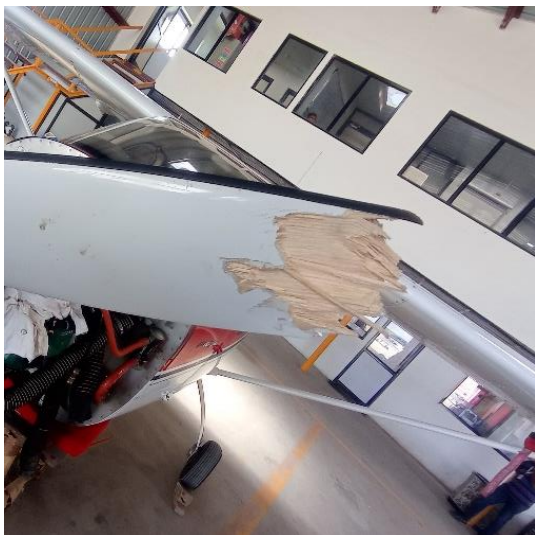
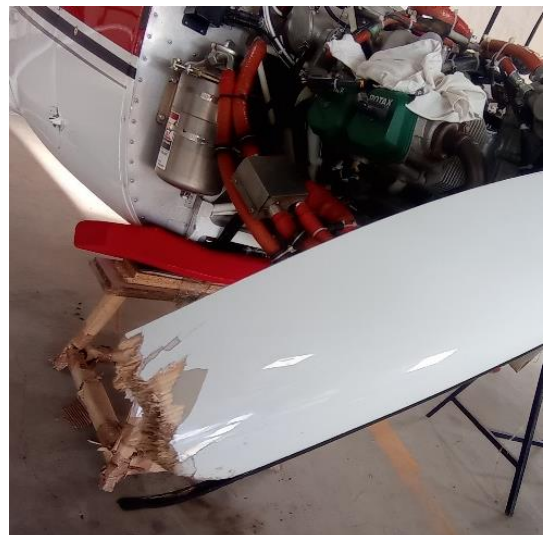
*Figure 1,2,3: Photographs depicting the damage to the propeller.*

Both wooden Propeller blades were found broken at their tips due to impact on the runway. Wrinkles were observed on the bottom side of the firewall. The nose landing support assembly fitting on the Left side of the firewall was damaged and the mounting bolts were bent.

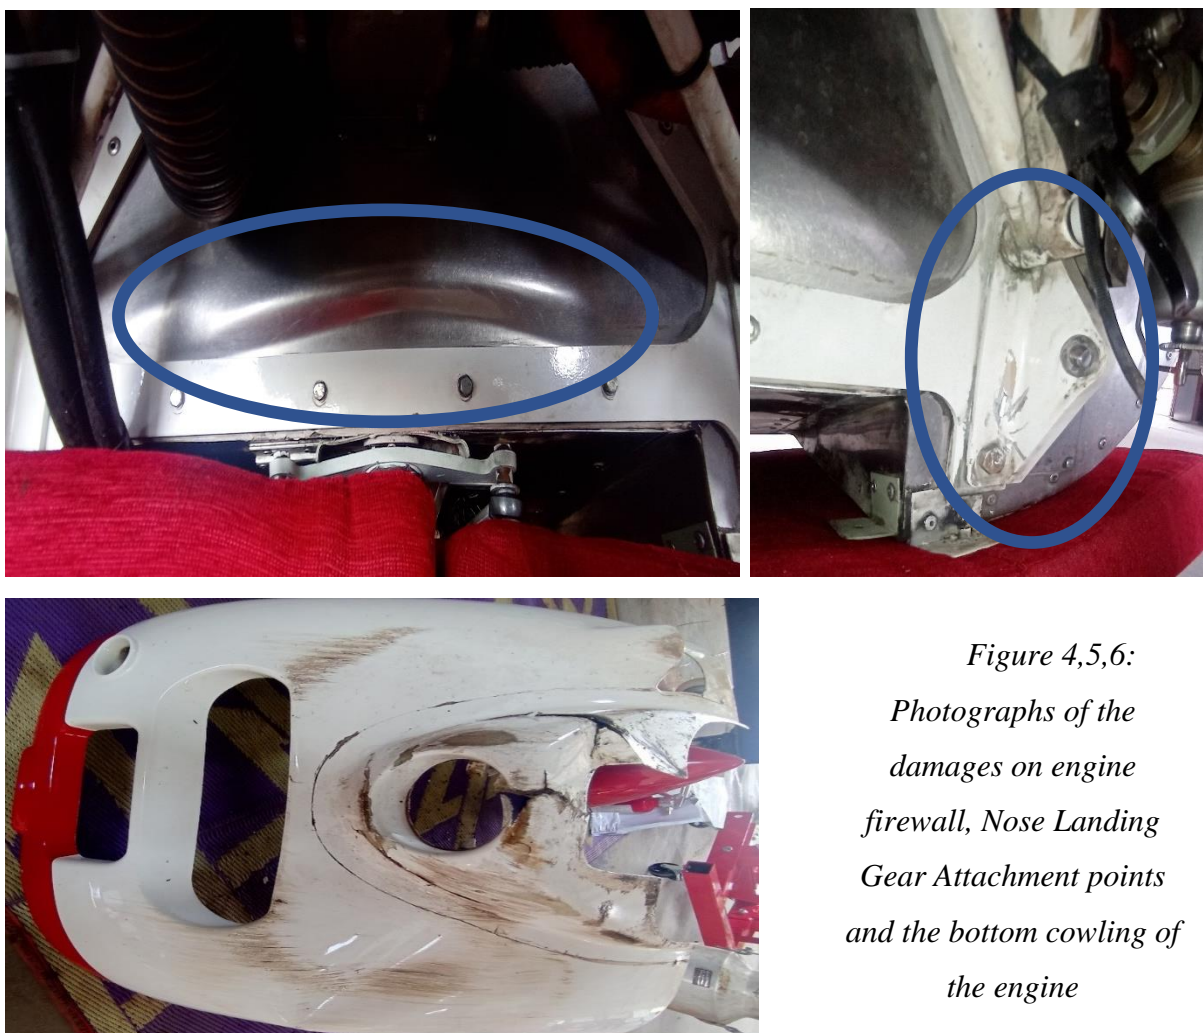
Dents and cracks were formed on both the upper and lower cowling of the engine. The lower cowling was severely damaged, whereas a crack was formed on the upper cowling. The landing and taxiing light was broken and separated from the cowling.

*Figure 4,5,6:  
Photographs of the  
damages on engine  
firewall, Nose Landing  
Gear Attachment points  
and the bottom cowling of  
the engine*

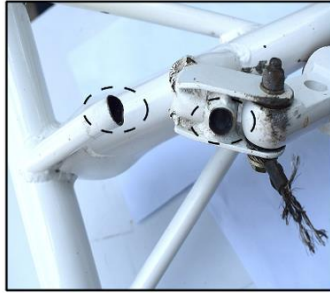
(b) Fracture at oleo-tubular leg attachment

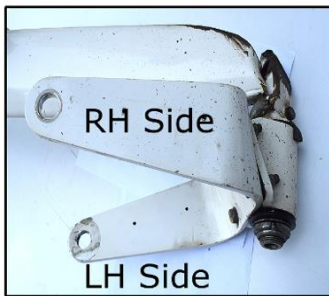
(c) Bent in Fork assembly

Due to the same impact on NLG, the nose wheel was disintegrated from the fork assembly resulting in a bend in the RH-side of the fork, and RH-side central bushing of the nose wheel. The tapered roller bearing unit (RH side) also suffered overload leading to brinelling from impact on roller units and depression on the outer ring raceway. Markings and rubber deposits consistent with the disintegration of the nose wheel with a bend onto the RH side were also found on the runway.

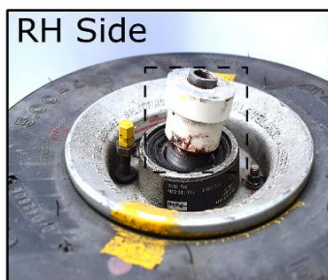
(d) Distortion in Central Bushing

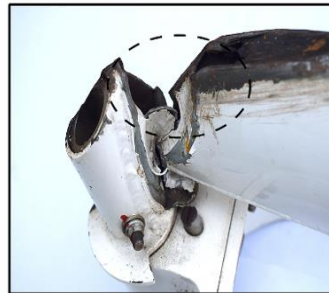
(e) Fracture at pivot-tubular leg attachment

- A significant fracture was found on the attachment between the pivot and tubular leg. Rub marks were observed on the pivot of the NLG assembly and the tubular leg with the signature of pitting corrosion. Slant and fibrous features were found on the fractured surface of the tubular leg.

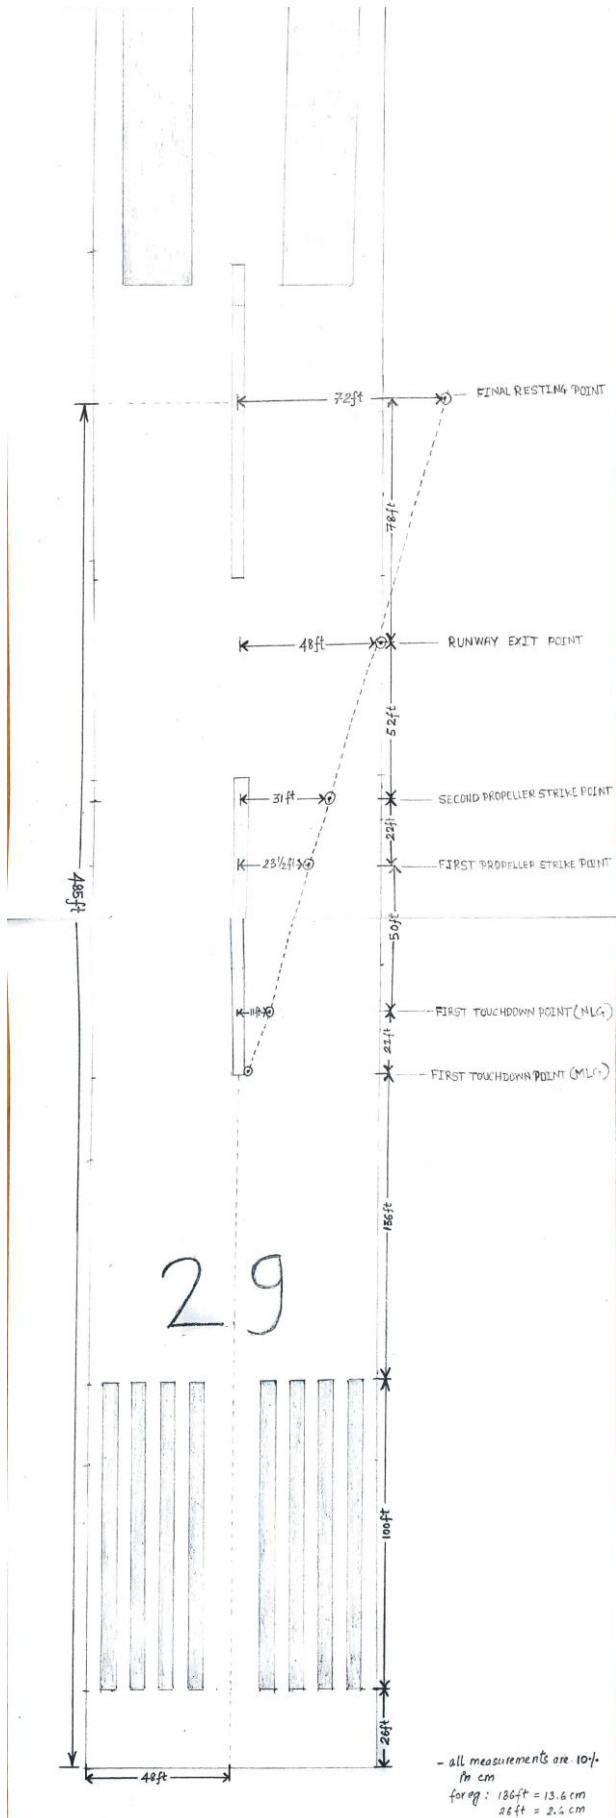
- The right main landing gear impacted the runway surface near the runway centreline at approximately 136ft from the end of the threshold marking of runway 29.
- The nose landing gear wheel and fork impacted the runway surface, 22ft from the main landing gear touchdown point.
- The propeller struck for the first time on the runway surface at 208ft from the end of the threshold marking of runway 29 and 23.5ft to the right from the runway centre line and the second time at 22ft ahead and 31ft to the right from the runway center line.
- The aircraft exited from the runway at a point 282ft from the end of the threshold marking of runway 29.
- The broken nose landing gear along with the bottom engine cowling scraped the runway surface with the propeller continuously striking the ground. The aircraft came to a halt at a point which is 485ft from the beginning of the runway.

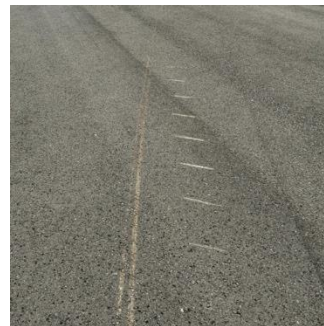
Propeller Strike I

come to halt. The propeller marks on the runway were found consistent with an engine on power and substantiate the statement of the instructor with regards to increasing the power for a go-around.
