**FINAL INVESTIGATION REPORT ON
HARD LANDING INCIDENT DUE VIBRATIONS TO M/s HELIGO
CHARTERS PRIVATE LIMITED BELL 412 HELICOPTER VT-HLG
ON 13/03/2019 AT VIJAYAWADA AIRPORT**

**GOVERNMENT OF INDIA
O/o, DIRECTOR AIR SAFETY, WESTERN REGION,
NEW INTEGRATED OPERATIONAL OFFICE COMPLEX,
SAHAR ROAD, VILE PARLE (EAST), MUMBAI-400099**

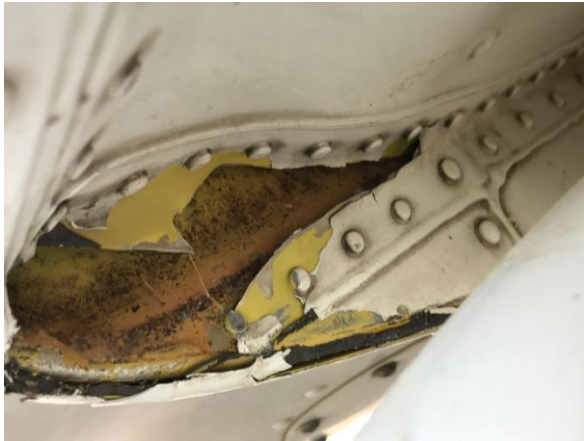
The helicopter had sustained damage due to the heavy landing. Inspection revealed that the cross tubes had yielded and spread across and the tunnel skin area on the right side was damaged. A small amount of debonding was found on the spindle bearings of one of the main rotor blades. None of the parts of the helicopter were detached from the structure. There was no fire during or after the incident.

Figure 1: Damage on aft cross tube area

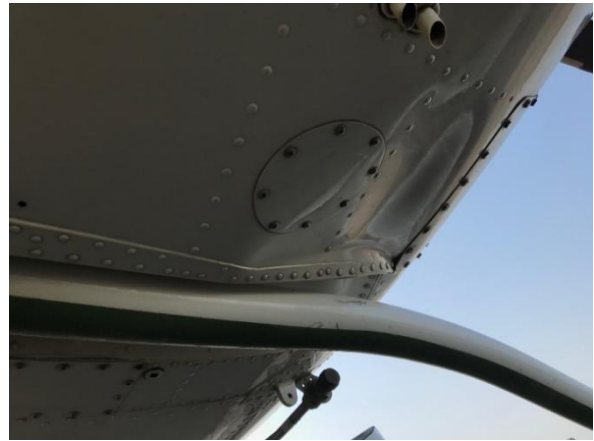
Figure 2: Dent on the bottom skin surface

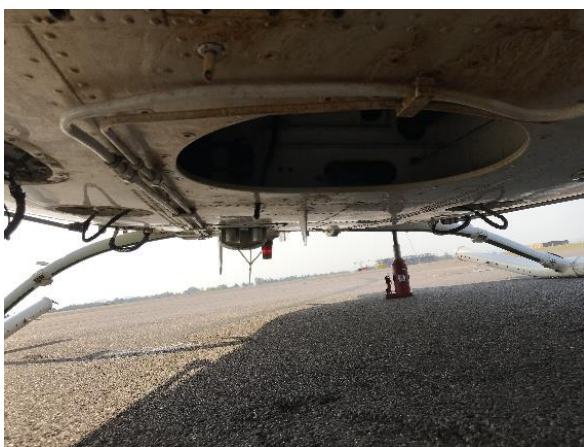
Figure 3: Underbelly picture showing yielded skid landing gear

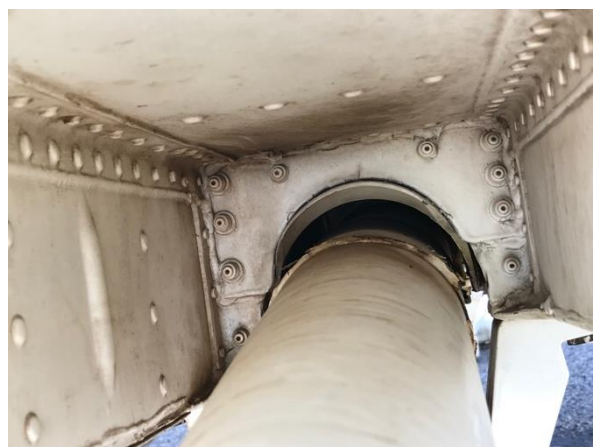
Figure 4: Damage to Crossbeam

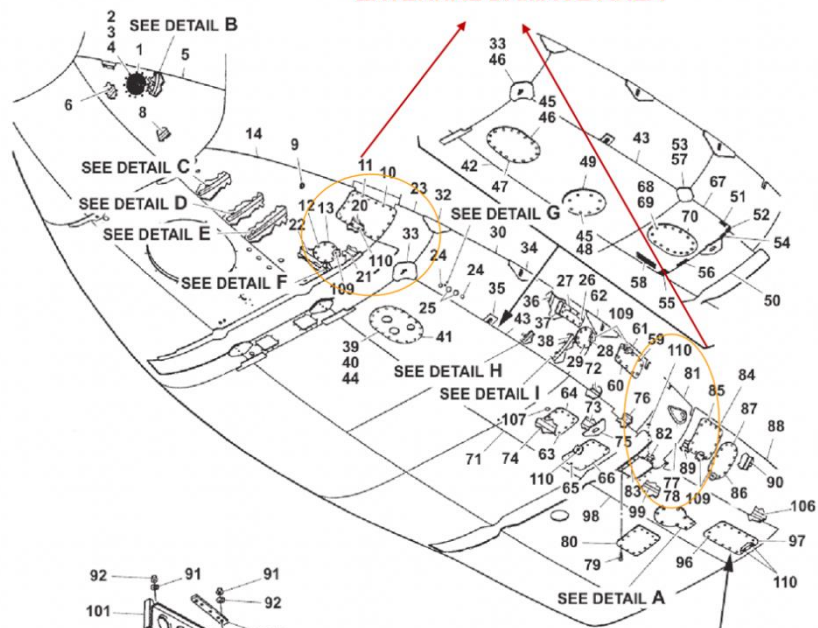
Figure 5: External Damage Area

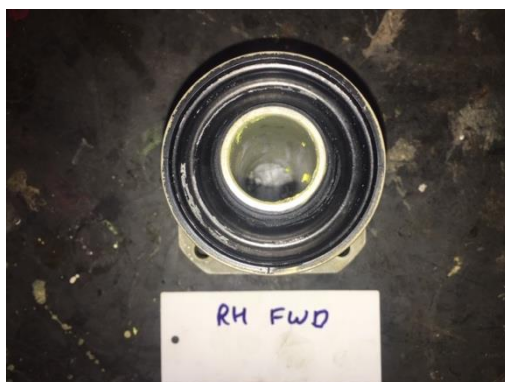
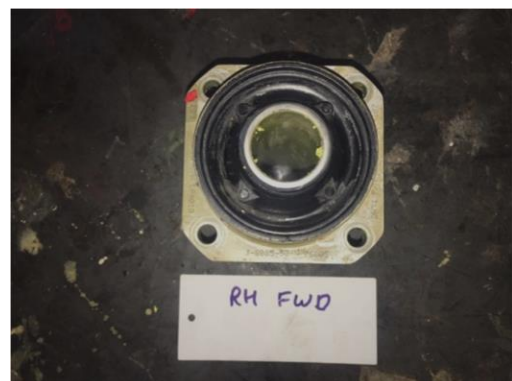
Figure 9: RH Forward Mount

As per the report of the laboratory, a visual inspection of the four pylon corner mounts showed no apparent defects or damage to the structure. All the mounts had small amounts of white residue on the elastomer. Spectroscopy of the same showed that the residue was paraffin wax, which is consistent with the dampers having undergone large oscillatory motions. Stiffness measurements indicate age hardening, but there are no signs of elastomer degradation.

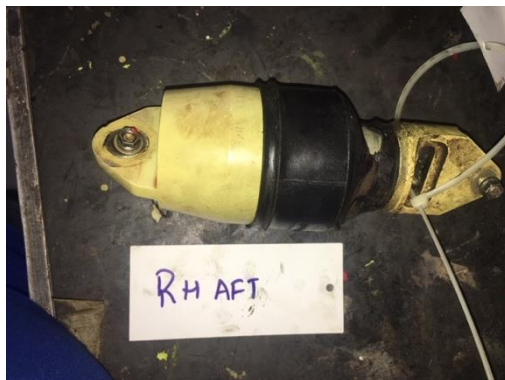
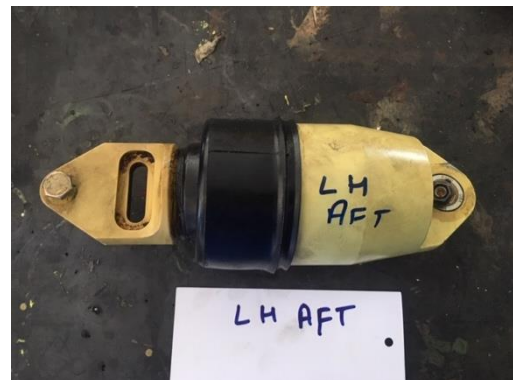
Figure 17: RH Aft Friction Damper

Figure 18: LH Aft Friction Damper

It was concluded that visual inspection and testing found the rod end bearings were in good condition. The characterization testing concluded that there was no degradation of damper performance found under high amplitude oscillatory motion.

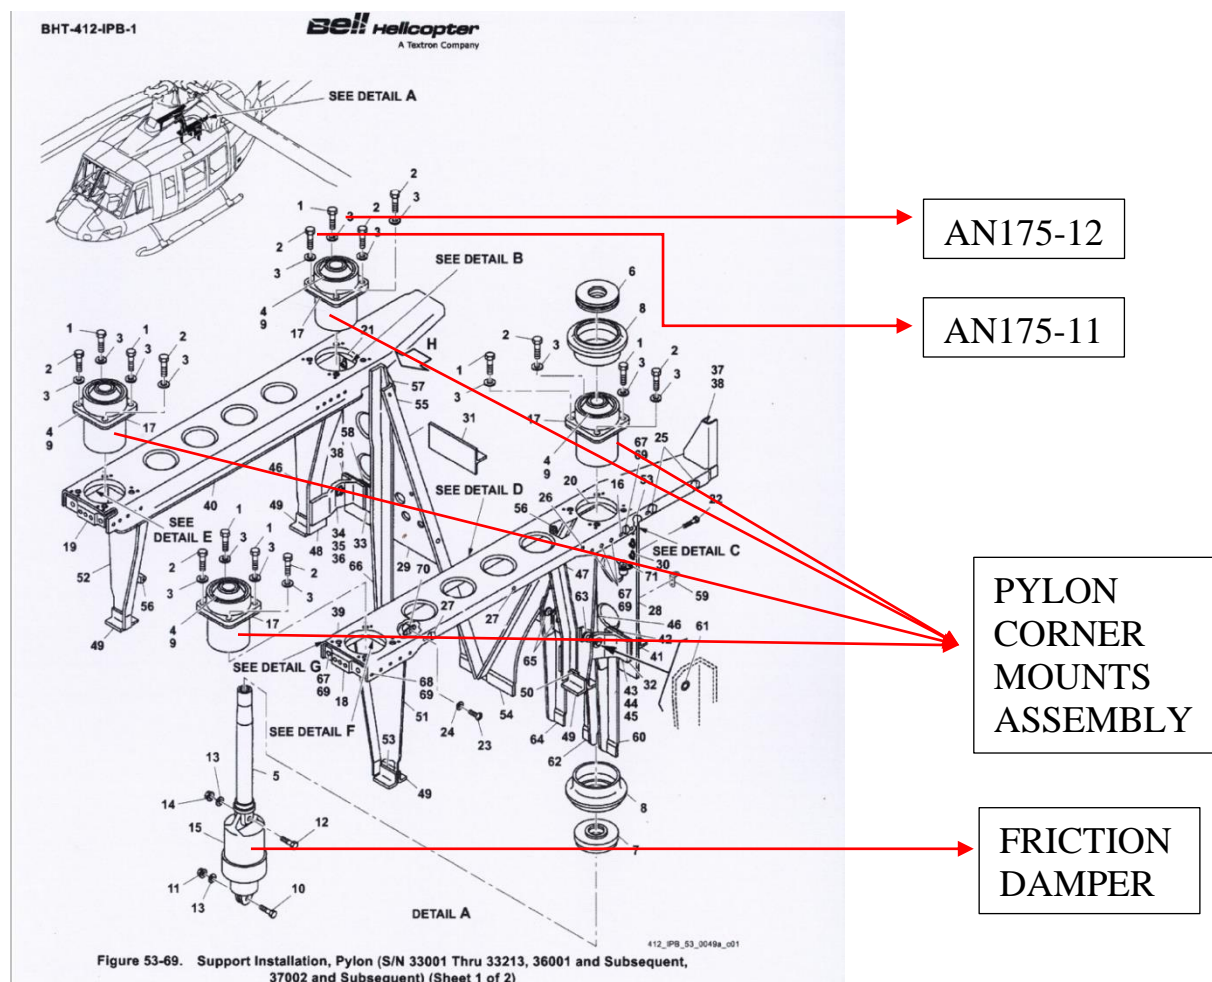
Figure 19: Pylon Corner Mount and Friction Damper depicting the Two Different bolts

In both LH and RH forward mounts, the bolts in the left/fwd corner and right/aft corner were found swapped. Such incorrect installation can result in insufficient clamping in the locations where a longer bolt was used. It is reported by the manufacturer, that this has been observed in at least one other field incident involving excessive vertical vibrations.

However, before the testing was initiated, during the visual inspection, it was found that the mounting locations of the bolts were swapped in both the forward mounts. The manufacturer has confirmed that the installation of longer bolts in the wrong locations can lead to insufficient clamping force and cause vertical vibrations. The manufacturer had also confirmed that this has been observed in at least one other field occurrence involving excessive vertical vibrations.

Bolts mounted at incorrect locations while installing the pylon corner mounts are found to be a probable cause of the incident. Inadequate communication between the crew and lack of knowledge of the Operational Safety Notice are considered contributory factors to the incident.
