**FINAL INVESTIGATION REPORT ON  
INCIDENT TO  
M/s. NFTI DIAMOND DA-42 AIRCRAFT, VT-NFT  
ON 05.12.2021 AT GONDIA**

**GOVERNMENT OF INDIA  
O/o, DIRECTOR AIR SAFETY, WESTERN REGION,  
NEW INTEGRATED OPERATIONAL OFFICE COMPLEX,  
SAHAR ROAD, VILE PARLE (EAST), MUMBAI-400099**

The cause of the incident is attributed to the failure of the RH unfeathering accumulator.

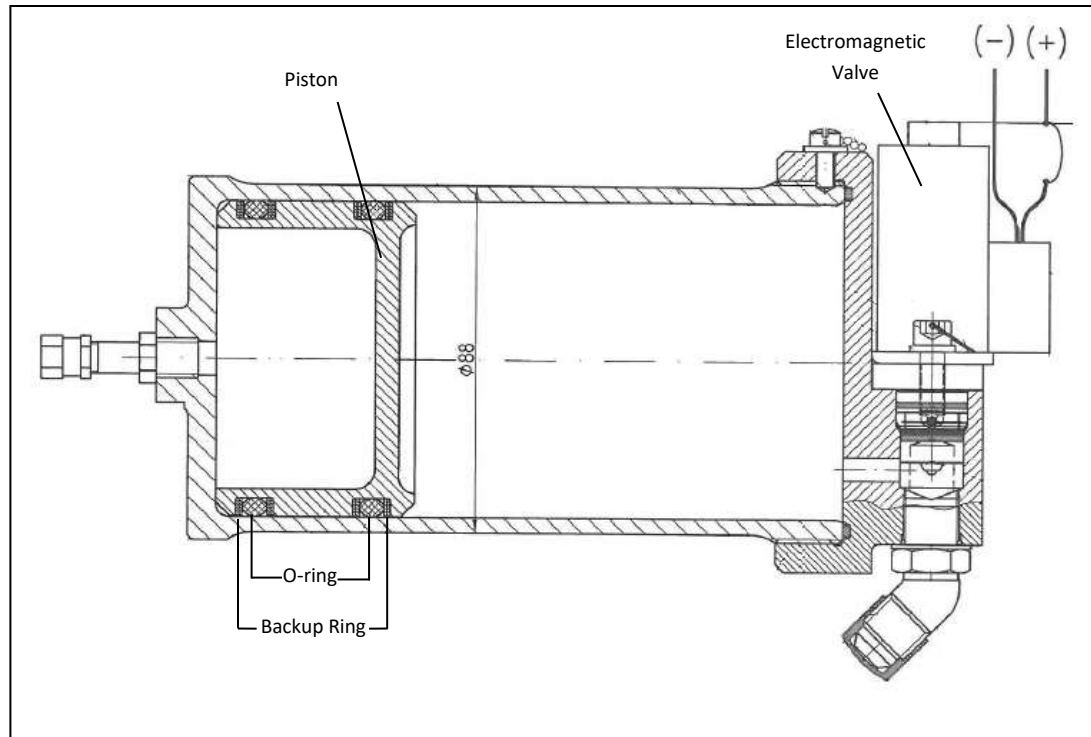
Fig. 2: Unfeathering Accumulator (sectional-diagram)

- The seat of the accumulator was found damaged.
- The cylinder was found with heavy deep scratches possibly caused by very dirty oil inside.

M/s MT propeller concluded that the leak was caused by deep scratches inside the cylinder. Also, the accumulator lost oil pressure through the seat of the control valve.

Hence, the only possible cause for the reduced air pressure at the air side would be owing to the gradual internal leak of air to the oil side through the deep scratches inside the cylinder during the several unfeathering operations of the unfeathering accumulator.

The probable cause of the incident is attributed to the gradual loss of air pressure to the oil side through the deep scratches inside the cylinder of the unfeathering accumulator, which prevented the RH propeller from unfeathering.
