**FINAL INVESTIGATION REPORT ON INCIDENT TO M/s GUJARAT
FLYING CLUB, CESSNA FA 152 AIRCRAFT, VT-EMM, ON 19.03.2020 AT
VADODARA**

GOVT OF INDIA
O/O DIRECTOR AIR SAFETY
WESTERN REGION
NEW INTEGRATED OPERATIONAL COMPLEX
SAHAR ROAD
VILLE PARLE (EAST)
MUMBAI-400099

a) Aircraft	Type & Model : Cessna FA 152 Aircraft
	Nationality: Indian
	Registration: VT-EMM
b) Owner	: M/s The Aero Club of India
c) Operator	: M/s The Gujarat Flying Club
d) Pilot in command	: SPL holder
e) Extent to injuries	: Nil
f) First Officer	: N/A
g) Extent to injuries	: N/A
h) Passengers onboard	: Nil
i) Extent to injuries	: N/A
j) Place of incident	: Vadodara, Gujarat (VABO)
k) Co-ordinates of Incident site	: N 22.340563, E 73.230490
l) Date and time of Event	: 19.03.2020, Approx. 11:33 IST
m) Last Point of Departure	: VABO
n) Point of Intended Landing	: VABO
o) Type of operation	: Training flight (Solo)
p) Phase of operation	: Landing
q) Type of Incident	: Abnormal Runway Contact

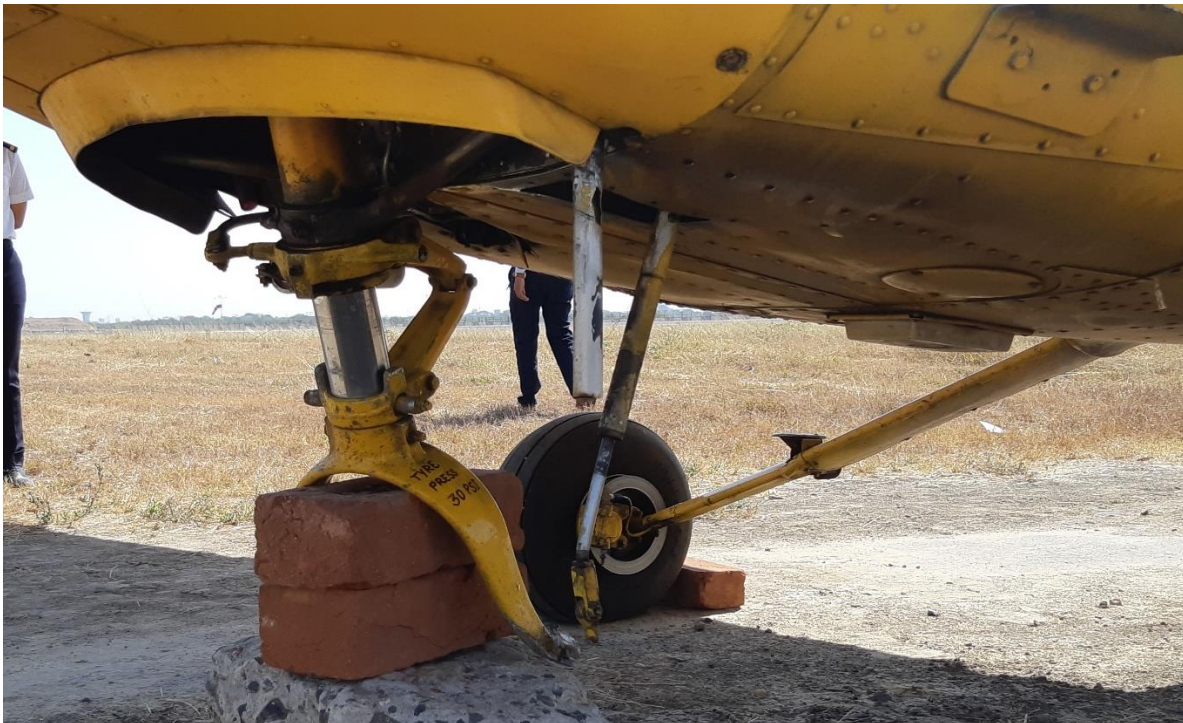
1. Due impact the nose landing gear fork found broken, subsequent the nose landing gear wheel detached from Nose landing gear fork & Nose wheel assembly also damaged. (Fig 01)

Fig 01 Photograph shows Nose landing gear fork & Nose landing gear assembly damaged

The failed / damaged parts of the nose wheel assembly were examined in Aircraft Engineering Directorate, DGCA Hqrs. Upon examination, The Inner Diameter of bearing inner race and Outer Diameter of tube axle at the corresponding bearing locations have been dimensionally examined and it is found that the parts under excessive clearance /play (undersized) in their assembly from the prescribed limits observed. Hence, tube axle (As Shown in Fig.05) is worn out and undersized at the bearing diameter locations. There was an indication of undersized tube axle, circumferential rubbing marking and pitting were noticed on the tube axle.

The worn-out tube axle outer diameter at the bearing locations would have eased the bearing units to rotate over the tube axle. This could have also caused the entire wheel assembly along with bearing unit (which is restrained by ring retainer within the wheel assembly) to move on lateral direction. The lateral movement of the wheel would have probably caused offsetting of wheel loading on the tube axle, movement of bearing units

Wheel assembly detachment failure could have probably due impact contributed by undersize/ worn out tube axle and subsequent the NLG collapsed.

The nose landing gear assembly is to be inspected during 100 Hrs/12 months & 50 hrs inspection which includes the inspection of NLG for condition and security of attachment, however there is no specific inspection to measure the dimensions of axle tube and the bearing of the nose wheel.

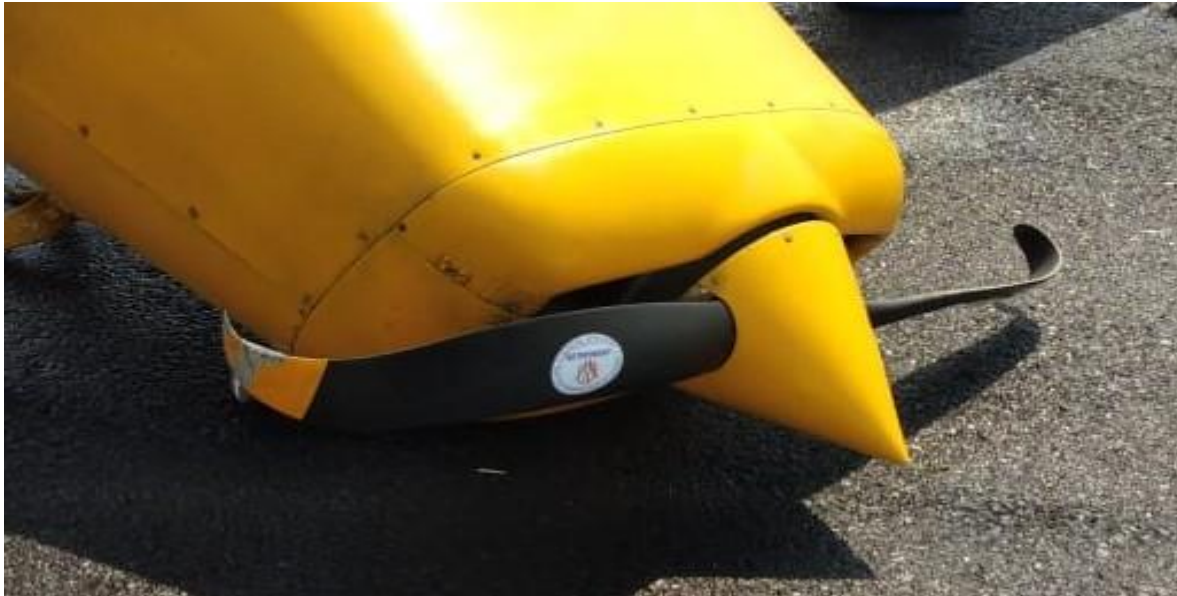
2. Due Propeller hit to the runway surfaces, both propeller blades were bent

Fig 02 Photographs shows Propeller blades bent

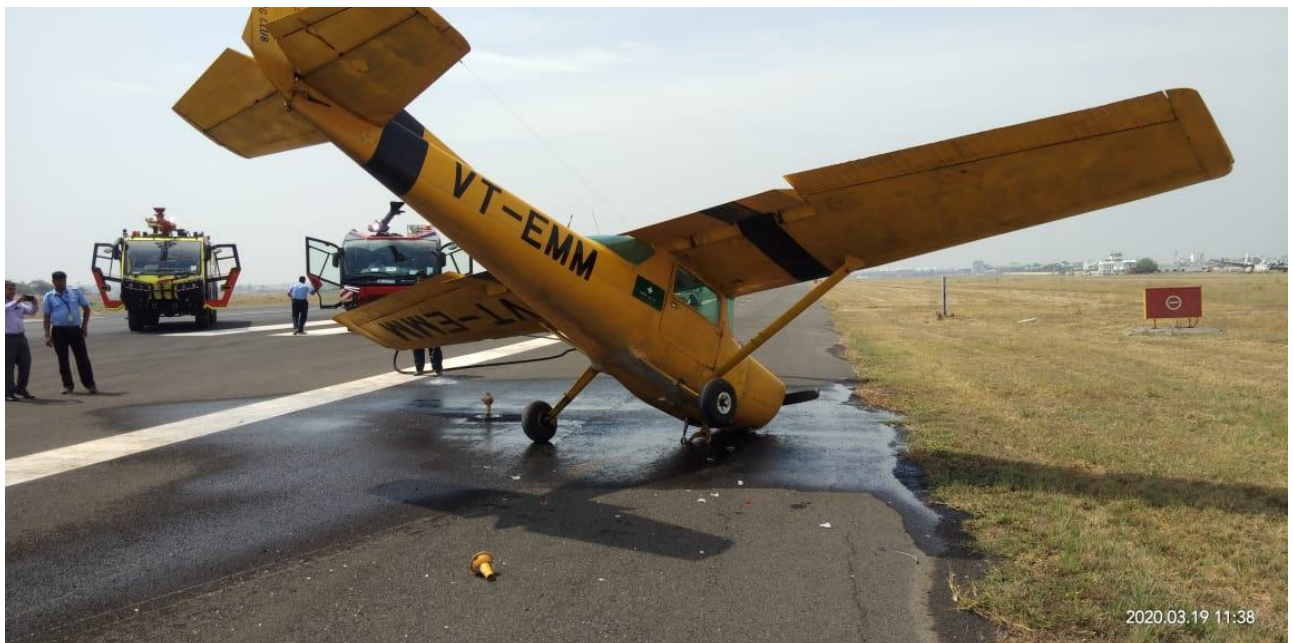
The aircraft was found disabled outside the RH Runway Edge of RWY 22 on basic strip at distance approx. 05 meters from the Runway Edge and approx. 582 Meters from RWY 22 threshold. & Nose Landing gear wheel was detached due impact on Nose landing gear during landing on touchdown. (Shown in Fig 03)

Fig 03. Aircraft VT-EMM in tail high position on right side runway edges of RWY22

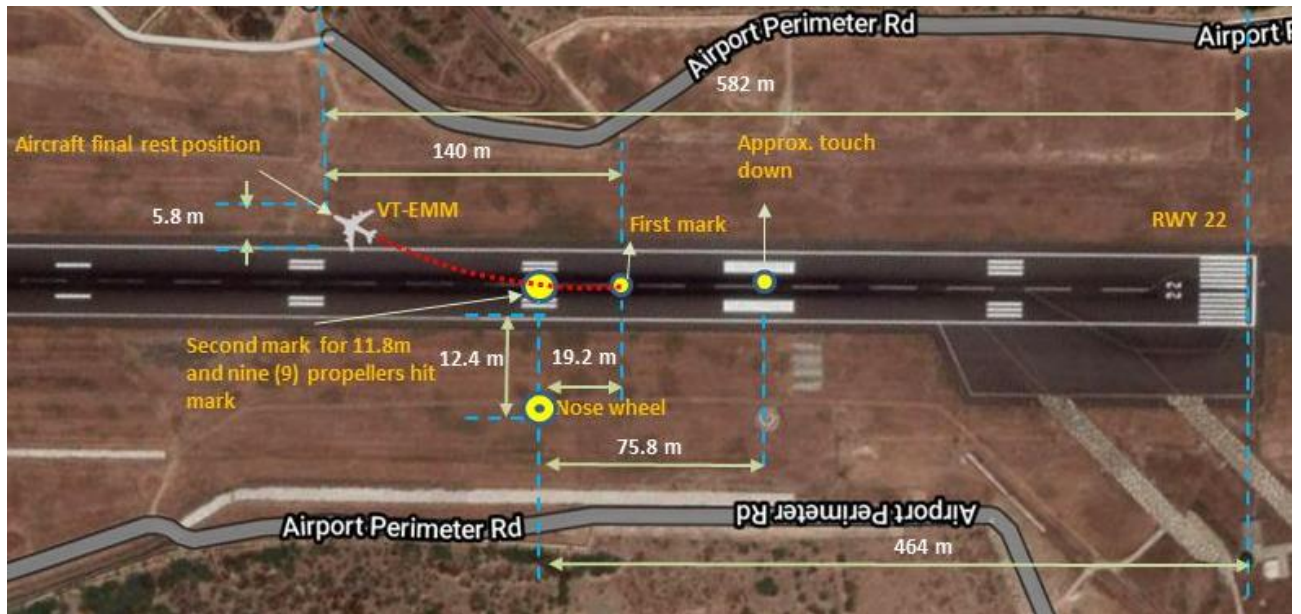
Nose Landing gear wheel was found from a distance 12.4 meters from the LH Runway Edge and approx. 464 Meters from RWY 22 threshold. (Shown in Fig 04). Fuel leak from the aircraft was observed. There was no fire on the aircraft after Aircraft veered off from RWY 22 to the RH Runway Edge.

Fig 04. Runway diagram depicts the flight profile VT-EMM after touchdown to final rest position
