DIRECTORATE GENERAL OF CIVIL AVIATION

**INVESTIGATION REPORT ON INCIDENT TO M/s HERITAGE
AVIATION PVT. LTD. EC-130T2 HELICOPTER VT-HEX DURING
FLYING FROM PANCHTARNI TO PAHALGAM ON 03.07.2022**

1	Aircraft	Type	EC-130T2
		Nationality	Indian
		Registration	VT-HEX
2	Owner	M/s Quantum Investment Ltd M/s Heritage Aviation Pvt. Ltd.	
	Operator		
3	Pilot – in –Command	Commercial Pilot License (Helicopter)	
	Extent of injuries	Nil	
4	Date & Time of Incident	03.07.2022 at 1750 hrs IST Approx	
5	Place of Incident	Enroute	
6	Co-ordinates of Incident site	Near Mahaguna Pass	
7	Last point of Departure	Panchtarni Helipad, Sri Amarnath	
8	Intended place of landing	Pahalgam Helipad	
9	No. of Passengers on board	Five (05)	
10	Type of Operation	Commercial (Pilgrim operation)	
11	Phase of Operation	Climb	
12	Type of Incident	Engine parameter exceedance during flight

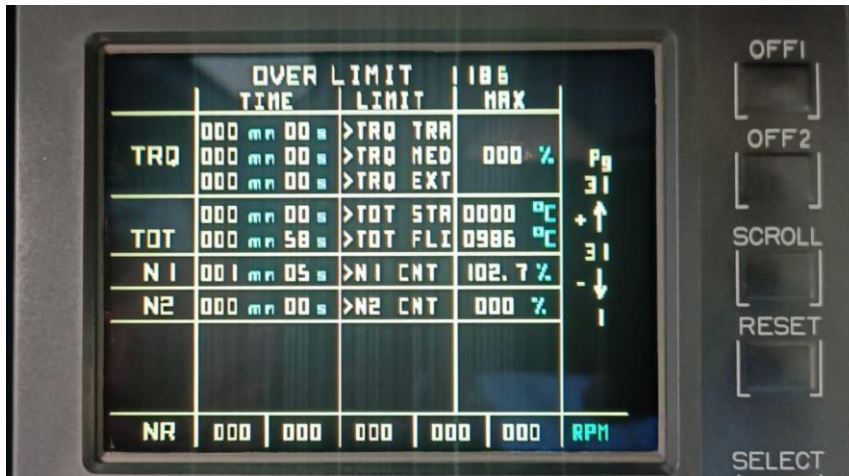
During the process of negotiating with the environment condition (downdraft), Engine N1 (Engine Generator Speed) and TOT (Turbine Outlet Temperature) exceeded for a brief period while Nr (Rotor Speed) decreased below safe limits, and associated warnings were recorded. The N1 reached up to 102.7%, TOT reached up to 986°C and Nr decreased to 88%. The N1 Exceedance was recorded for a period of 65 seconds, TOT exceedance was recorded for 58 seconds and Nr drop was recorded for 23 seconds. The exceedances were recorded in VEMD (Vehicle and Engine Multifunction Display) and EDR (Engine Data Record).

Helicopter is not fitted with any flight recorders. However there was an Exceedance of N1 and TOT verified from VEMD.
