### **FINAL REPORT ON INCIDENT TO M/S.SPICE JET LTD.Q-400 AIRCRAFT VT-SUF AT CALICUT ON 04/08/2017**

**DIRECTORATE GENERAL OF CIVIL AVIATION  
MINISTRY OF CIVIL AVIATION  
NEW DELHI**

**FINAL REPORT ON INCIDENT TO M/S.SPICE JET LTD. BOMBARDIER**  
**Q-400 AIRCRAFT VT-SUF AT CALICUT ON 04/08/2017**

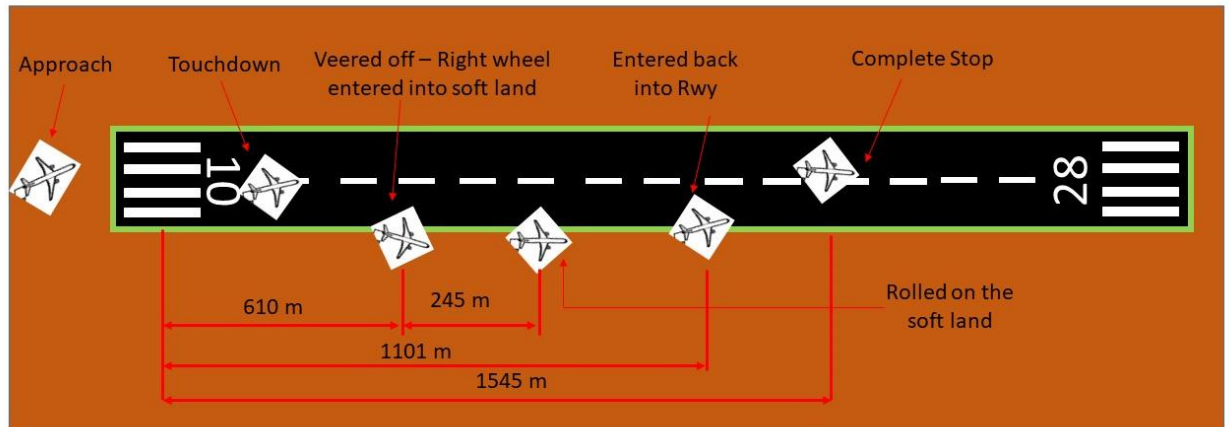
At a distance of 1101 m from RWY 10 threshold, the aircraft wheel markings show that the aircraft had entered back into the runway and at a distance of 1545 m from RWY 10 threshold, the aircraft had come to a complete stop. During this landing roll, aircraft had damaged 05 runway edge lights on right side.

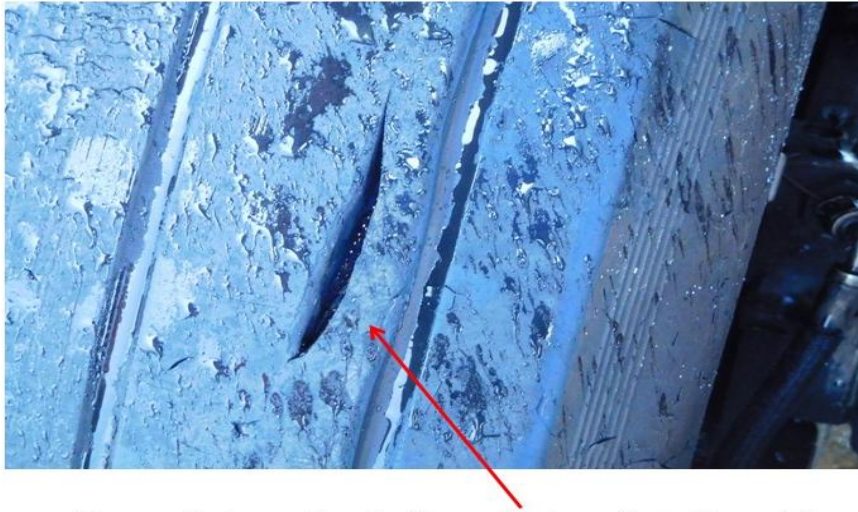
- Left main landing gear tire No.1 and No.2 checked and found with deep cuts on both the tire.
- Small cuts and small glass pieces are found on the left nose wheel assembly.

**Deep Cut on the Left main Landing Gear Tire**

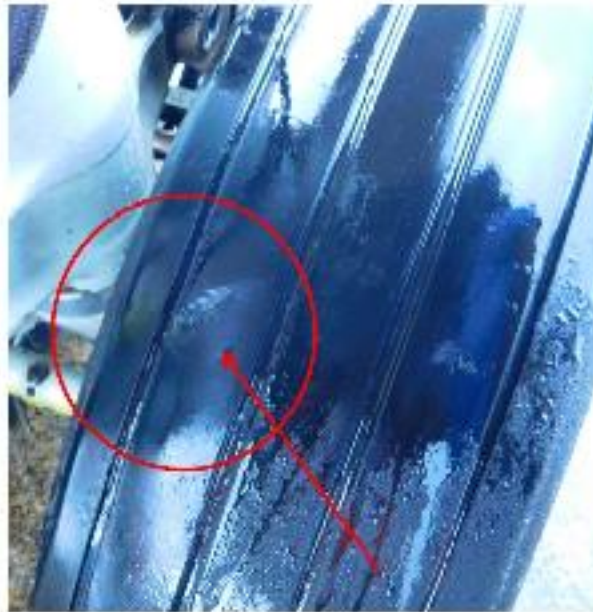
**Cut on the Left main Landing Gear Tire**

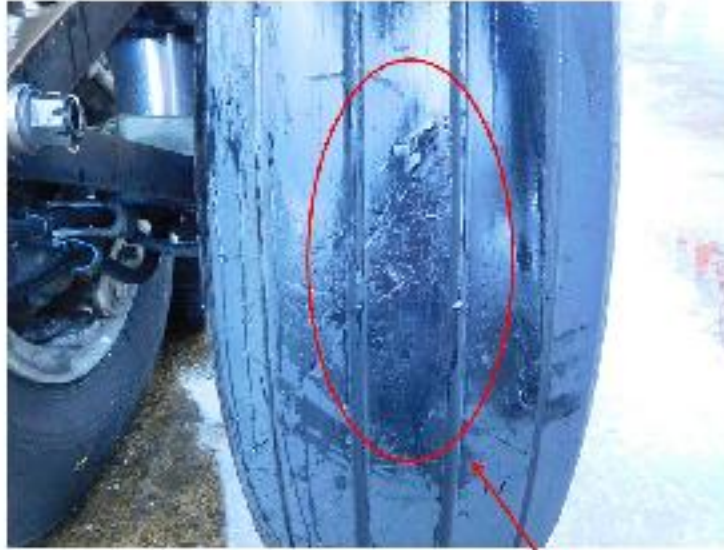
**Damage on the Left main Landing Gear Tire**

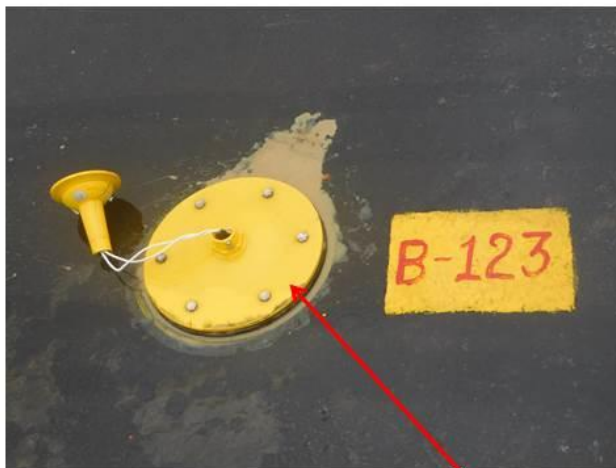
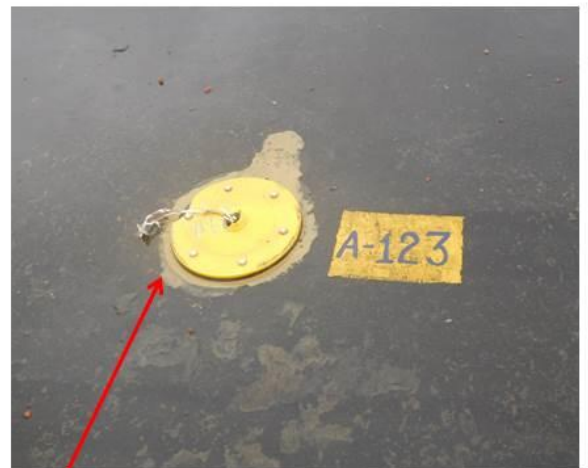
The left main landing gear impacted the runway edge lights and 05 lights were damaged.

**Runway edge lights broken**

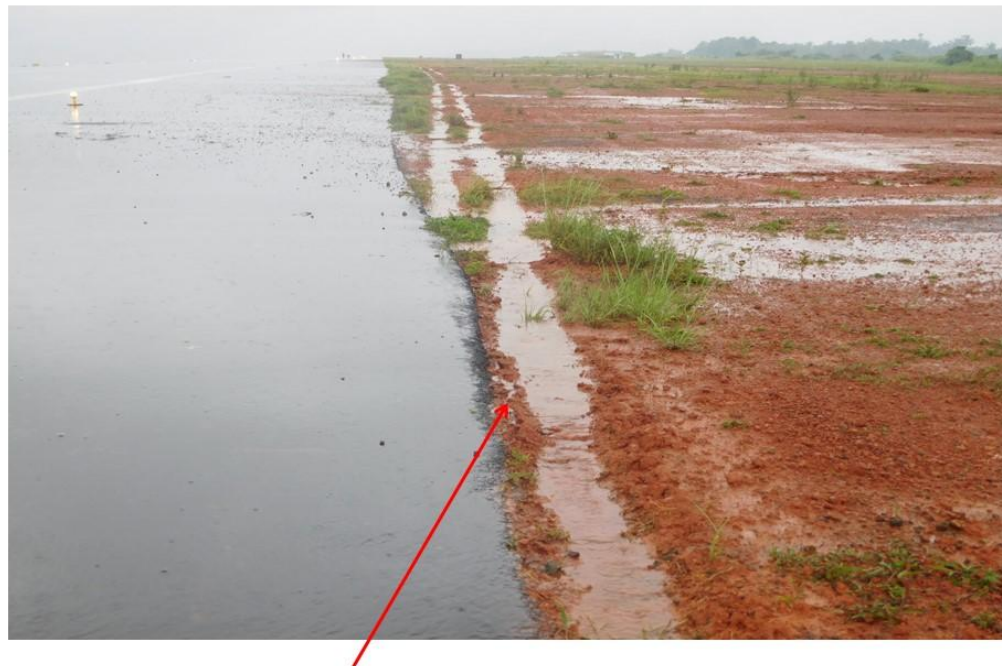
As per the evidences collected at the incident site, the aircraft after touchdown got veered off to the right of RWY 10 and impacted the runway edge lights. At a distance of around 610 m from RWY 10 threshold the aircraft wheel marking shows that the aircraft right wheel had entered into the soft land on the right of RWY 10 and whereas left wheel of the aircraft rolled over on the shoulder of the RWY 10. Further the right wheel of the aircraft had rolled for a distance of around 245 m on the soft land and at a maximum distance of 11.1 m from the right edge of the runway. Left wheel of the aircraft rolled on the shoulder of the RWY 10 and damaged the 05 runway edge lights. The first edge light broken due to aircraft impact was at a distance of 750 m from the threshold of RWY 10.

**Aircraft right wheel entered into soft land**

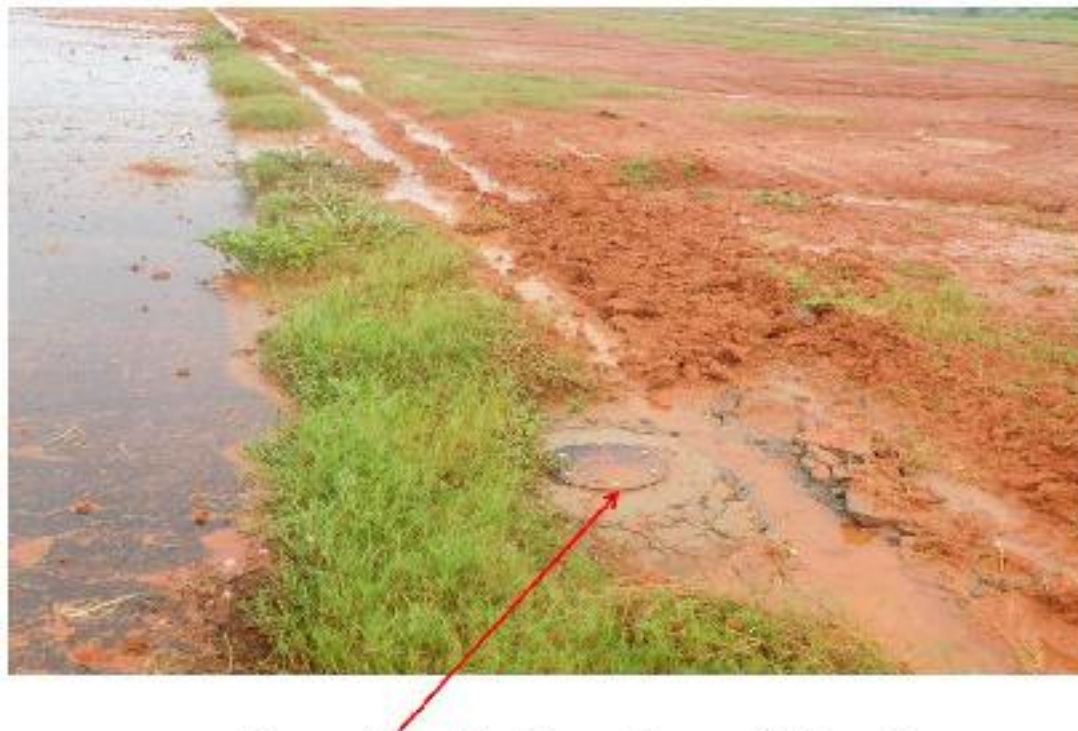
**Aircraft rolled on the soft land**
