**INVESTIGATION REPORT ON TAIL STRIKE INCIDENT
TO M/s INTERGLOBE AVIATION LTD.
AIRBUS A 321neo AIRCRAFT, VT-IMW AT AHMEDABAD
ON 15.06.2023**

**GOVERNMENT OF INDIA
DIRECTORATE GENERAL OF CIVIL AVIATION**

Investigation Report on Tail Strike incident to
M/s InterGlobe Aviation Ltd. Airbus A321neo aircraft VT-IMW at
Ahmedabad on 15.06.2023

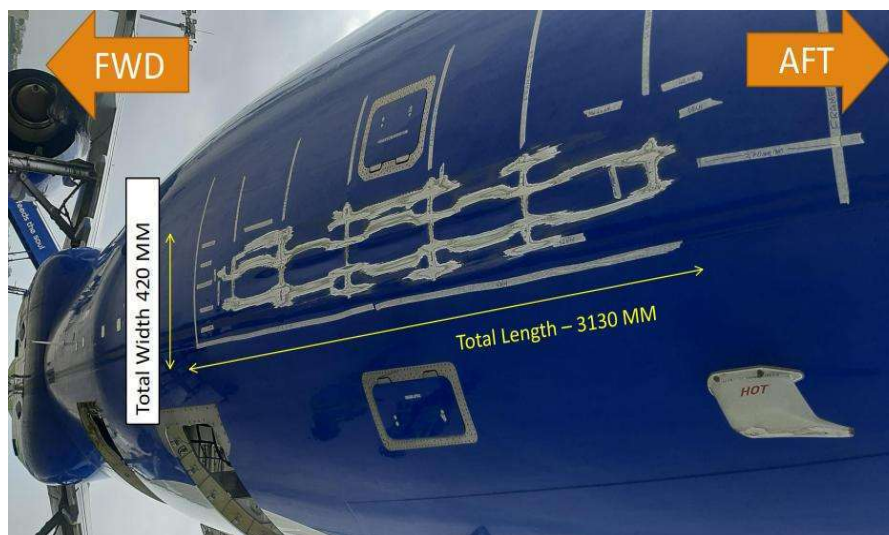
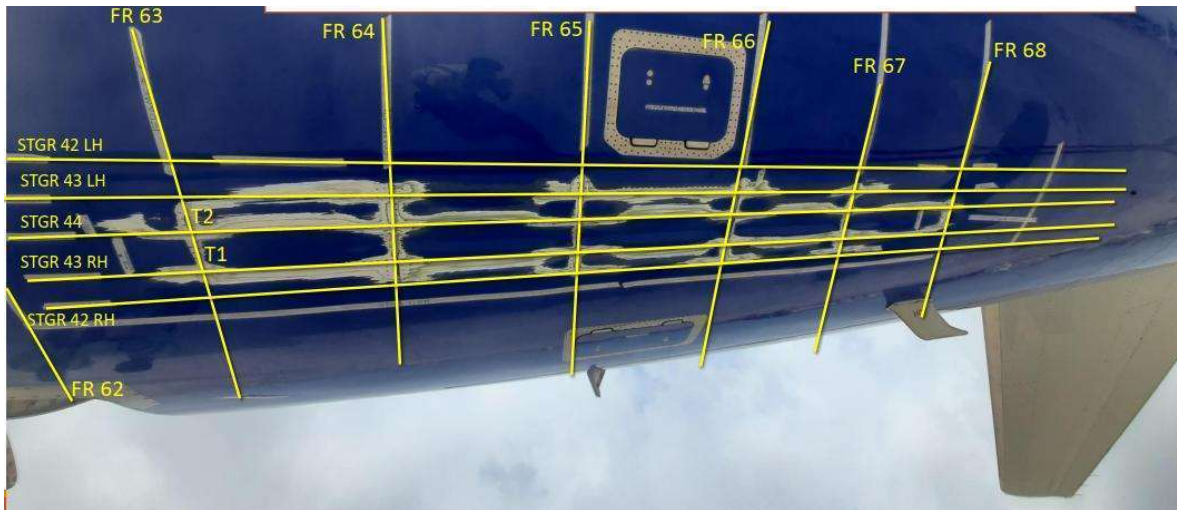
1. Skin damage noted between FR(Frame) 62 and FR 69 & between STGR(Stringer) 42 LH TO 41 RH.
2. Total length of Damage: 3130 mm.
3. Damage starts 305 mm aft of FR 62 & extended to 160 mm aft of FR 68.
4. Maximum width of damage (at FR 67 & BTW STGR 42 LH TO 41 RH): 420 MM

Drain mast installed on the skin was found bent by 10 MM and rubbed however no abnormalities were found on Drain mast support structure and its surrounding area.

1. At FR 63 & STGR 44 to 43 RH found butt strap bent inwards.
2. Intercostal web attaching top of FR 64 to FR 65 & STGR 44 found deformed.
3. At FWD of FR 64 between STGR 44 to 43 RH, butt strap bend inward and found sealant crack on clip joining FR 64 & STGR 43 RH. At AFT of FR 64, butt strap bend inward between 44 & 43 RH.

4. At FWD of FR 65, clip between FR 65 & STGR 44 found bent. Vertical strut attaching bottom of FR 65 & top of FR 65, found bend from middle. At FWD of FR 65, butt strap bend between 44 & 43 LH and also between STGR 44 & 43 RH. Sealant crack between STGR 43 RH & 42 RH. Sealant crack at STGR 43 LH and attaching clip at FR 65 (FWD). At AFT of FR 65, between STGR 44 & 43 RH, puncture observed.

5. Butt strap bend inward & sealant crack at FR 66 between STGR 43 RH & 44. At AFT of FR 66, between STGR 44 & 43 RH, puncture observed & butt strap bend inward. At FR 66, between STGR 44 & STGR 43 LH found sealant crack.

6. At FR 67, STGR 43 RH & STGR 44, found butt strap bent inwards and also sealant crack between 44 & 43 LH. At FR 67, sealant crack at butt strap between STGR 43 RH & STGR 42 RH.

7. At FR 68, between 44 & 43 LH as well as between 42 LH & 43 LH, found sealant crack at butt strap.

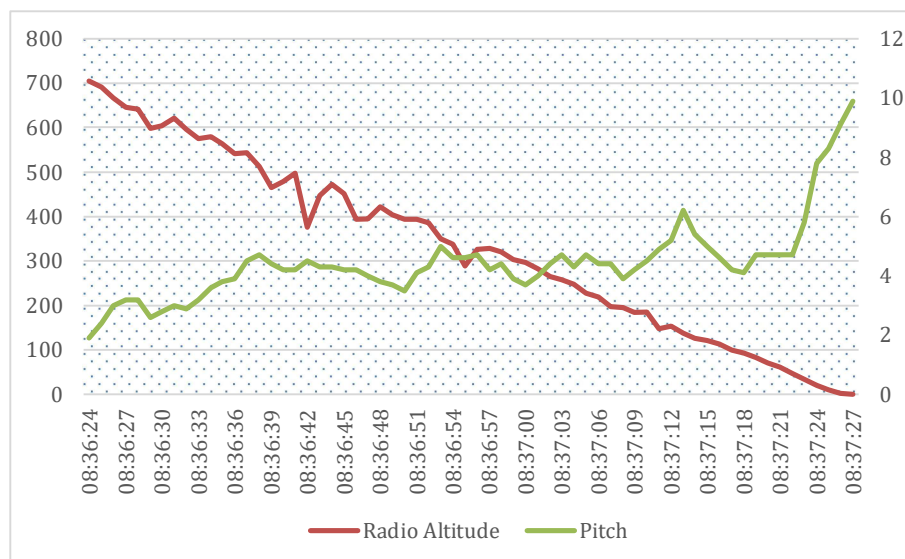
Radio altitude and Pitch Vs Time (UTC)

20. The aircraft pitch was about 4° - 5° during final approach below 500ft radio altitude. Below 50ft radio altitude the aircraft pitch started increasing from 4.7° and reached a maximum of 10° at touchdown of main wheels which was at 08:37:26UTC.
The aircraft vertical speed was 128ft/min at touchdown and vertical acceleration of 1.85g.
The aircraft speed, IAS at touchdown was 125kt and ground speed was 124 kt.

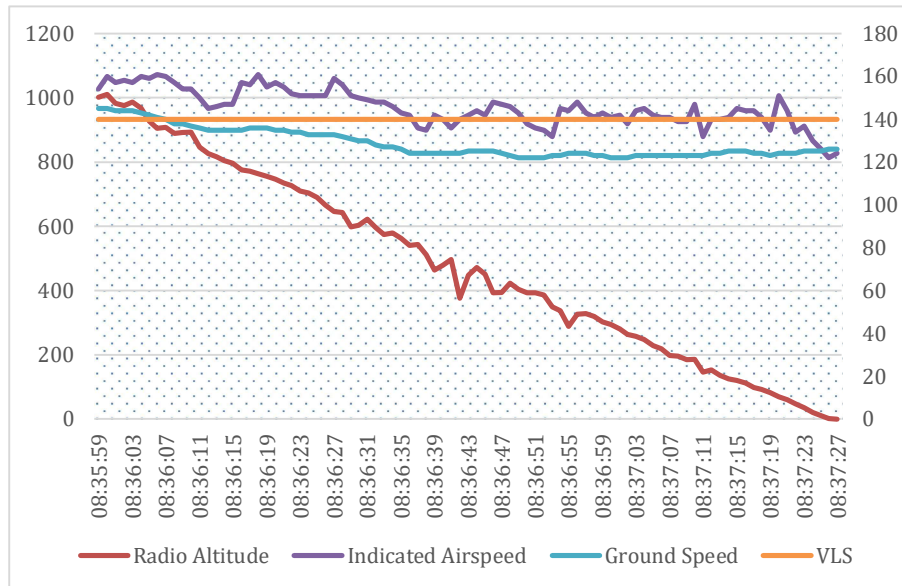
Radio altitude, Indicated Air Speed, Ground Speed and VLS Vs Time (UTC)

The system design for managed speed/Mach is such that the lowest target is VLS. However, in the approach phase, VAPP is memorised at 700 ft RA, so that if the FMS loses the VAPP below 700ft RA, the managed speed target will still be computed. The lower limit of the managed speed target is the VAPP that is computed by the FMS, and displayed on the MCDU. In the subject scenario, the VLS was 140kt and the Ground Speed Mini function adjusted target speeds for the wind conditions during approach. However below 700ft radio altitude, the target speed was the memorised Vapp which in this case, due to selection of Landing Configuration as CONFIG FULL was less than VLS (which was calculated for selected configuration of CONF 3). This resulted in the target speed being lower than VLS. The PF and the PM did not monitor the drop in the target speed and the drop in aircraft speed below the VLS was not announced.

To summarise the above; due to CONFIG FULL selection made in the performance(PERF) page during the FMS setup and CONF 3 being selected during approach, the FMS memorised target speed (Vapp) which was below VLS for CONF 3 was maintained below 700ft during the approach. The decrease in speed is of the extent of VLS-15 which caused a decrease in aircraft energy. The low energy state of the aircraft and variations in the prevailing winds resulted in an increase of pitch and the ensuing tail ground contact during touchdown.

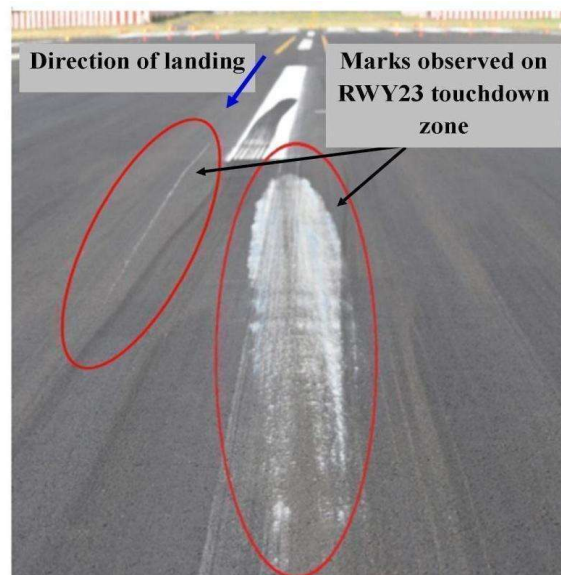
Photograph of VAAH (Ahmedabad) - RWY 23, location of VT-IMW tail ground contact

VT-IMW landed at Ahmedabad on Runway 23 at 0837 UTC (1407 IST) and was parked at Stand 09 at 0842 UTC (1412 IST). During runway inspection at around 1000 UTC (1530 IST), operations vehicle observed abnormal abrasion on runway pavement measuring approx. 9m. Paint marks/ abrasion were located at approx. 220m from beginning of RWY23.

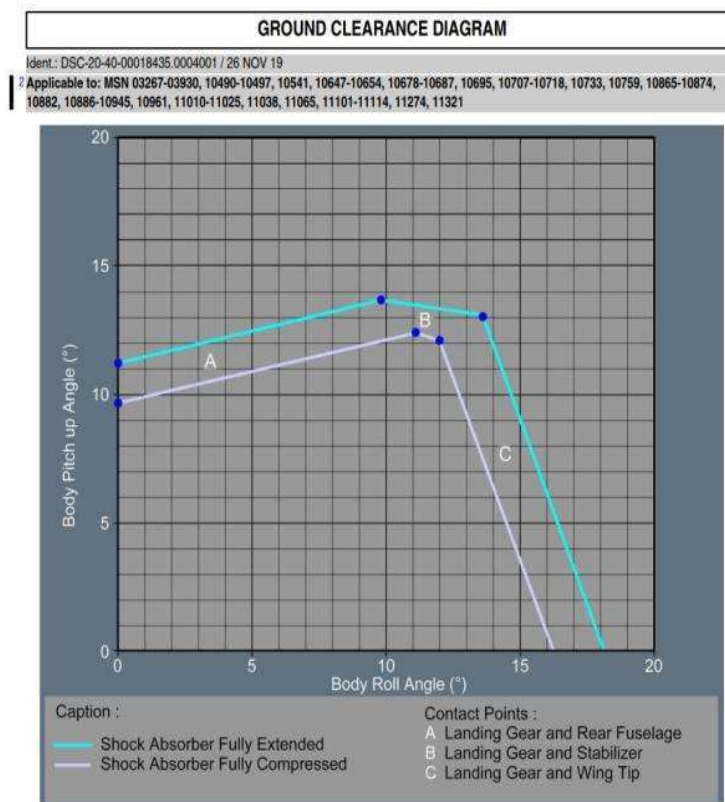
1.18.2 FCOM Reference: Ground Clearance Diagram

As per DFDR data the during flare phase Pitch angle reached +10.02° with both AP's engaged.
As per the above mentioned PITCH WARNING conditions, AP's must be OFF to active the PITCH PITCH warning. This was the reason for non-activation of PITCH PITCH warning during the event.

Pitch attitude limit with MLG fully compressed for A321 is 9.7°. Pitch attitude limit with MLG fully extended is 11.2°.
