FINAL INVESTIGATION REPORT ON SERIOUS INCIDENT TO M/S MP FLYING CLUB CESSNA-172S AIRCRAFT VT-MPF ON 10.03.2023 AT INDORE

**FINAL INVESTIGATION REPORT ON SERIOUS INCIDENT TO M/S MP FLYING CLUB
CESSNA-172S AIRCRAFT VT-MPF ON 10.03.2023 AT INDORE**

1	Aircraft	Type	Cessna
		Model	172S
		Nationality	Indian
		Registration	VT-MPF
2	Owner and Operator	M/s Madhya Pradesh Flying Club Ltd	
	Pilot-in command	Student Pilot licence (SPL) holder	
3	Extent of Injuries	Nil	
4	Date & Time of Incident	10.03.2023 & 11:40hrs UTC approx.	
5	Place of Incident	Indore Airport	
6	Co-Ordinates of Incident Site	Latitude 22°43'24"N Longitude 75°48'20"E	
7	Last Point of Departure	VAID (Indore Airport)	
8	Intended place of landing	VAID (Indore Airport)	
9	No. of Passengers on Board	Nil	
10	Type of Operation	Training flight (Solo)	
11	Phase of Operation	Landing	
12	Type of Incident	Runway Excursion

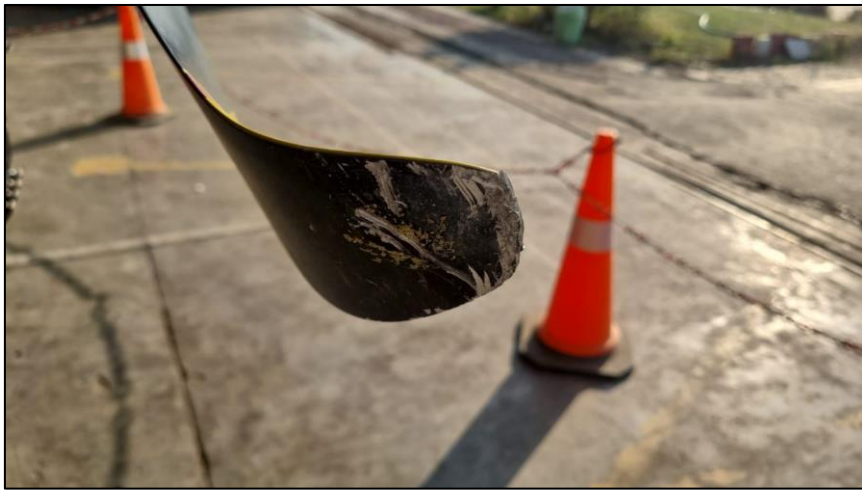
- Propeller blade Tips found bend. Refer Photograph# 1 & 2.
- Left Horizontal Stabilizer skin found deformed. Refer Photograph# 3.
- Scratch marks found on bottom surface of the Right Landing gear strut. Refer Photograph# 4.

(Photograph# 1- Propeller blade Tip found bend)

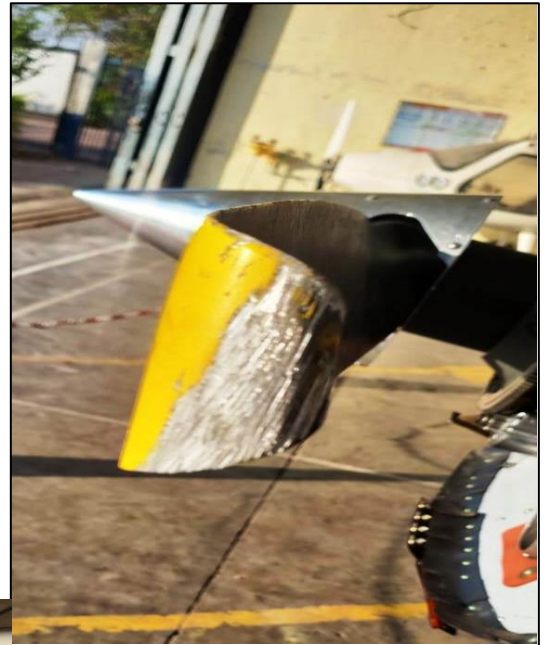
(Photograph# 2- Propeller blade Tip found bend)

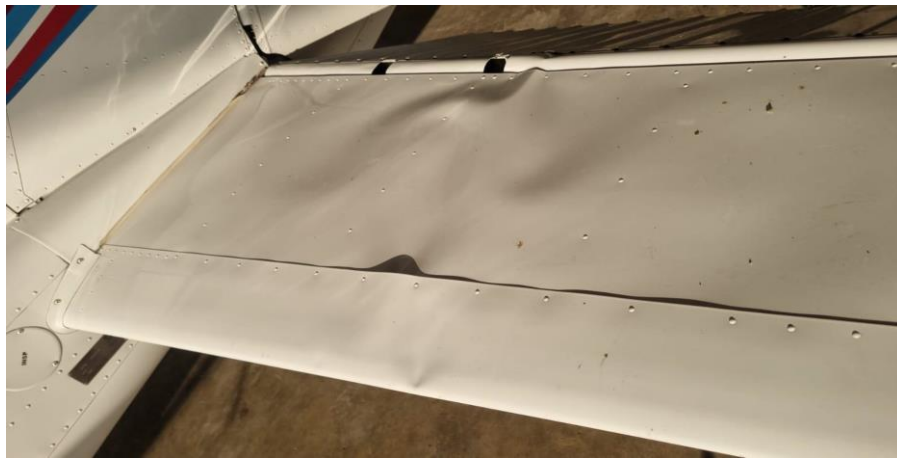
(Photograph# 3-Left Horizontal Stabilizer skin found deformed)

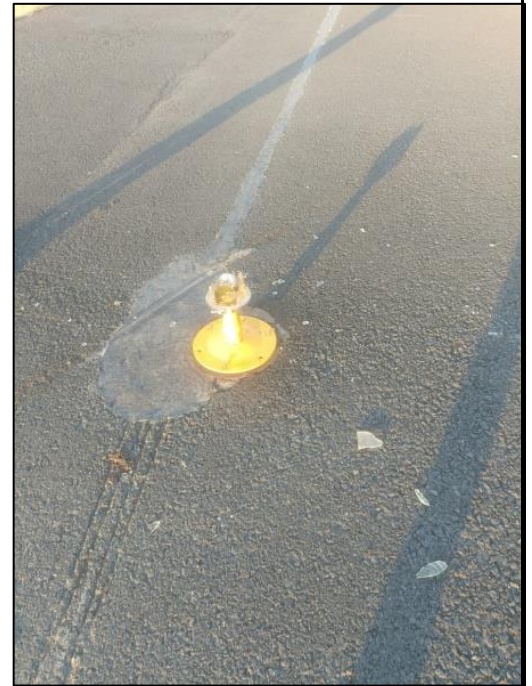
One of the runways Edge light near to Taxiway 'D' was found damaged. Refer Photograph# 5.

(Photograph# 5- One of the runways Edge light near to Taxiway 'D' was found damaged)

At the time of incident, Runway 25 was in use. During post incident runway inspection, one of the runways Edge light near to Taxiway ‘D’ was found damaged.

During this veering off, one of the runway edge lights near taxiway D was damaged by the aircraft.

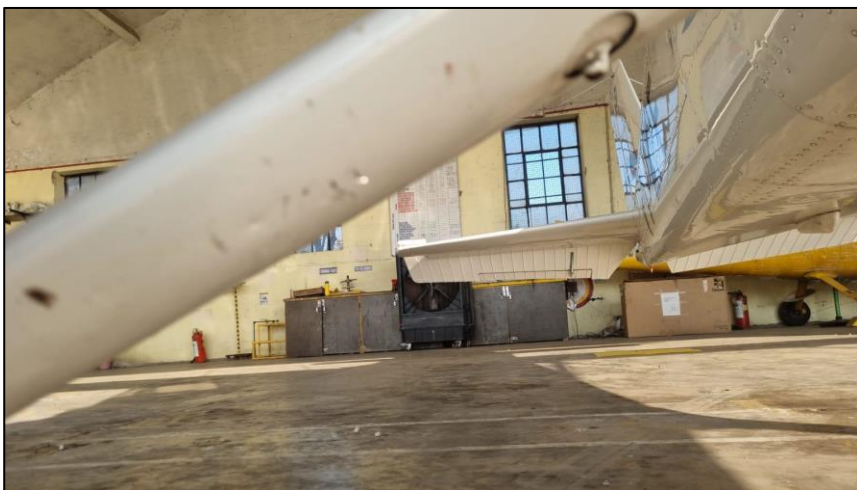
(Photograph# 4- Scratch marks found on bottom surface of the Right Landing gear strut)

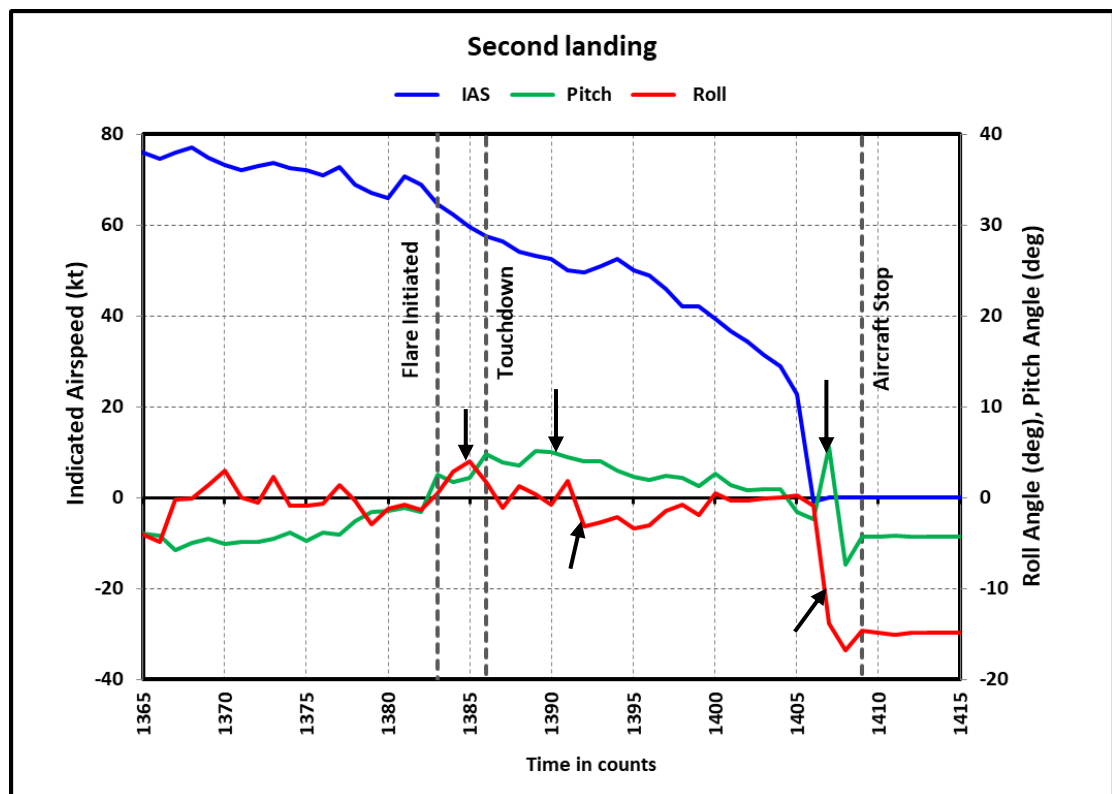
Graph: 1

The graph 1 depicts that in the final approach, the flare was initiated where the pitch is seen increasing towards positive value. During this process, aircraft was slightly rolled to right about its longitudinal axis with positive value of maximum 4° and soon the aircraft touched down with 57kt IAS. Further, aircraft slightly tilted to left for 8 seconds. Finally, aircraft's pitch and roll abruptly varied during the stop.

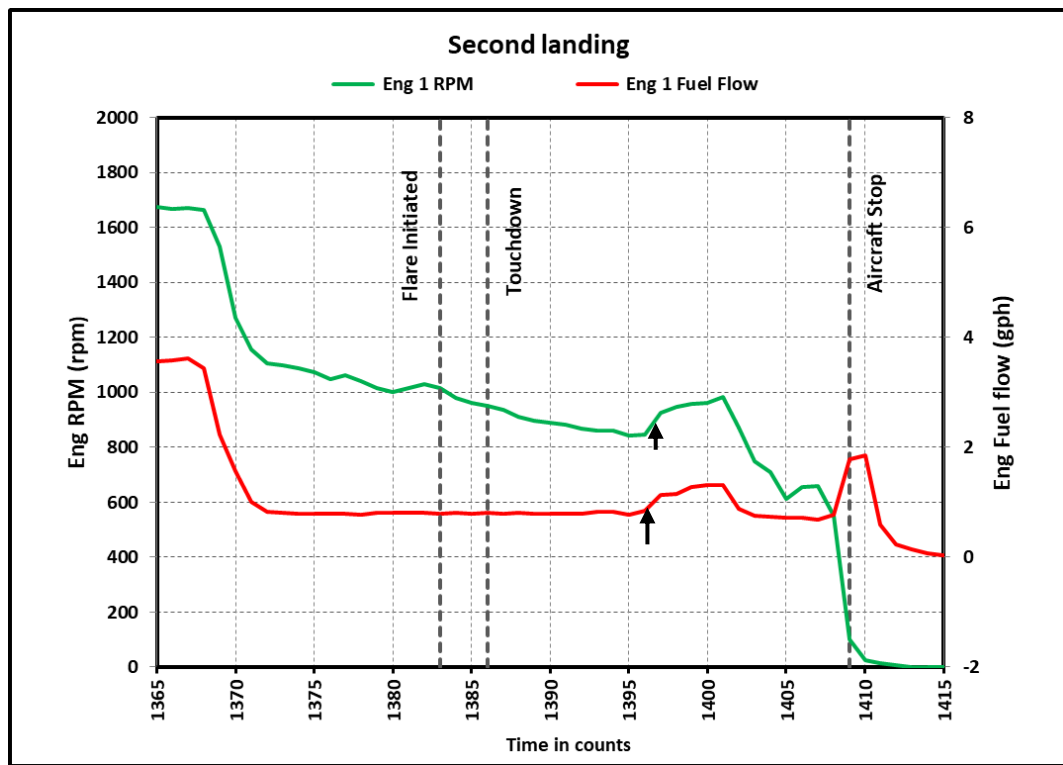
Graph: 2

The graph 2 depicts that 10 seconds after touchdown, a slight increase in engine fuel flow is observed along with engine RPM, which is then seen to decrease.

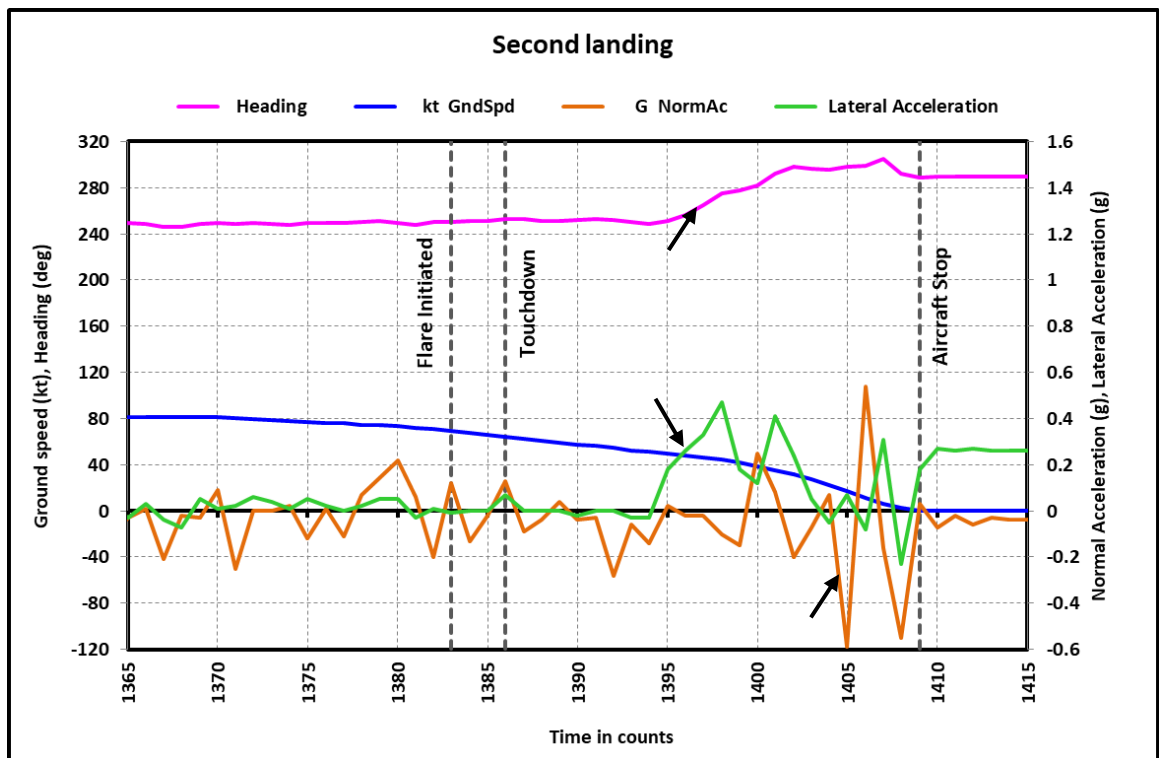
Graph: 3

The graph 3 indicate that 10 seconds after touchdown, the aircraft seen yawed/veered towards right side with positive lateral acceleration and observed variations in normal acceleration. During this time, the aircraft heading was also changed from 251.5° to 305°. Further, aircraft was brought to stop abruptly where ground speed became zero.

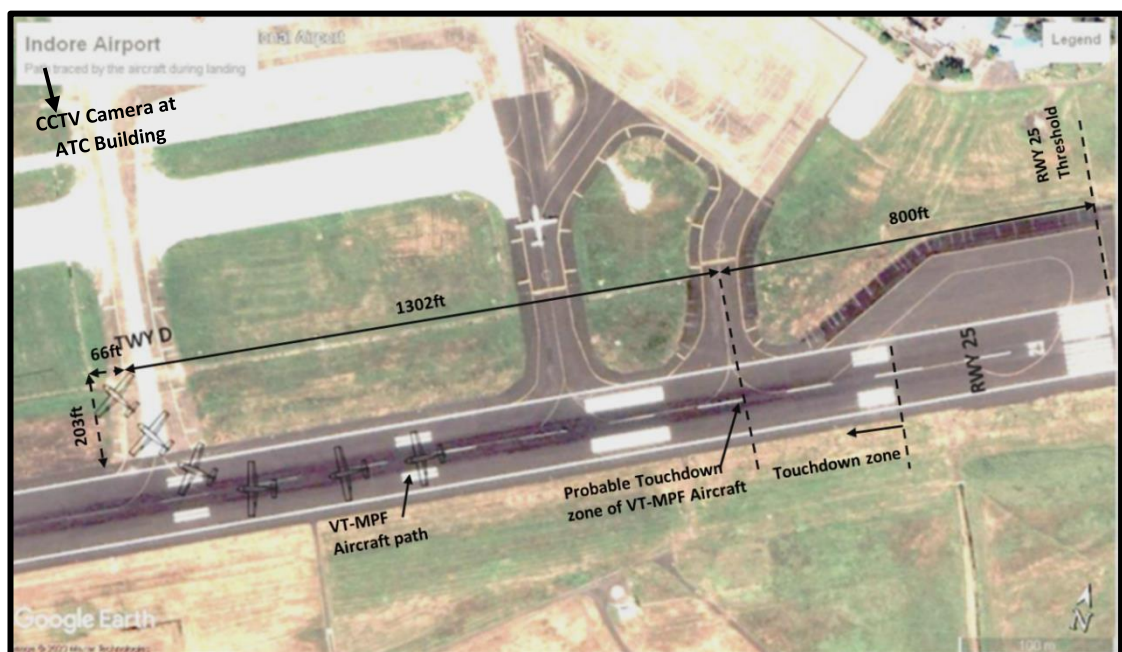
(Photograph# 7)

After touchdown approximately 800ft from the RWY 25 threshold (between first and second touchdown zones), the aircraft was moving along the runway centreline. Further, the aircraft was veering right, decelerating, going out of the RWY 25 (approximately 1924ft from RWY 25 Threshold), crossed TWY D, entered unpaved surface and halted on a concrete slab (drain cover), which was near to the RWY sign boards. The final aircraft stopping position was at 203ft to the right of the nearest runway edge and 2168ft from the RWY 25 threshold. The actual point of touchdown could not be identified from the runway due to the absence of tyre markings or from CCTV footage, as the visuals were not available from the RWY 25 threshold. Hence, the approximate touchdown point mentioned above was obtained from the latitude/longitude data from Garmin system. The aircraft path is simulated in the Photograph 7. There was no wreckage.

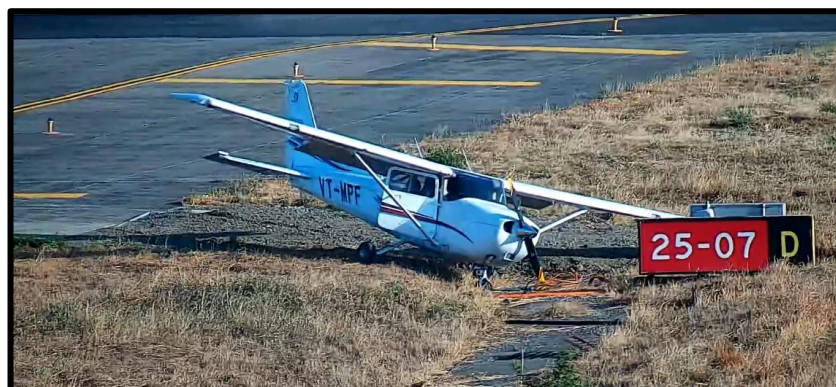
(Photograph# 8)

One of the runways edge light near to Taxiway 'D' was found damaged, which was 1936ft from RWY 25 Threshold. There were no tyre marks (brake application), propeller hit marks found on the runway. Tyre marks were found on the TWY D and on unpaved surface. Propeller strike marks were visible on the concrete slab where the aircraft finally stopped. Refer Photograph 8.
