FINAL INVESTIGATION REPORT ON THE INCIDENT OF BELLY LANIDNG OF PIPER SENECA PA-34 AIRCRAFT VT-TAO OF M/s ALCHEMIST AVIATION PVT LTD AT JAMSHEDPUR ON 16.03.2022.

O/o Director General of Civil Aviation

Air Safety Directorate,

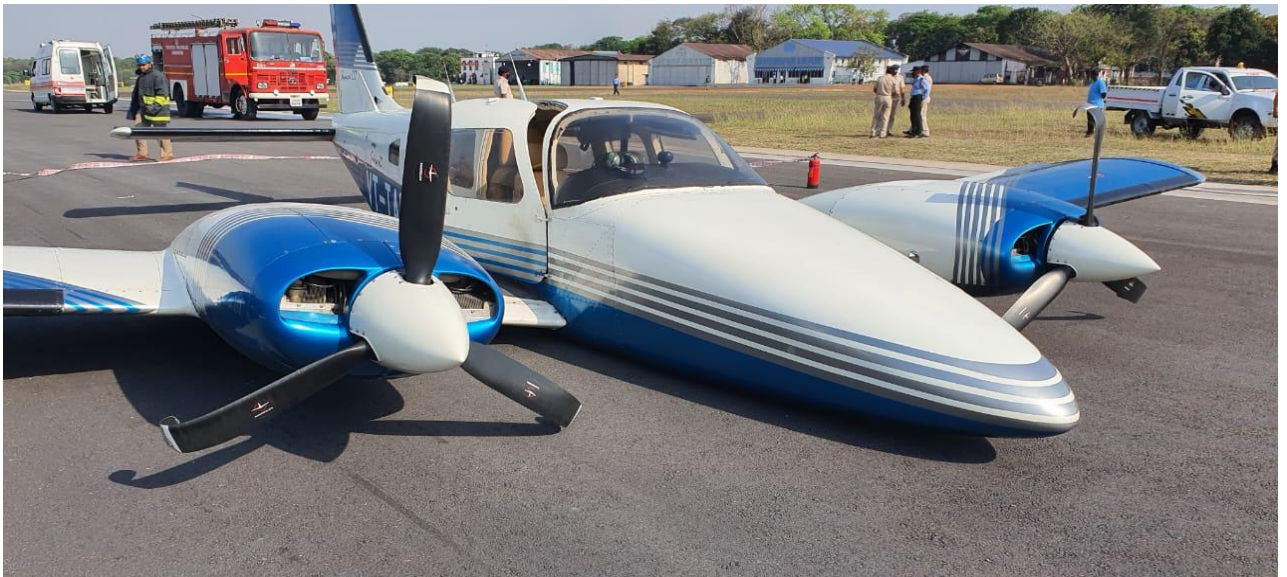
1.3.1. Nose Section: There were scratches on both nose landing gear doors and bottom skin.

1.3.2. Engine Section: The tips of the propeller blades of both engines were curled backwards. There was rubbing on cowl flap.

1.3.3. Wing Section: Both flaps were found defective and there was a dent on RH aileron.

1.3.4. Fuselage Section: Nose cone assembly, both spar cap, step assembly and adjoining areas were damaged.

Position of Aircraft VT-TAO on runway after belly landing incident.

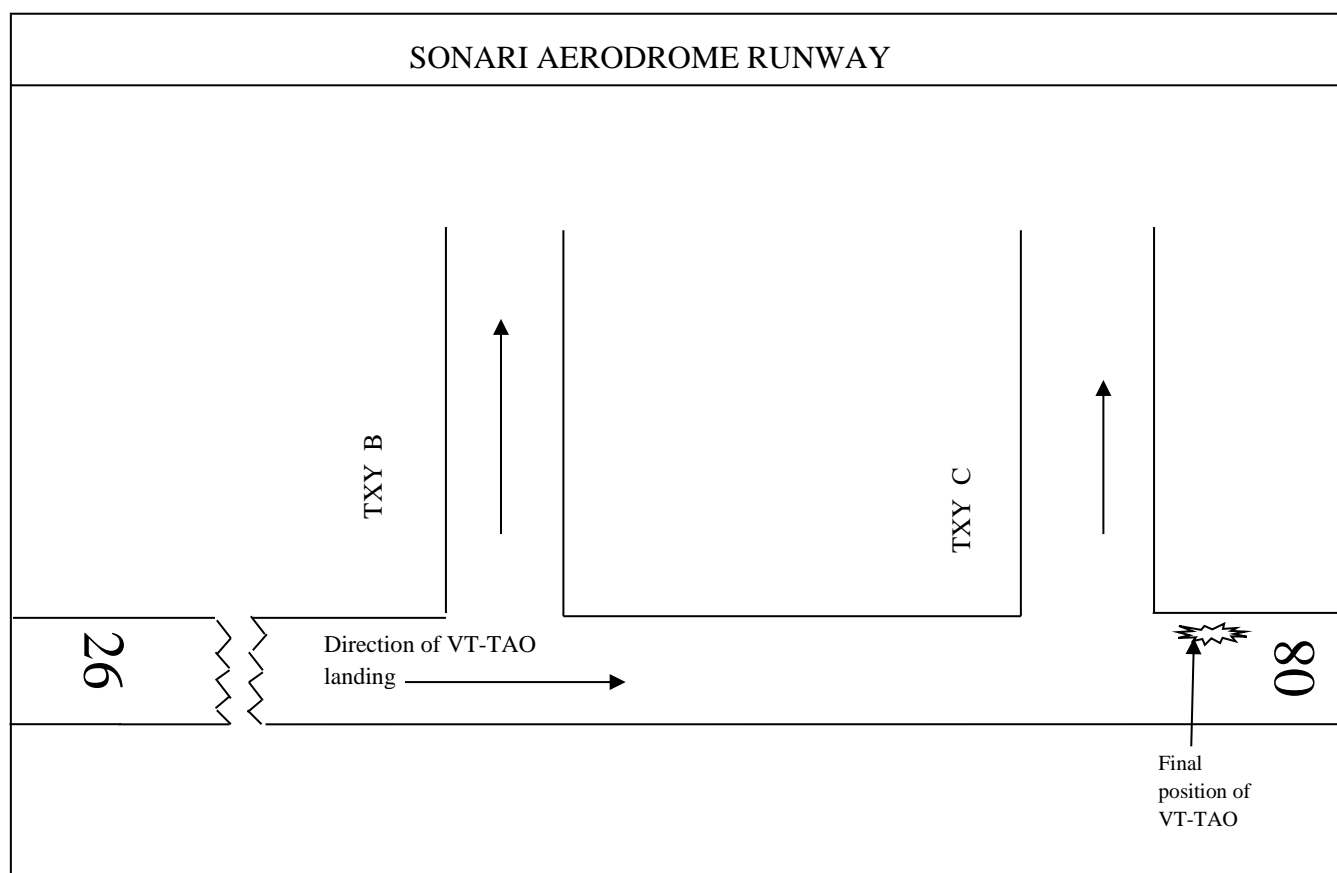
Fig 1. Schematic diagram of the Runway & Incident Site

3.1.11. After belly landing, the aircraft VT-TAO continued to slide on its belly on the runway and stopped little ahead of TXY C. The aircraft stopped on the runway and became disabled. It was then removed from the runway manually to clear the runway for operations.

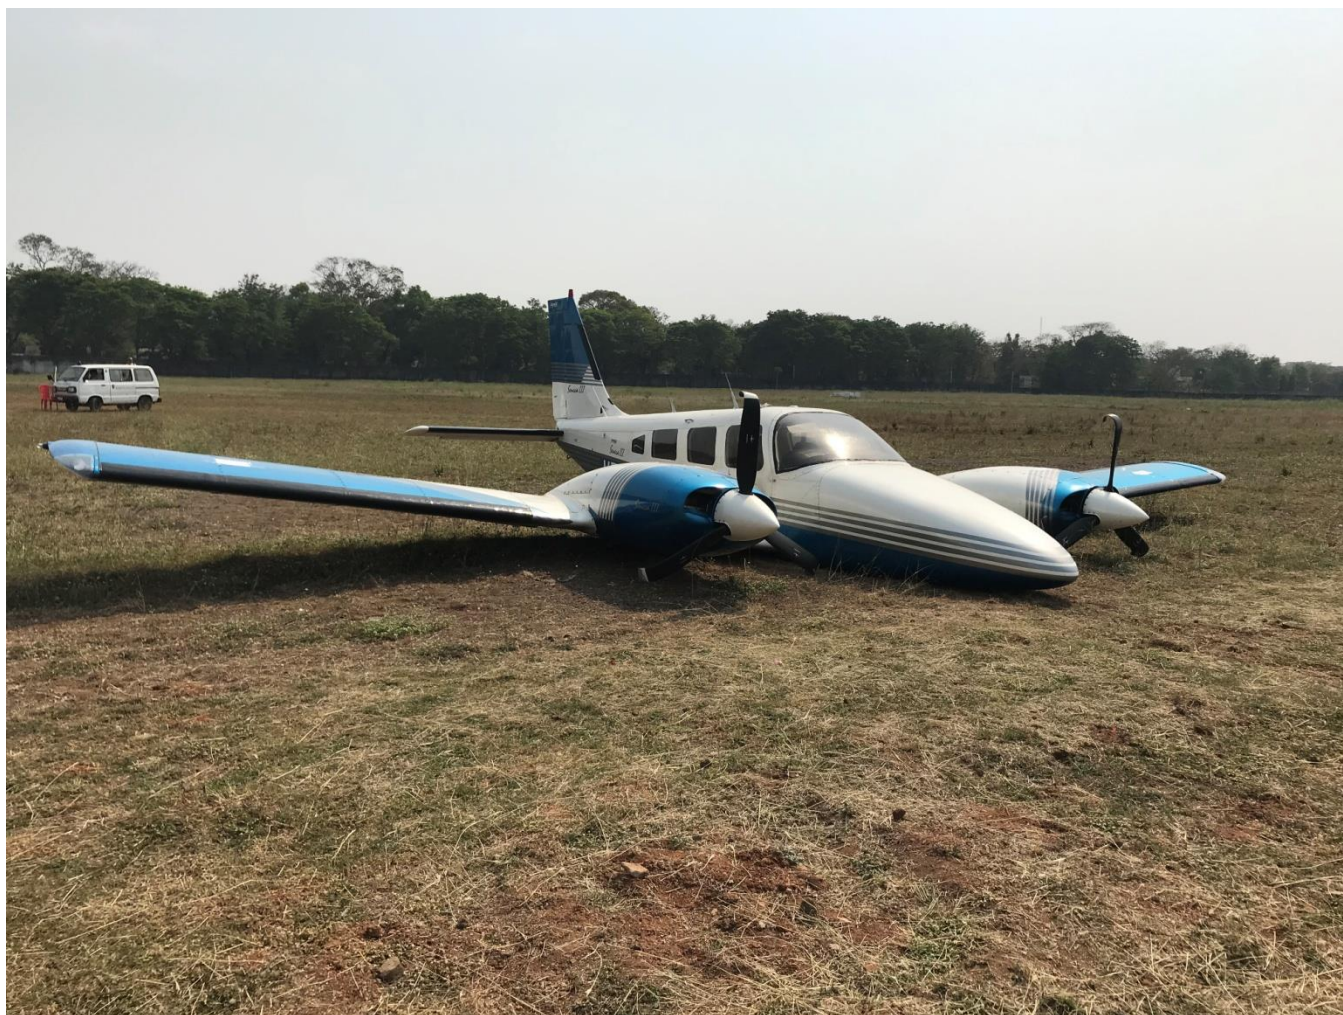
Aircraft VT-TAO removed and shifted away from runway at Sonari Aerodrome after the incident.
