Government of India
Directorate General of Civil Aviation

**Final Investigation Report on M/s Redbird Flight Training Academy
Tecnam P2008JC Aircraft VT – RBS Runway Excursion Incident on
20.06.2023 at M/s AAI Belgaum.**

Type : Tecnam
Model : P2008JC
Nationality : INDIAN
Registration : VT - RBS

2. Owner : M/s REDBIRD FLIGHT TRAINING ACADEMY PVT. LTD.
3. Operator : M/s RED BIRD FLIGHT TRAINING ACADEMY PVT. LTD.
4. Pilot-in-Command : SPL Holder
5. Extent of injuries : NIL
6. Date of incident : 20.06.2023
7. Time of incident : 07:45 UTC (approx.)
8. Place of Incident : M/s AAI Belgaum Airport
9. Co-ordinates of incident site : 15°51'34"N (Latitude), 074°37'22"E (Longitude)
10. Last point of Departure : VOBM (Belgaum Airport)
11. Intended place of Landing : VOBM (Belgaum Airport)
12. Type of operation : Circuit & Landing (Solo)
13. Type of Incident : Runway Excursion.

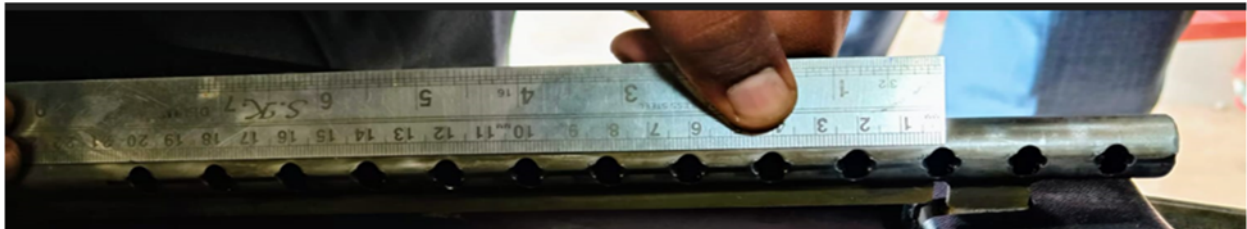
There are 13 seat positions to choose with keeping the perspective of the pilot in mind in order to see the nose of the aircraft. There is a gap of 20mm from one seat position to the other, caution needs to be exercised for seats are positively locked and seat adjustment lever is aligned with the aircraft longitudinal axis and spring of the seat adjustment lever back to the neutral position.

There are high chances of seat going backwards abruptly if the seat is not properly locked, it could impact the pilot's ability to access the cockpit controls.

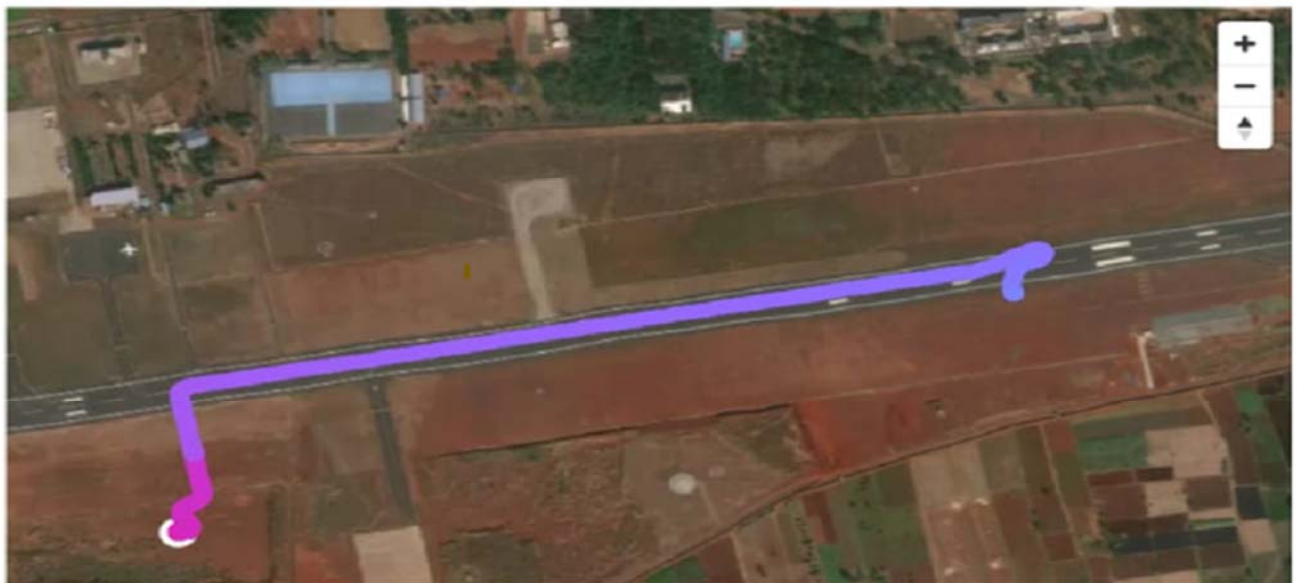
Flight Path Map

Image shows the path of aircraft rolling on the runway and veered to the left and entered kaccha

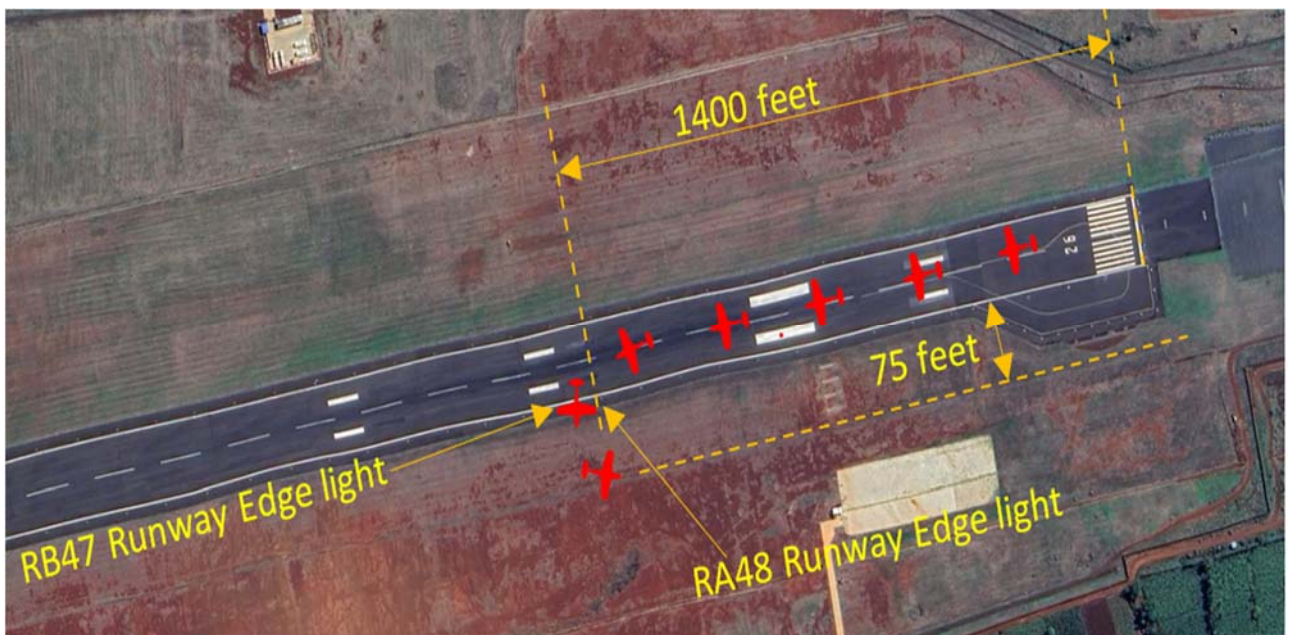
There was no structural disintegration of aircraft during the incident and on-site inspection revealed that there were neither damages nor defect on the aircraft due incident. The Aircraft came to a complete halt at 1400 feet from Runway 26 threshold, distance of 75 feet (22.86 meters) from the Left-Hand Side Runway Edge and track Aircraft followed is as shown in the picture next page and other distances measured is as shown in the tabular column.

S. No.	From	To	Distance
01	Runway 26 Threshold	Longitudinal Distance of Aircraft final position.	1400 feet
02	Runway Shoulder edge (LH)	Aircraft Nose	75 feet (22.86 meters)
03	LH Main Landing Gear	Runway Shoulder edge (LH)	14.8 meters
04	RH Main Landing Gear	Runway Shoulder edge (LH)	13.2 meters
05	Nose Landing Gear	Runway Shoulder edge (LH)	15.8 meters
06	Runway Edge Light RA48	RH Main Landing Gear track	13.2 meters
07	LH Main Landing Gear track	Runway Edge Light RA48	14.8 meters
08	Runway shoulder width measured through NLG travelled		7.9 meters
