**Directorate General of Civil Aviation**

**Final Investigation Report on Incident to M/s Redbird Flight Training Academy  
Cessna 172S Aircraft VT – CAY on 25.06.2023 near Kalaburagi Airport, Kalaburagi.**

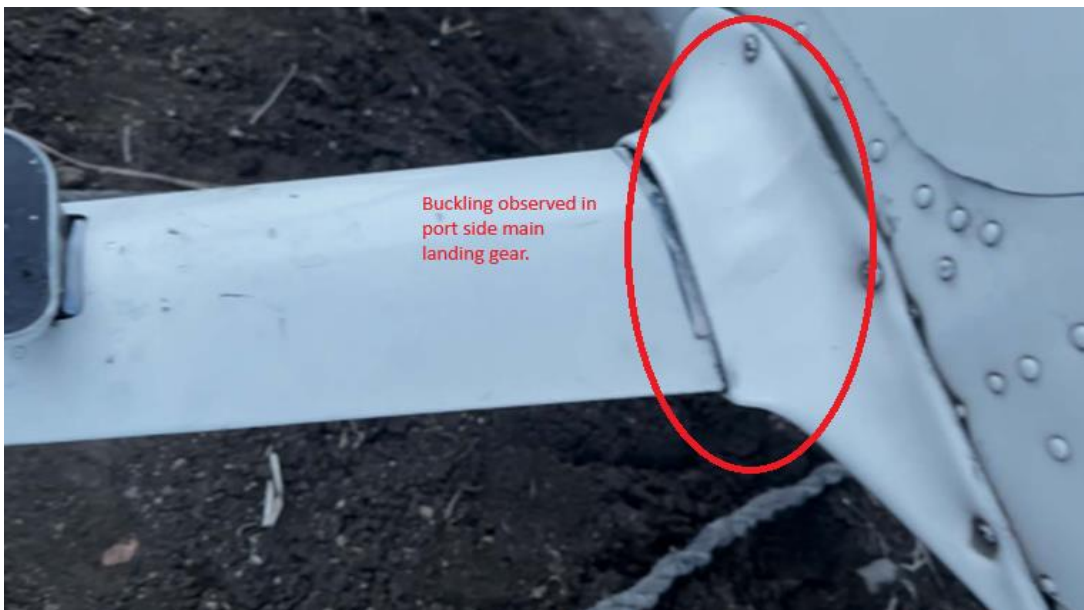
Pic:1

Buckling of Port Side Fairing of Main Landing Gear as shown in the picture below:

Post incident in the site, AME carried out visual inspection for any damage and found buckling of port side fairing of main landing gear. Then the aircraft was moved from the open field to Kalaburagi Airport, after obtaining necessary clearance from DGCA. The aircraft was brought to the hangar in dismantled condition after the incident. Before removal of aircraft from the incident site, fuel and oil were drained out and store separately.

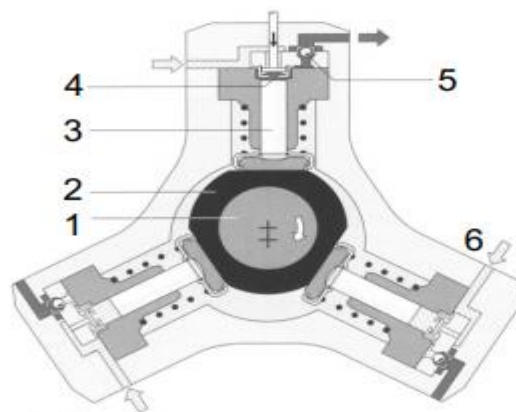
Figure 3 High Pressure Pump

High-Pressure Pump and Rail pressure control valve were sent to OEM for fault identification. During inspection of the HPP the inlet valve was found blocked in the closed position and metal debris was found inside the HPP which however the metal debris was not originating from the High-Pressure Pump of the fuel system. OEM has recommended to check the entire fuel system. Fuel system was checked by the operator as per the recommendation of OEM and the same found satisfactory.

In this situation, the issue is that, the High-pressure pump was not generating adequate pressure because of the blockage of inlet valve of High- Pressure pump due the presence of metal debris, which resulting in falling short of the adequate pressure. Consequently, the rail pressure control valve is not receiving enough fuel from the pump. As a result, the engine did not receive sufficient fuel, causing it to fail to deliver power, ultimately leading the aircraft to forced landing in an open field.

On 03.07.2023 as per the recommendations of OEM, AME replaced the High-Pressure Pump and tried to restart the engine. This time engine started normally and all parameters were found in range.

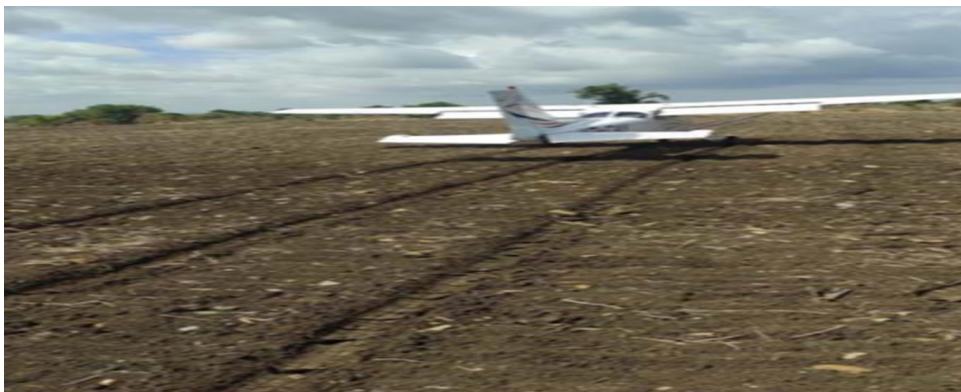
Fig: Path followed by the aircraft and its final position

On-site inspection revealed that there were neither damages nor defect on the aircraft due incident except bulking observed on the port side of the main landing gear. Aircraft after rolling for about 127 feet (approximately), aircraft came to a complete halt (Refer Pic Below).
