**FINAL INVESTIGATION REPORT ON AIR TURN BACK INCIDENT TO
M/s AIR INDIA EXPRESS LTD, BOEING 737-800 NG AIRCRAFT,
VT-AXW, FLIGHT IX-350 ON 09.02.2019 AT MUSCAT**

GOVT OF INDIA
CIVIL AVIATION DEPARTMENT
O/O DIRECTOR AIR SAFETY
WESTERN REGION
NEW INTEGRATED OPERATIONAL OFFICE COMPLEX
SAHAR ROAD
VILLE PARLE (EAST)
MUMBAI-400099

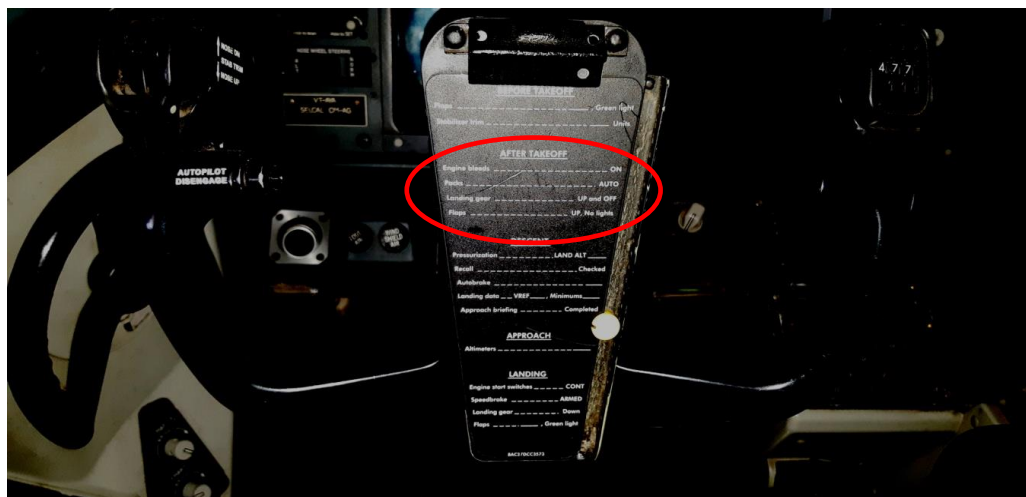
Standard/ Normal procedure checklist is also affixed on the control column of aircraft VT-AXW for ready reference of the crew. The After Take-off procedure clearly reflects the Packs to be in AUTO. Refer figure# 1 below.

Figure# 1 depicting standard/ normal procedure affixed on control column
