**FINAL INVESTIGATION REPORT ON
INCIDENT TO
M/s TRU JET LTD. ATR 72-212A (500
Series) INDIAN REGISTERED
AIRCRAFT
VT-TMK ON 18-11-2021 AT KANDLA**

**INVESTIGATION REPORT ON INCIDENT TO M/s TRUE JET LTD. AIRCRAFT
VT-TMK ON 18.11.2021**

| 12. Type of incident | | : | Runway excursion and Tail strike |

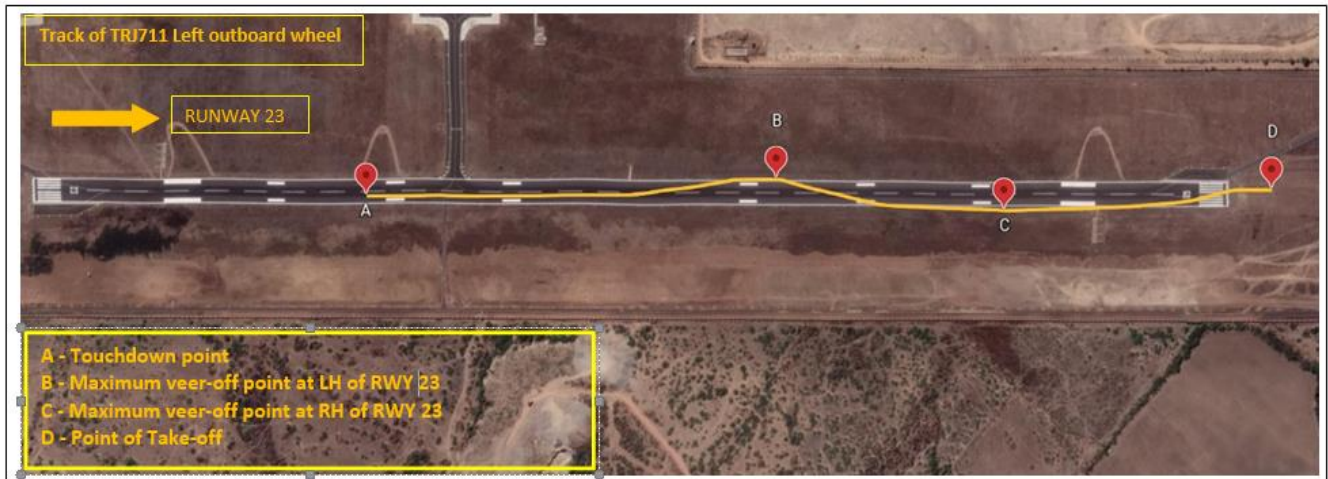
Attempts by the crew were made to keep the aircraft on runway center line, however the aircraft had veered off towards left of runway. Therefore the PIC decided to Go Around, however as the Take-off configuration was not set and the aircraft continued rolling towards the left. Thereafter, the LH Main Landing Gear wheel had exited the paved surface (890m from threshold) and entered the soft ground. During this, one of the runway edge light was damaged (point B). Thereafter, the LH Main Landing gear wheel re-entered the paved surface (955m from threshold). After entering the paved surface the aircraft once again veered off to right side on the runway, with all the wheels of the aircraft exiting the paved surface(at 1089 meters from threshold). As the aircraft was still not in Take-off configuration followed by the crew trying to rotate the aircraft prior to aircraft

attaining the rotational speed resulted in the aircraft experiencing a tail strike(point C). Further, the aircraft rolled on the strip (soft ground) for approximately 300 meter. After entering the paved surface, the aircraft had crossed the runway end of RWY23, overrun by 58m and then took off from the end on strip(point D).

Illustrations of aircraft movement on runway 23 till go around (Not as per scale)

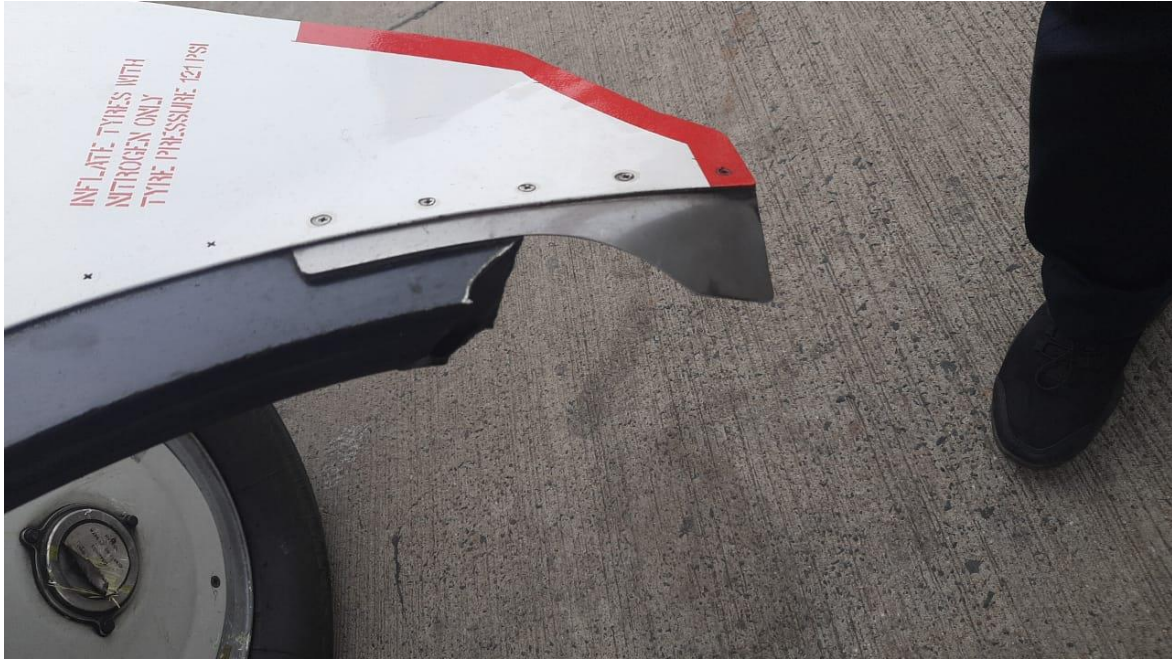
A. Damage to LH main L/G door-

- From the edge of main L/G door, 130 mm delamination in the upward direction.
- From the edge, 150mm inward direction, rubber bulb seal was found missing.
- Bending from edge of the main L/G door 170mm in length, 2mm depth and radius of curvature is 80mm.

- LH main wheel No.01 hub missing (material 250mm)
- Main wheel no. 03 Tyre peeled off & inner ply layer visible.

Fig 1. Door of Left MLG

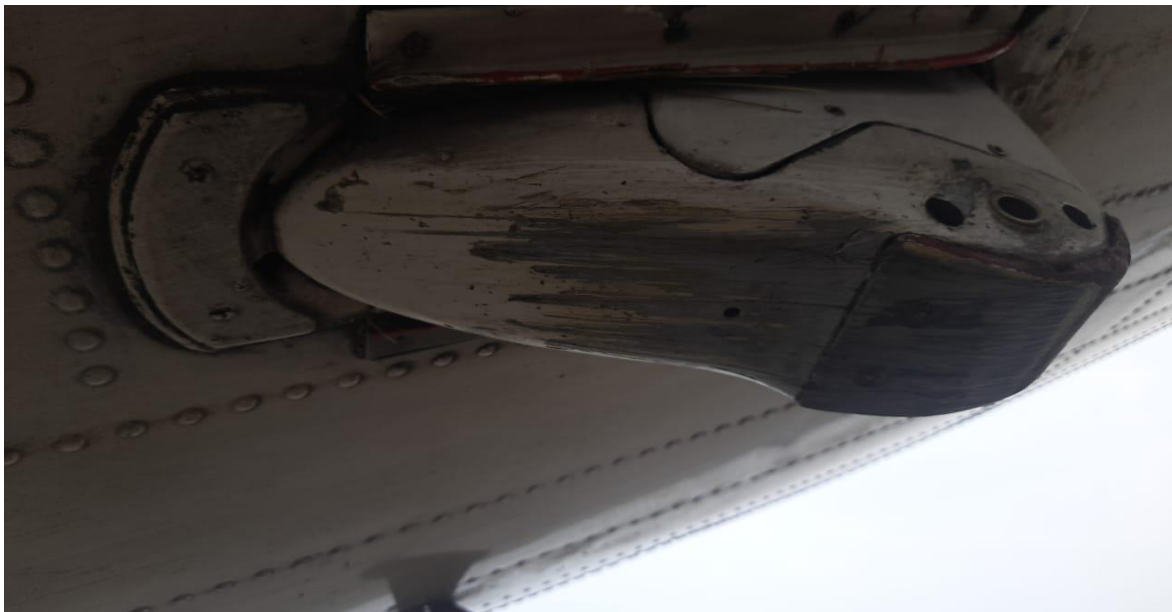
C. Tail skid observed with rubbing mark.

Fig 2: Scratches on Tail shoe

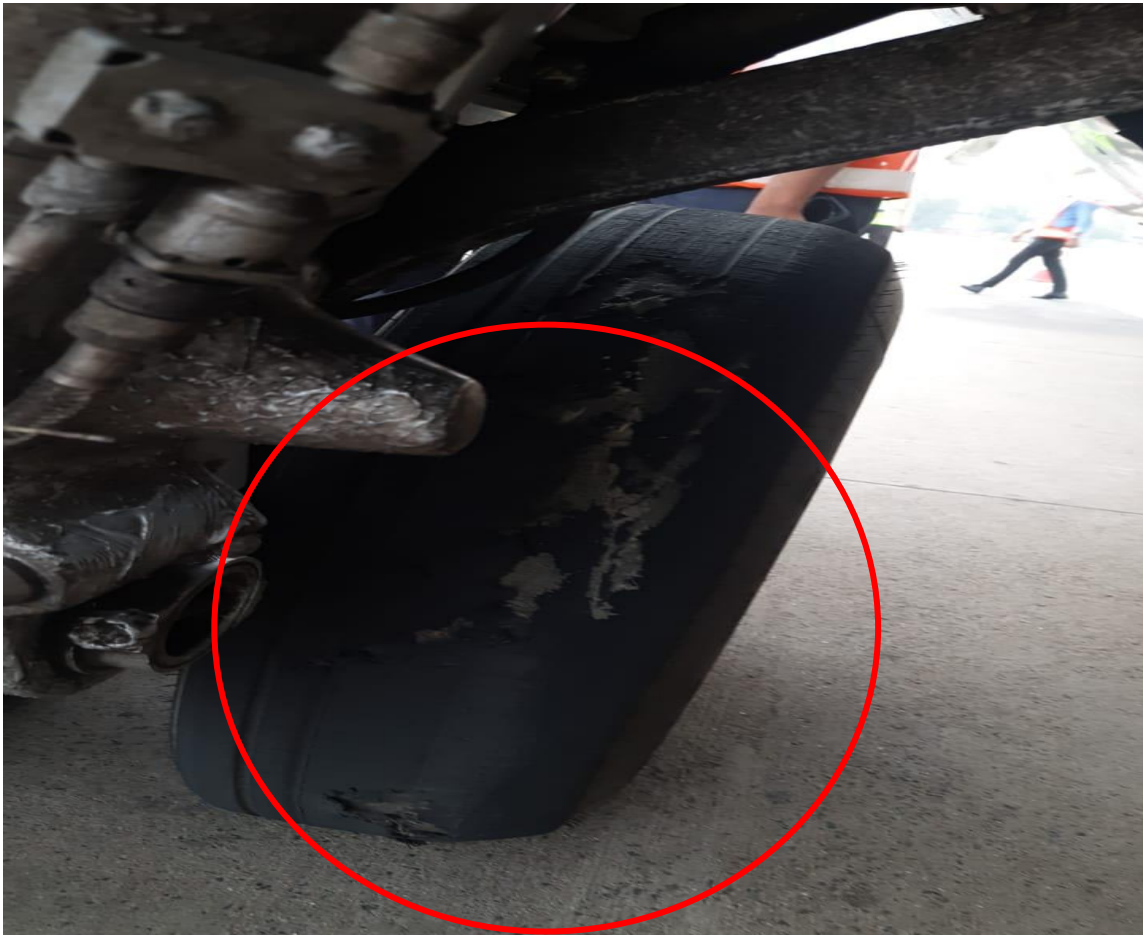
Fig 3. Peeled off tyre No. 3 of Left MLG

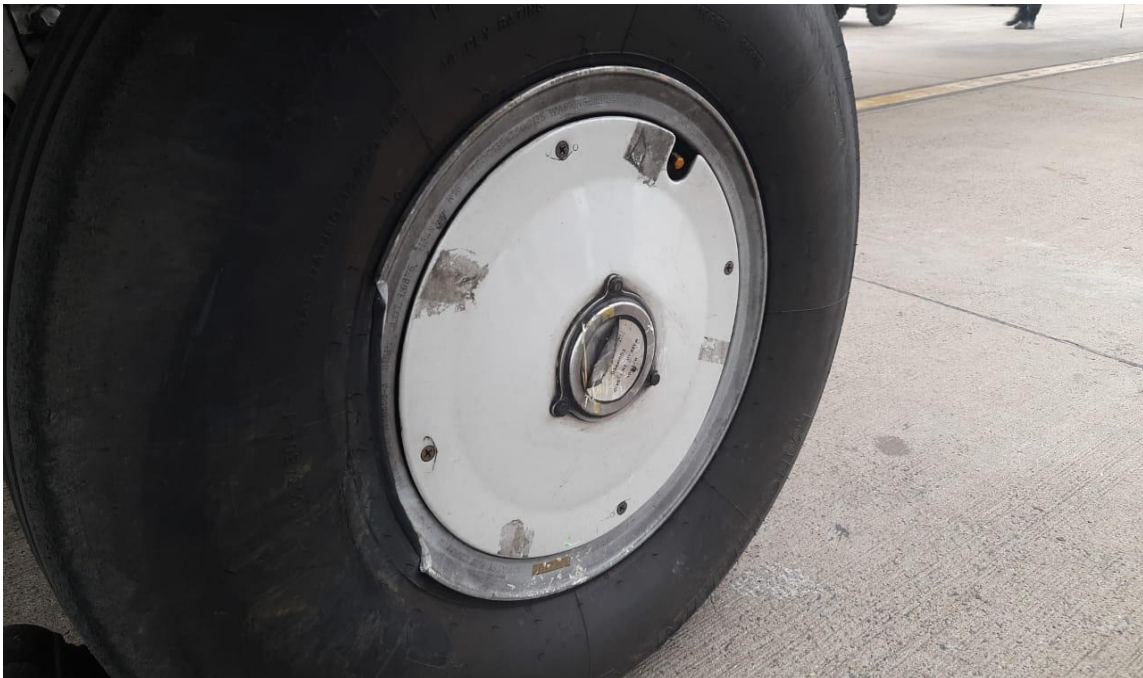
Fig 4. Broken rim of Left MLG

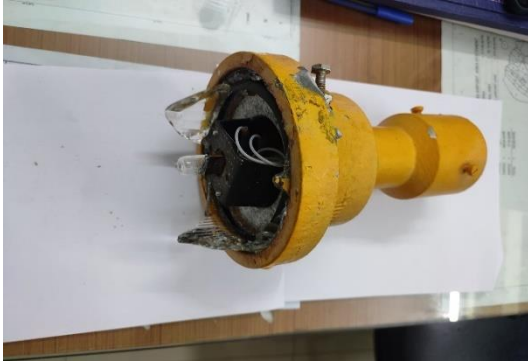
- a. Runway Edge light fitting No. B-88 broken from tangible coupling and shattered to pieces.

Fig 5. Broken Runway Edge light

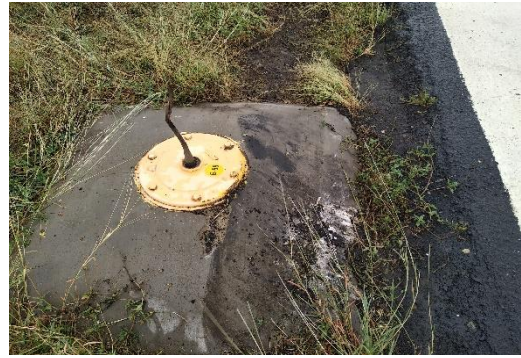
- b. Scratch marks on Runway Edge light fitting No. B-88 foundation.
- c. No damage on runway surface found.

Fig 6. Damage to foundation of B-88

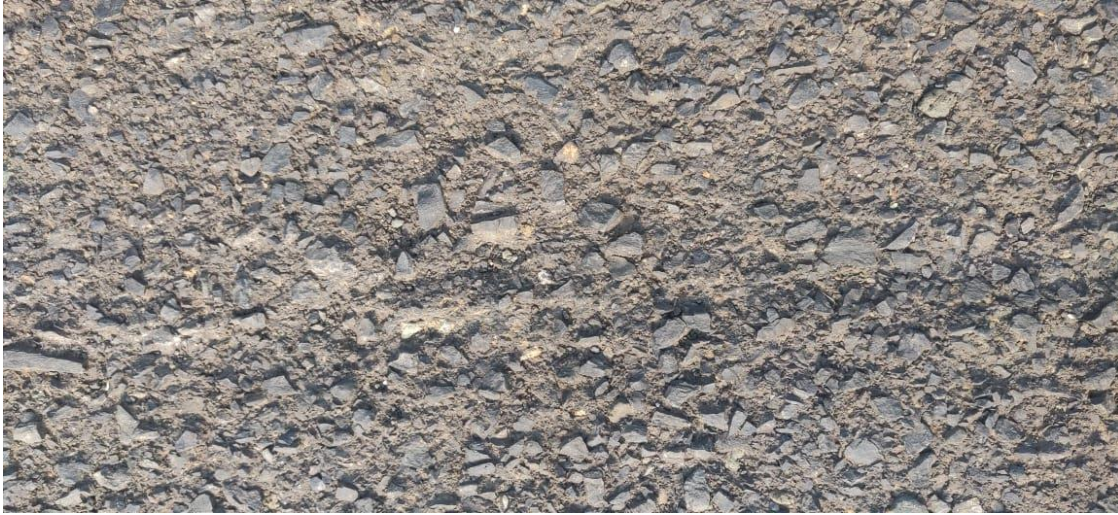
- Runway markings and signages were in place. Aerodrome license is valid 27 Nov 2021.
- During runway inspection it was found that in touch down zone of RWY23 a lot of metal aggregates are coming out of runway surface and becoming FOD. The area requires resurfacing. Last runway resurfacing carried out was in Oct 2013.

Fig 7. Metal aggregates on Touch Down Zone of RWY 23

27. During inspection of runway, it was found on Touch down Zone of RWY 23, a lot of metal aggregates (bitumen) are coming out of runway surface and posing as FOD hazards.

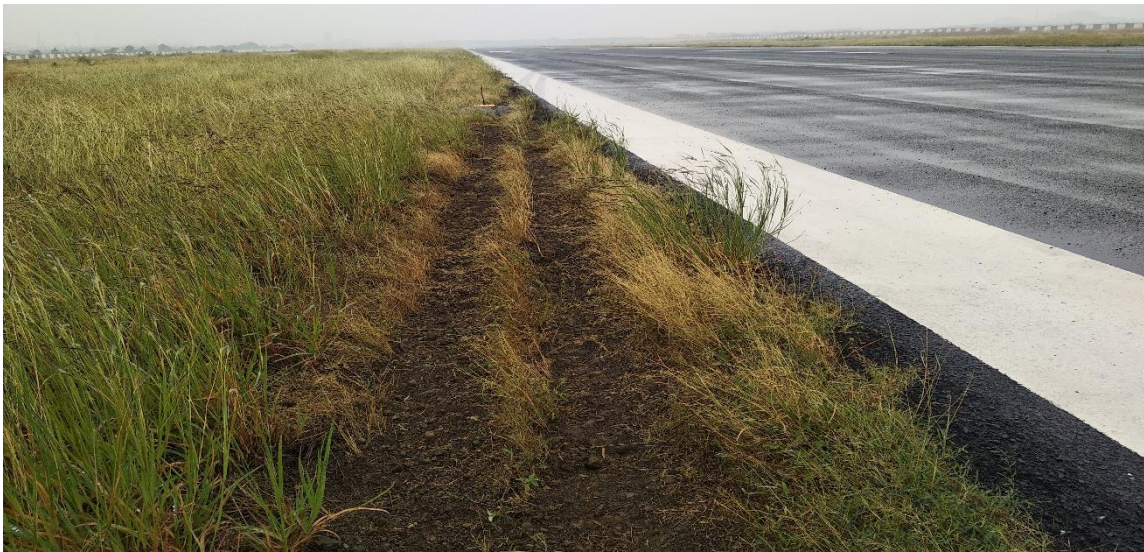
Fig 8. Large Grass on strip

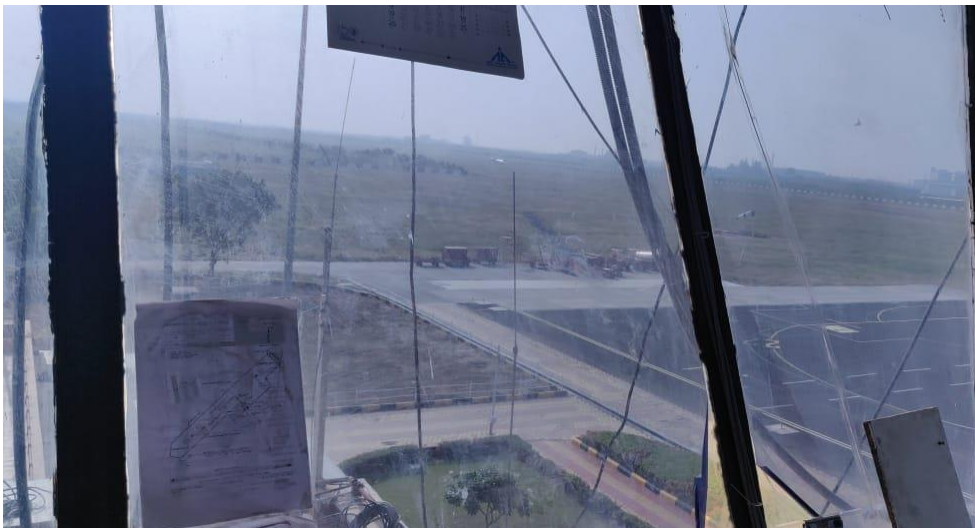
Fig 9. Broken and non-transparent ATC Glass

29. Glass covers of ATC room are in dilapidated condition. The glasses were found broken and turning opaque due ageing, which lead to poor visibility of runway/approach/ go around for controller and no sound proof.

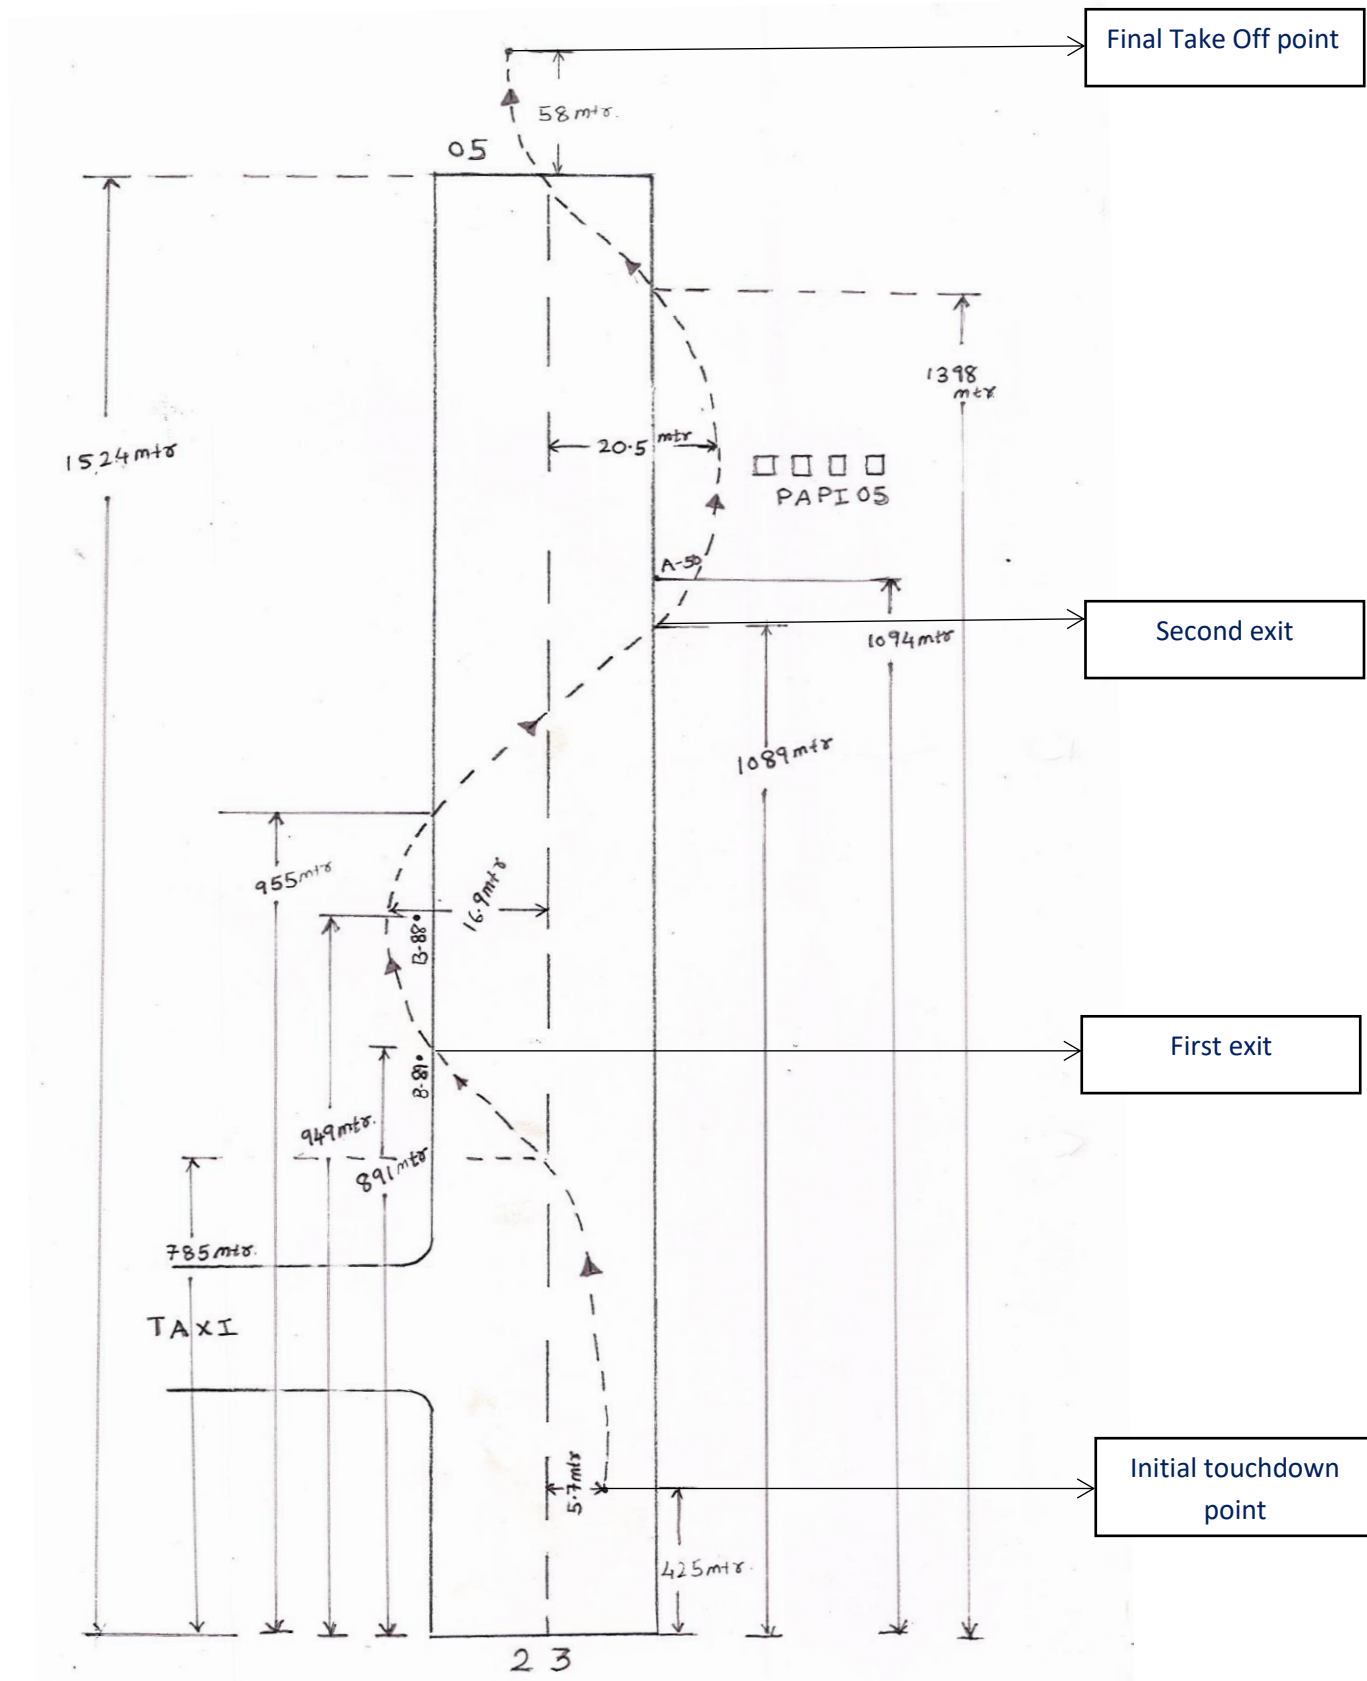
Fig 10

During site visit, it was observed from marks (Refer Fig 10), that the aircraft touched on the runway 23 towards 7 m right from center line and 420 meters beyond the threshold of runway 23.

Further it was found the aircraft had veered off towards left of runway and the LH Main Landing Gear wheel had exited the paved surface (891m from threshold) and entered the soft ground. In the process, one of the runway edge lights got damaged. Thereafter, the LH Main Landing gear wheel was found to have entered the paved surface (955m from threshold).

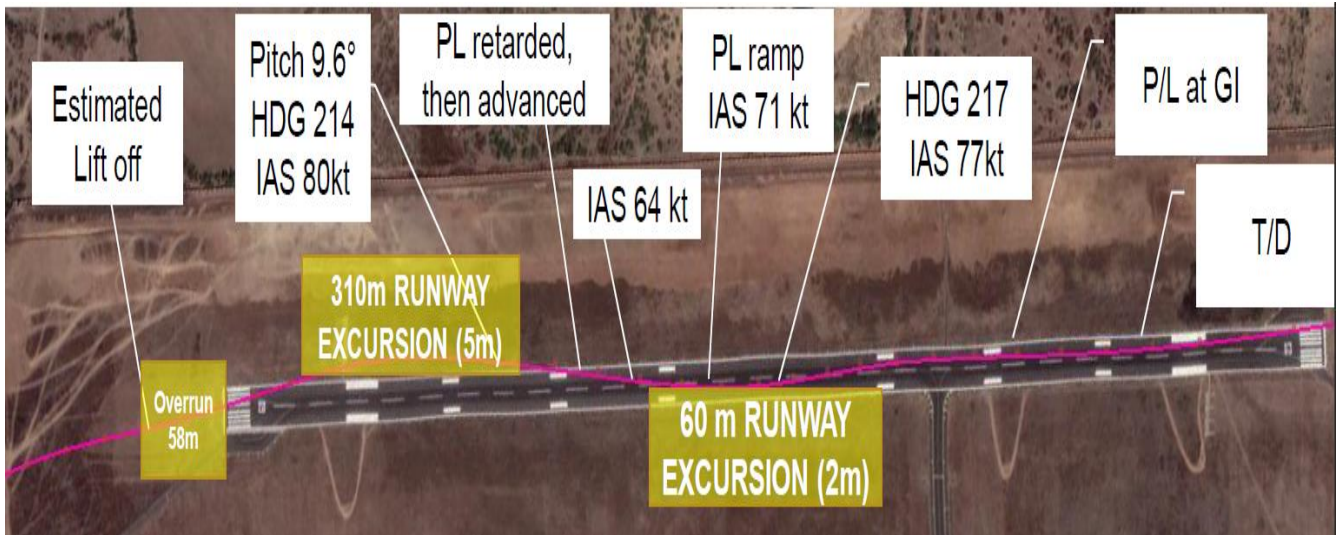
Track of aircraft from touchdown to lift off

The aircraft veered towards the extreme left of the runway with left MLG exiting the paved surface(890 m from threshold) and entering through the soft ground(the aircraft was in the soft ground for 60 m) and breaking the light (loud sound heard from CVR and 3.97 g recorded in DFDR). The 3.97G value was most probably due to the contact with either a left lateral edge light or its concrete base which has resulted in loss of data recording for 3 seconds. Pilot applied right rudder pedal input. Thereafter the aircraft has entered the paved surface(955 m from threshold). During the data loss, the aircraft experienced a runway excursion on the right side of the runway (traces on the ground). The heading shows the pilot wanted to control the aircraft on the center line. Elevator and power levers are consistent with a go around action. Continuous right rudder pedal application had caused the aircraft veering towards the right and completely exits the right side of the runway. It was found that

all the wheels of the aircraft had exited the paved surface(at 1089 meters from threshold).
