**FINAL INVESTIGATION REPORT ON RUNWAY EXCURSION INCIDENT TO
M/s. NATIONAL FLYING TRAINING INSTITUTE PVT LTD
DIAMOND DA 40 AIRCRAFT, VT-NFK
ON 17.06.2017 AT GONDIA AIRPORT, NAGPUR, MAHARASHTRA**

**GOVERNMENT OF INDIA
OFFICE OF DIRECTOR OF AIR SAFETY (WESTERN REGION)
INTEGRATED OPERATIONAL OFFICE COMPLEX,
SAHAR ROAD, VILEPARLE (E), MUMBAI – 400099**

FINAL INVESTIGATION REPORT ON RUNWAY EXCURSION INCIDENT TO
M/s. NATIONAL FLYING TRAINING INSTITUTE PVT LTD (NFTI)
DIAMOND DA 40 AIRCRAFT VT-NFK AT GONDIA ON 17.06.2017

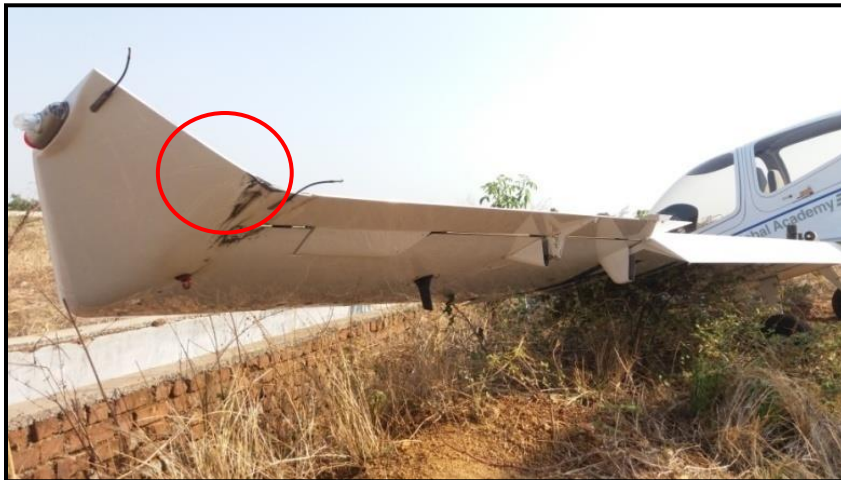
Fig 1. Damage to left wing tip

- xi. As a result of stall, the aircraft started banking and the left wing tip drooped down and contacted the Runway -Taxiway B surface. Thereafter the aircraft had few propeller strikes on ground. The nose wheel got detached from the strut during the sudden impact and the aircraft continued to move towards left side of the RWY with the broken end of strut scraping the ground surface.

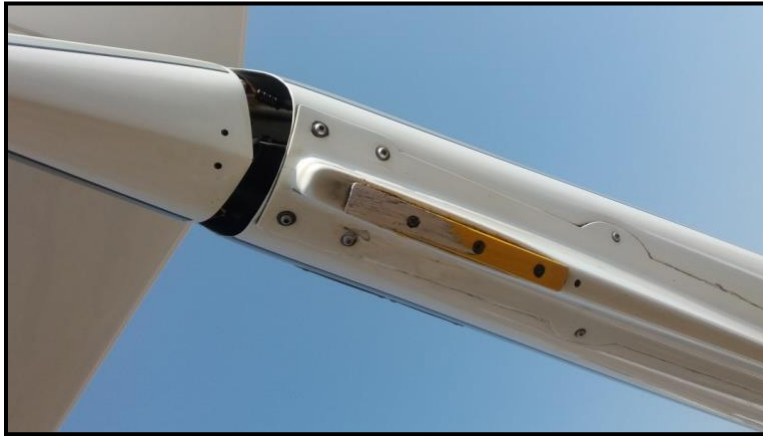
Fig 2. Scraped tail shoe

- ix. During the bounce the student pilot kept on increasing the pitch and this caused the aircraft tail to touch on ground.
- x. The bounce recovery technique used by the student pilot i.e action for Go around was made with high control lever input for pitch, which caused the aircraft to nose up further more. This resulted an increase in resistance to the aircraft (drag) and eventually led the aircraft to a power ON stall.

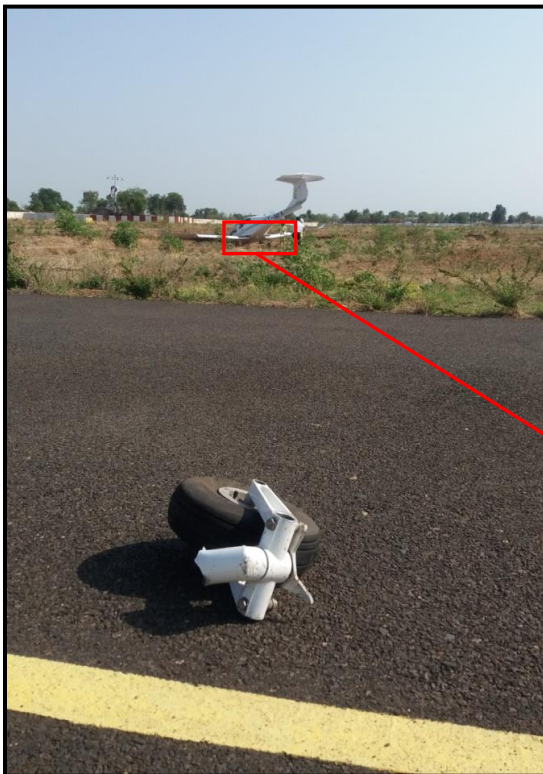
Fig 4. Final position of the nose landing gear after break off (on TWY B shoulder)

The nose gear got disintegrated from the main aircraft body and found positioned at the TWY B shoulder area near the edge light (Refer Fig15). Few elastomers of the nose gear were found in the aircraft path on the kutcha area.

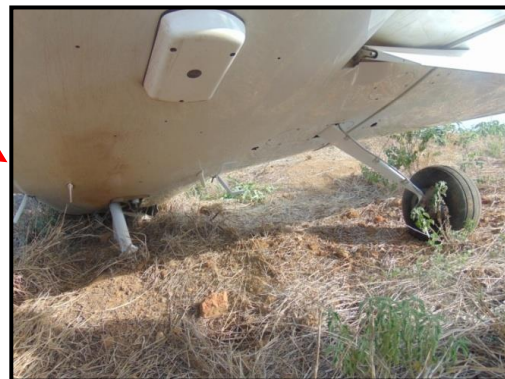
Fig 3. Nose landing gear sheared and strut bent

gear got detached from the strut. The aircraft continued to move towards left scraping with the broken end of the nose strut on the surface of the Runway-Taxiway B joining. The aircraft eventually went out of the RWY in between two edge lights on TWY B.

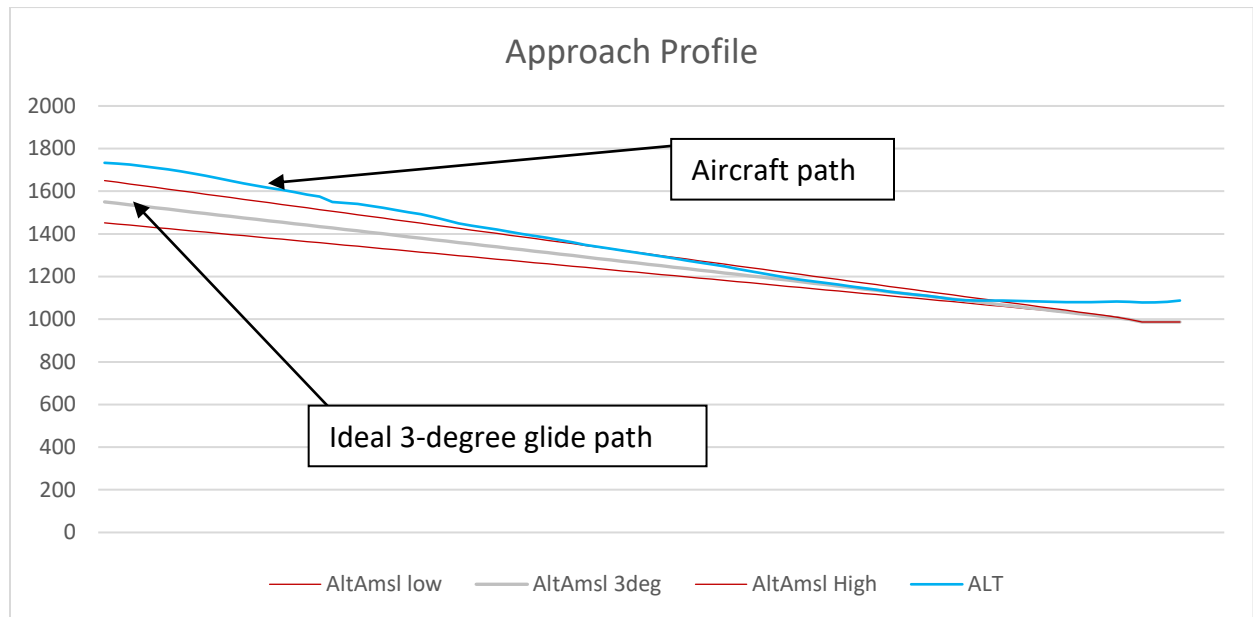
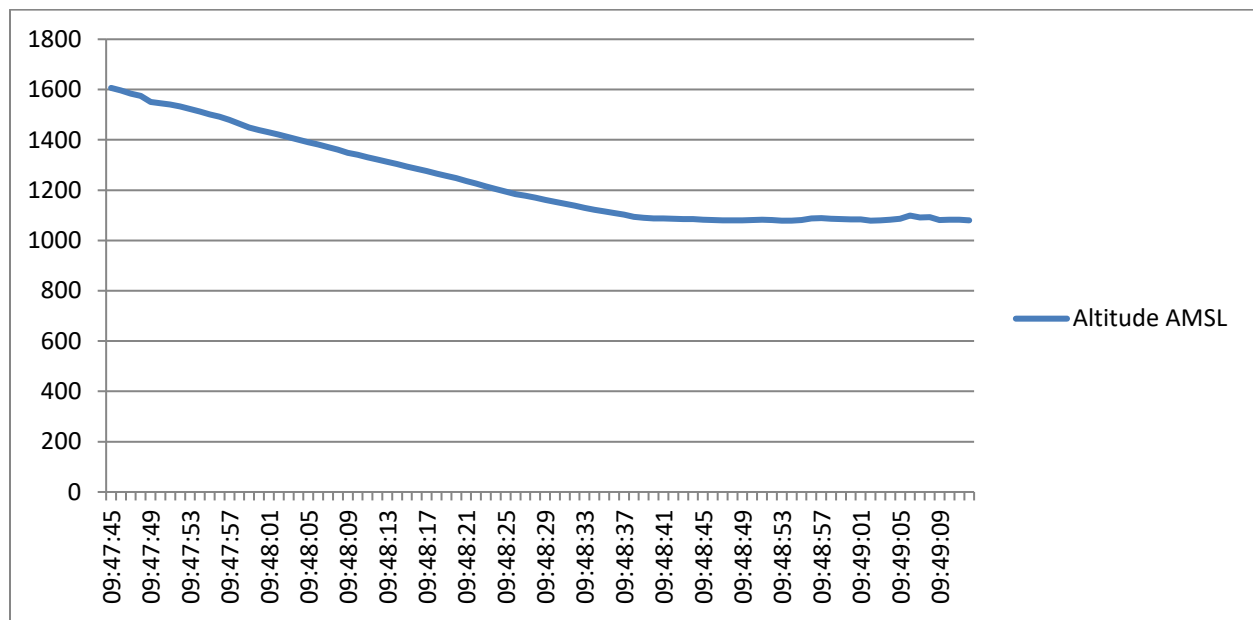
Fig.6.Approach profile of the aircraft (blue line)

Fig.7. Altitude (AMSL) ft variation of the aircraft w.r.t time

In fig.6 & 7, the vertical axis is altitude Above Mean Sea Level (AMSL). In fig.6, the grey line shows the ideal 3-degree glide path, with red lines as tolerance limits (plus/minus 0.5 degrees) for a stabilized approach. The blue line is the actual path followed by the aircraft VT-NFK during the second approach. In this case, it is clear from the comparison that the initial phase of approach was above the tolerance values of glide path. The student pilot

brought the aircraft within the glide path limits at around 1200ft above mean sea level only. The approach was not stabilized on the glide path till very short finals.

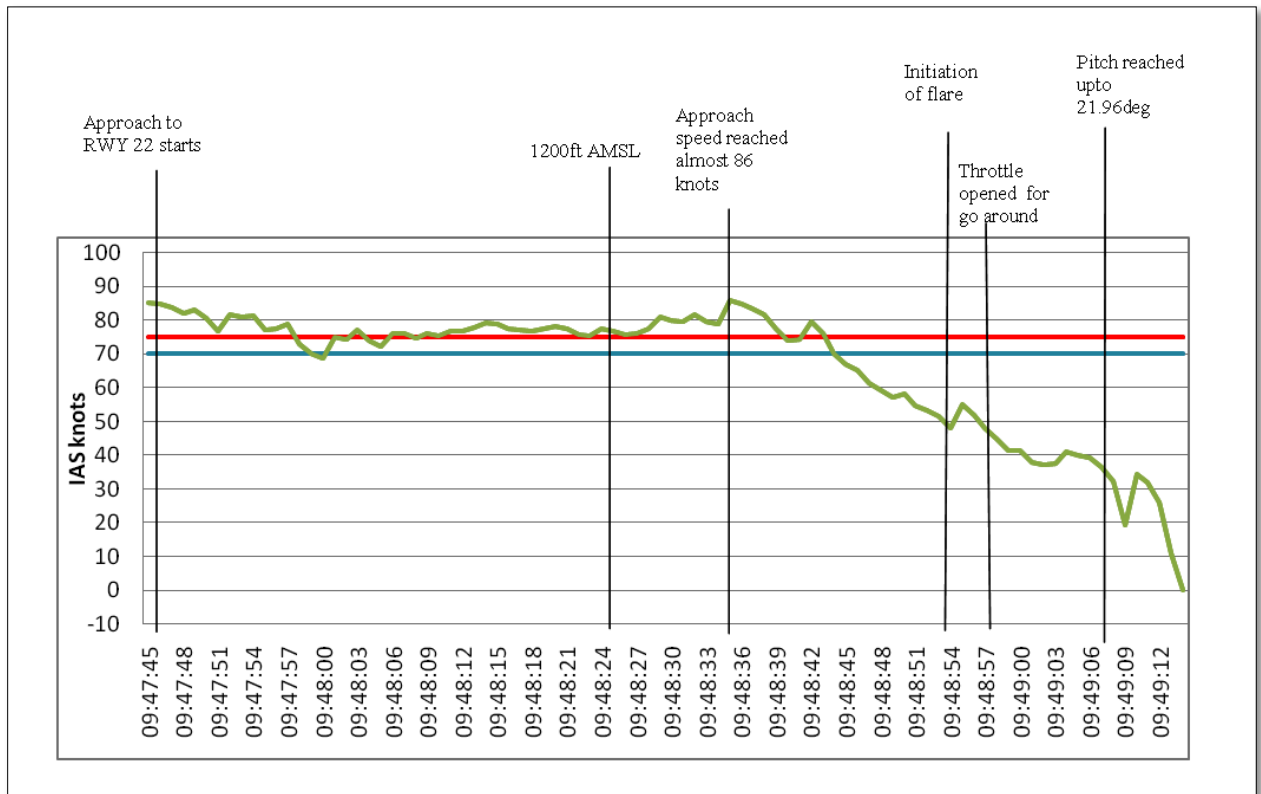
Fig.8.Approach speed of the aircraft

In fig.8, the vertical axis shows the approach speed (IAS) in kts against the time during the second approach (in UTC). The red and the blue lines are the tolerances levels (75 and 70 kts respectively) considering the normal operating airspeed procedures as per Aircraft Flight Manual. The green profile shows the actual approach speed of the aircraft.

It can be seen from fig.8 that the aircraft had a higher speed in the initial stage of approach, higher than the limits. The speed was then controlled for a limited period but went above the limits again. There was a spike in the Indicated Air Speed (IAS) to about 86 kts on short finals. The IAS of the aircraft at the time of initiation of flaring was around 51kts. The variation in the IAS of the aircraft also reflects that the approach was not stabilized.

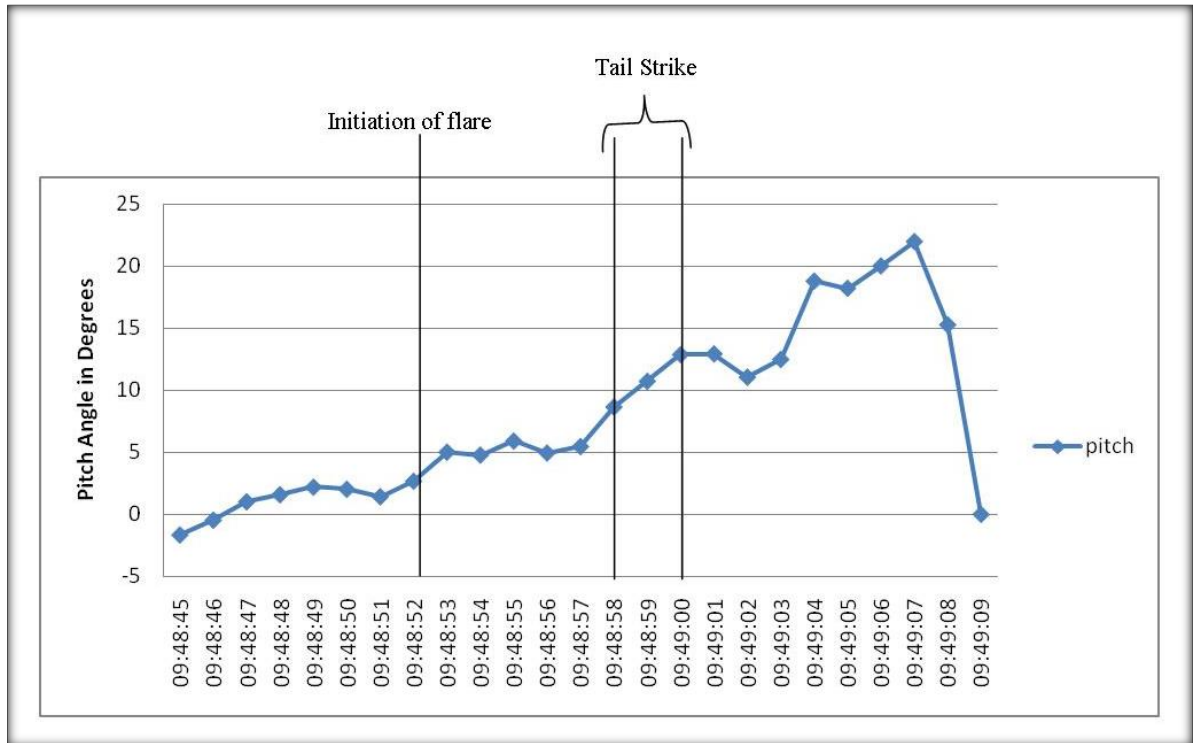
Fig.9.Pitch attitude of the aircraft w.r.t time

The above graph (Fig.9) is a representation of the pitch attitude during flare and touchdown phase. The blue line represents the variation of pitch attitude in degrees. As per the recordings, the pitch angle starts to move from negative value to greater than zero at time 094846 UTC at which the aircraft is at a height of 1081ft AMSL. The pitch attitude is seen varying for almost 7seconds from 094846 UTC. A sudden increase in the pitch value from 2.67 degrees to 5.1degrees in less than one second of time is observed at time 094852 UTC depicting flare. The pitch and the engine power kept on increasing thereafter. The pitch got increased from 5 degrees (at 094853 UTC) to 12 degrees (at 094900 UTC).

The pitch value at 094858 UTC was increasing from 8.64 degrees to 12degrees and it was the touchdown period followed by tail scrape. The aircraft started showing increase in banking attitude once the pitch value crossed 12 degrees. Aircraft altitude also raised simultaneously. The aircraft banked towards right (up to 8.26degrees) at time 094904UTC, during which the pitch value was 18.2degrees. The student pilot then reduced the power. The pitch angle kept on increasing and reached the highest recorded value of 21.96 degrees at time 094907UTC. At this point the aircraft had power ON stall with the wings banking towards left (bank angle of 21.03degrees) making a contact at the RWY surface. The aircraft came to a halt after 06 seconds from the moment wing tip touched on the ground. Some of the DFDR parameters showed erratic values after the stall.

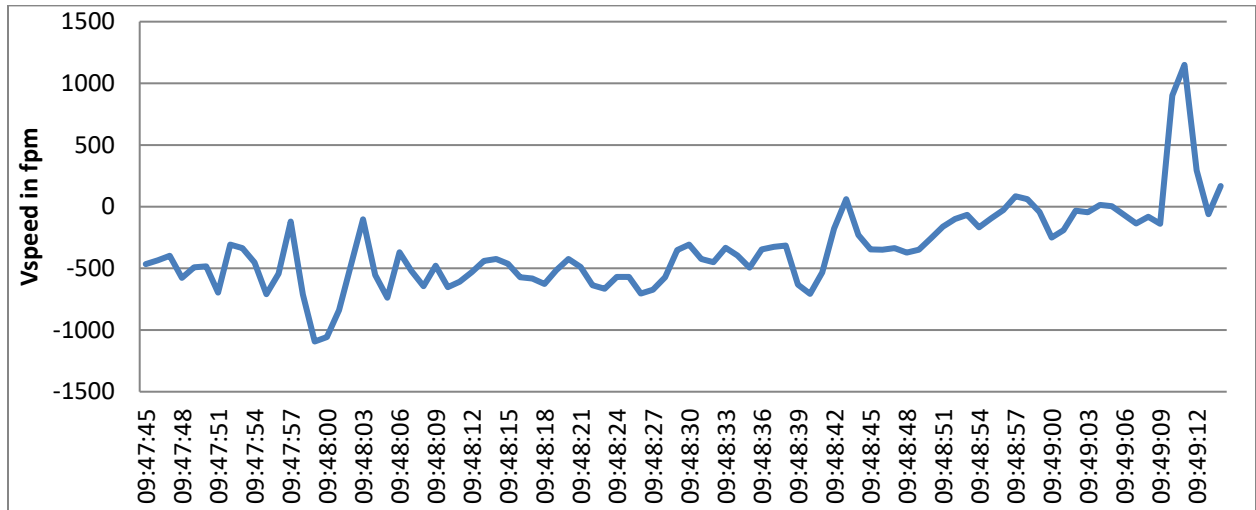
Fig.10. Vertical speed of the aircraft

It is understood from the variation in the normal acceleration values that the aircraft was not stabilized in second approach. Rise in the normal acceleration values during the flare indicates that the aircraft had a touchdown at around 094858 UTC followed by a bounce.

The above graph (Fig.10) shows how the vertical speed of the aircraft varied with time (in UTC). The sudden peak (towards the end) in vertical speed of approximately 1100 ft/ min is where the aircraft was at onset of stall which was followed by a sharp dip.

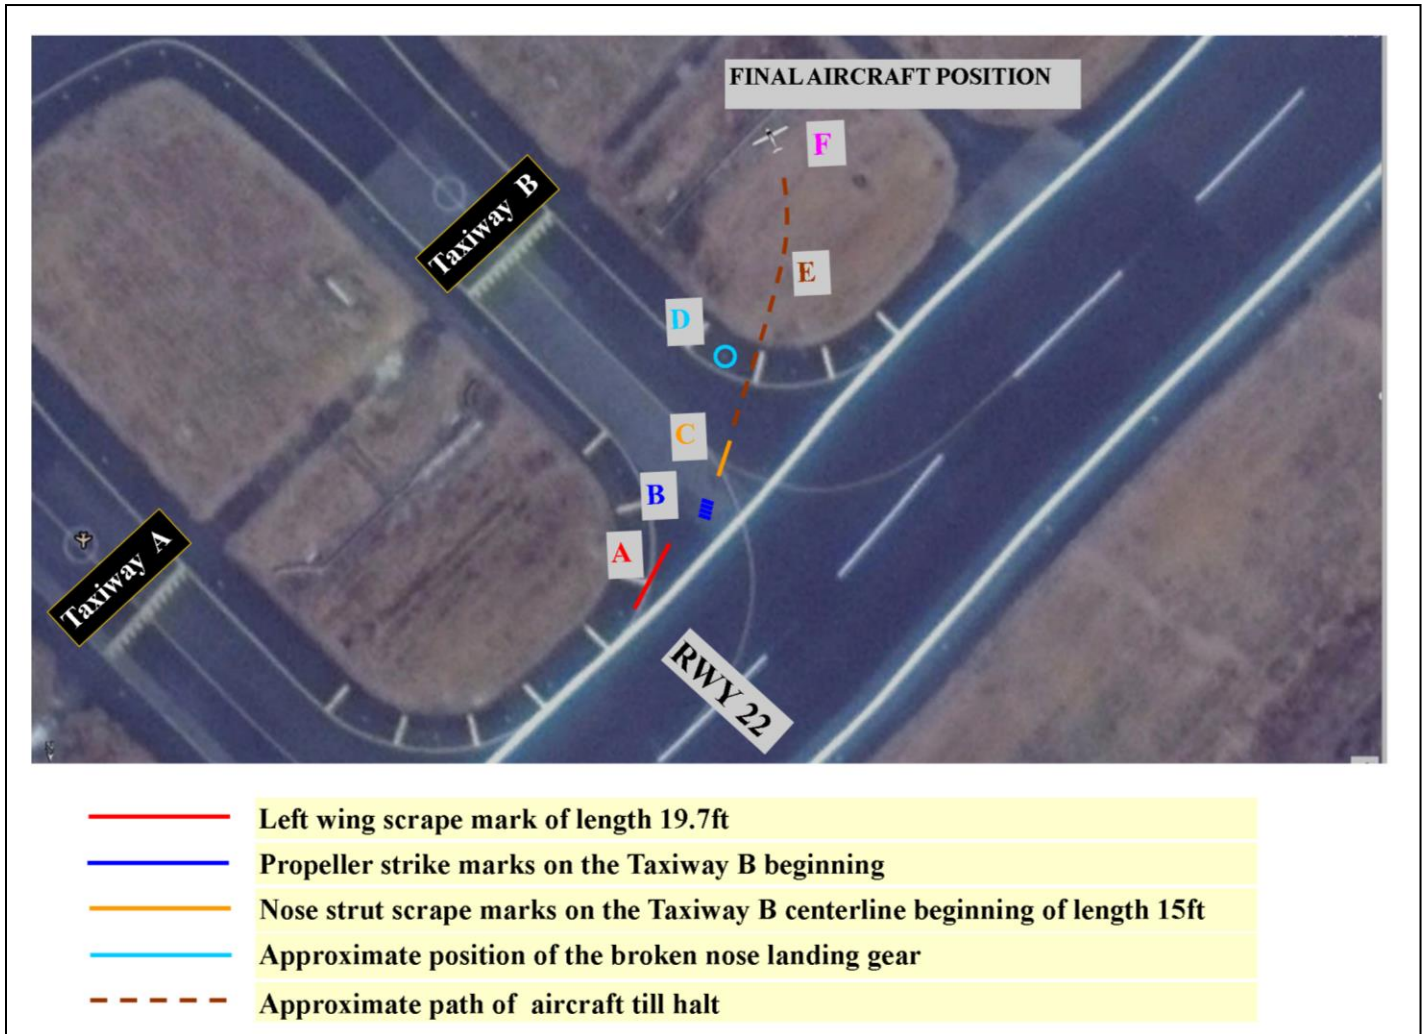
The second approach by the aircraft was made for RWY 22. The aircraft first came in contact with the RWY surface and then bounced in the air. Later, the aircraft touched with the left wing near the TWY B beginning making a scratch mark of length 19.7ft. The scratch was in an inclined path with one end at 82ft and another end at 86ft from the RWY centerline (Refer Fig12). There were four propeller strike marks on the TWY beginning after the wing tip scratch. (Refer Fig13).

Fig.11. Representation of various damages in aerial view

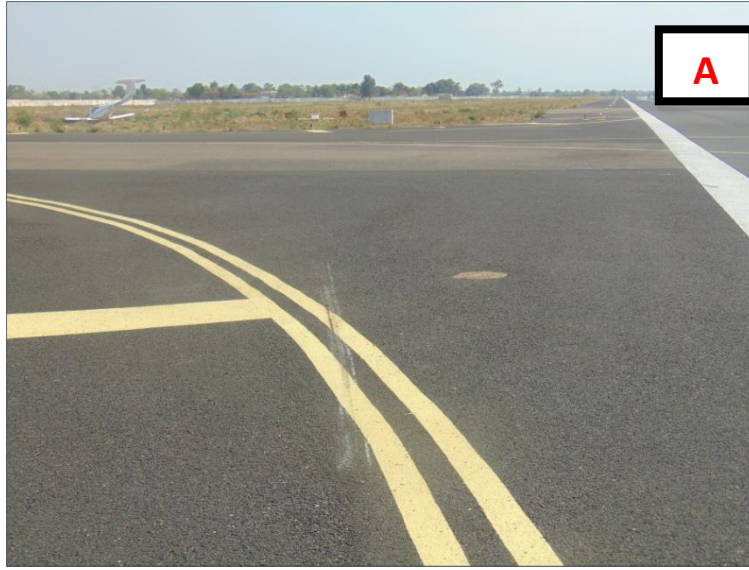
- i. : Damage happened to the surface of Runway–Taxiway B joining area due to left wing scrape, propeller strikes and nose strut scrape. (Ref Fig 12, Fig 13 and Fig 14).

Fig.12. Left wing scrape mark

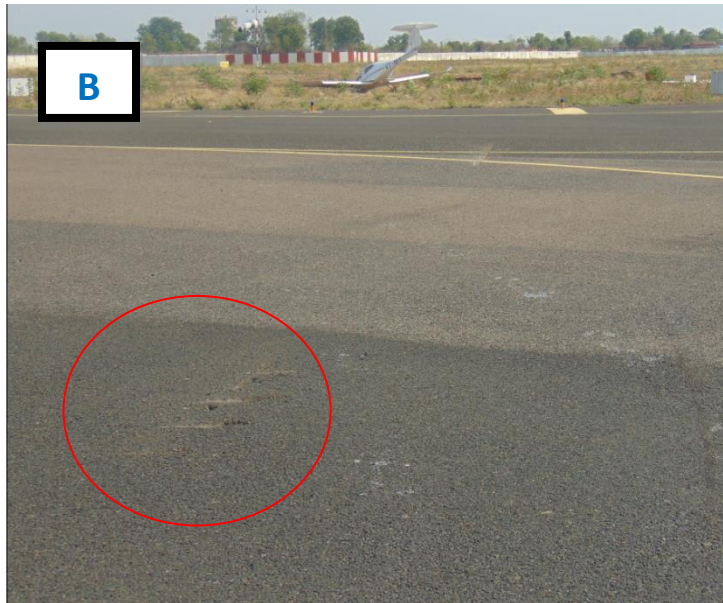
Fig.13. Propeller strike marks

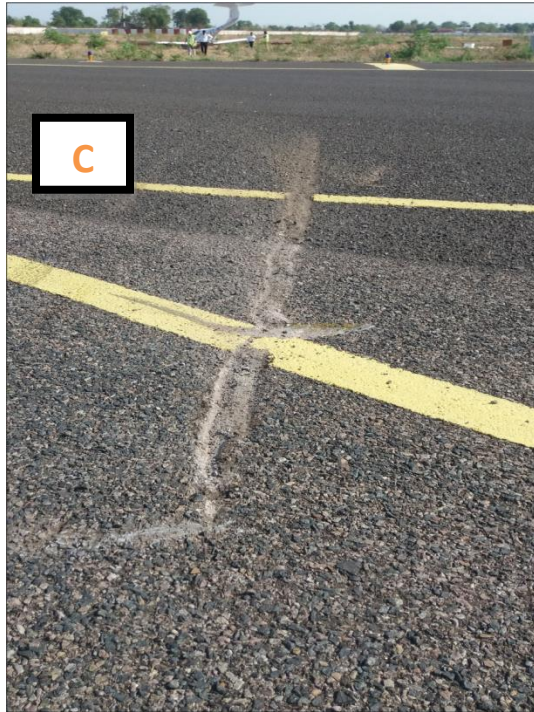
It was followed by nose landing gear strut scrape mark of length 15ft (Refer Fig14). The scrape mark was 27.2 ft (on one edge) and 33.8 ft (on other edge) from the RWY 22 edge line. The right tire marking was seen near to the nose strut scrape mark. Tire path markings were also observed in the kutcha area (Fig 16).The aircraft finally stopped in the kutcha area making a rest in south- east direction near the drainage canal wall area as shown in Fig 16.

Fig.14. Nose strut scrape marks

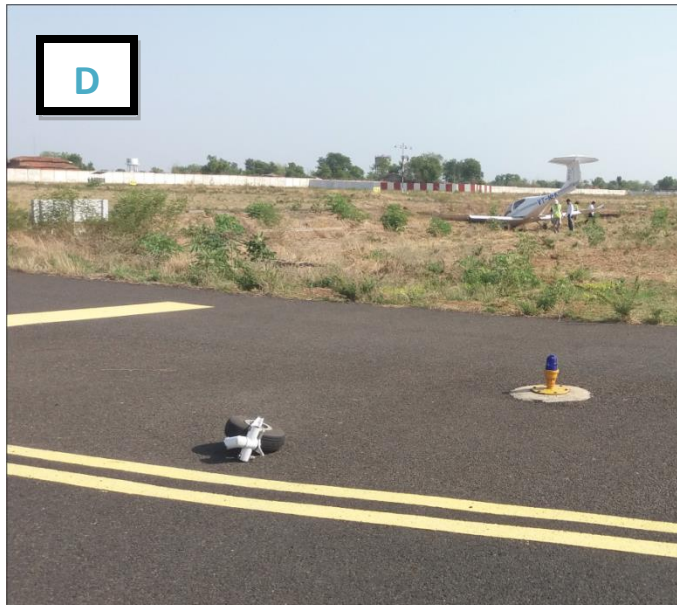
Fig.15. Detached nose gear and the aircraft

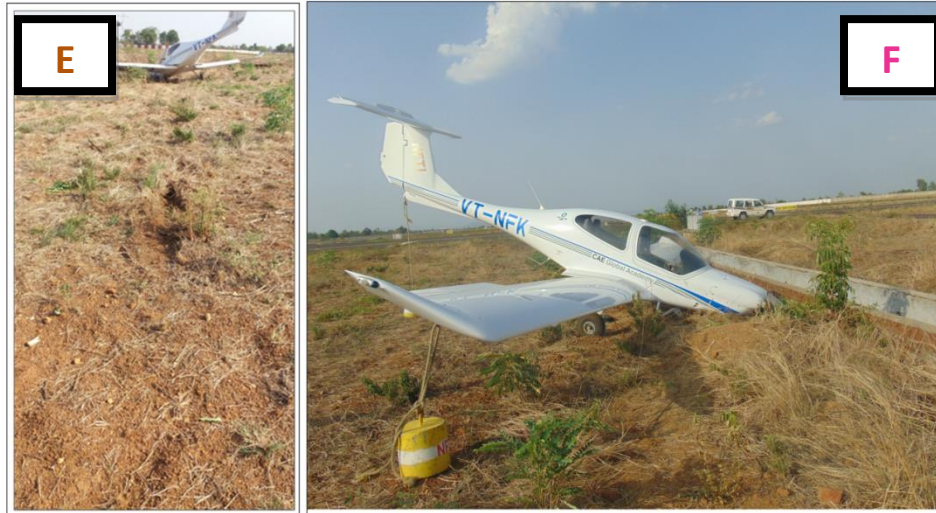
Fig.16. Markings on kutcha area and aircraft final position.

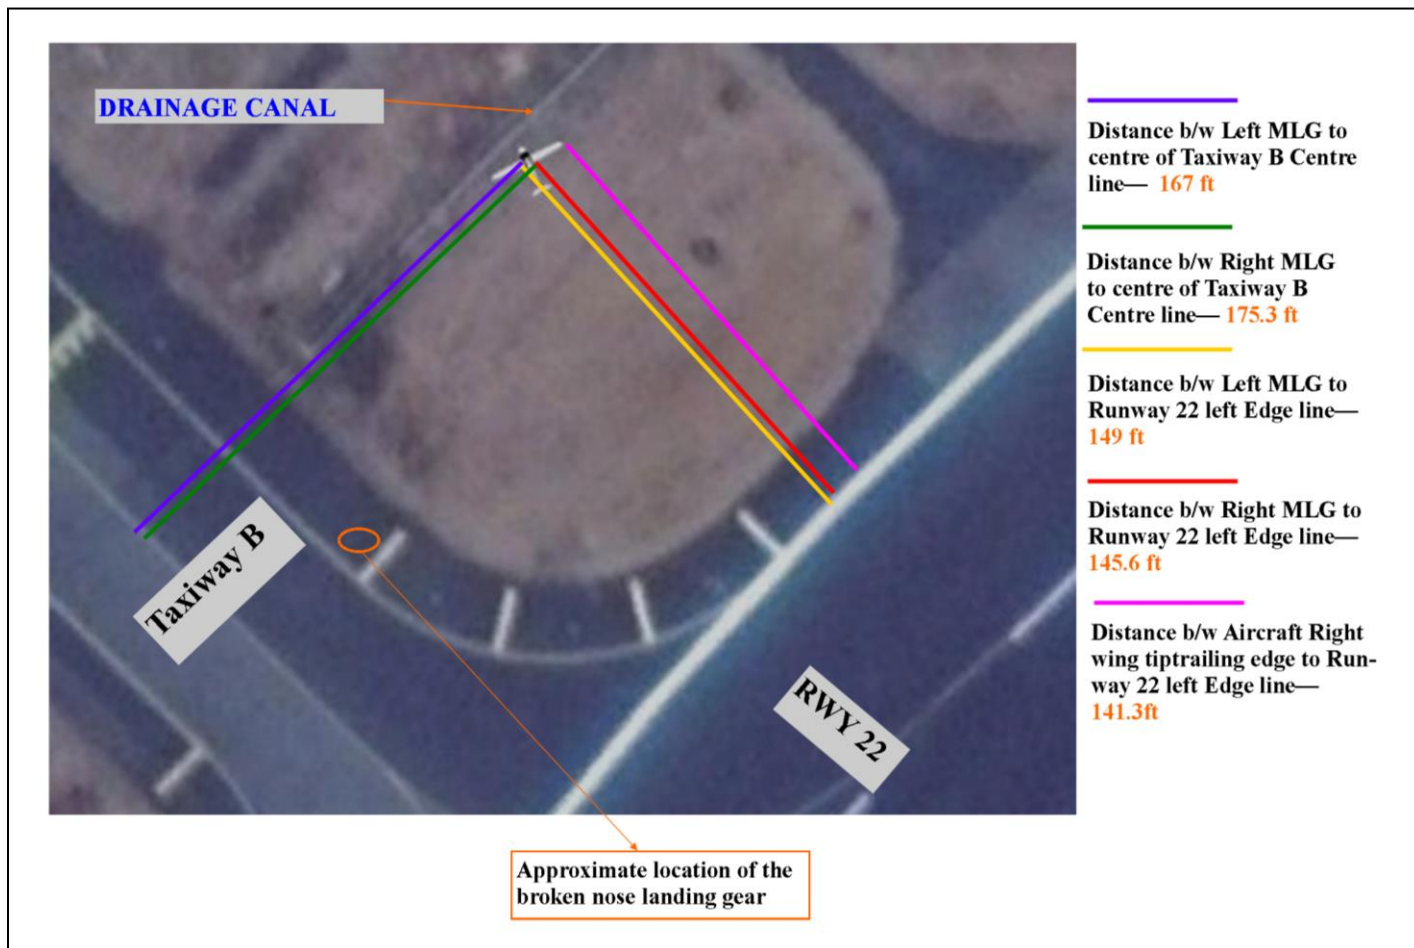
Aircraft final position was such that the RH landing gear was 145.6ft from RWY22 left edge line 175.3ft from TWY B centerline, whereas LH landing gear was 149ft from RWY22 left edge line and 167ft from TWY B centerline. (Refer Fig17)

Fig.17.Aircraft position after coming to halt- aerial representation
