## **FINAL INVESTIGATION REPORT**

### **HARD LANDING INCIDENT TO M/S INDIGO A321 NEO AIRCRAFT VT-IUM AT COIMBATORE ON 17<sup>th</sup> MAY 2022**

**Office of Director of Air Safety (WR)  
Integrated Operational Office Complex, Sahar Road,  
Vile Parle (E), Mumbai – 400099**

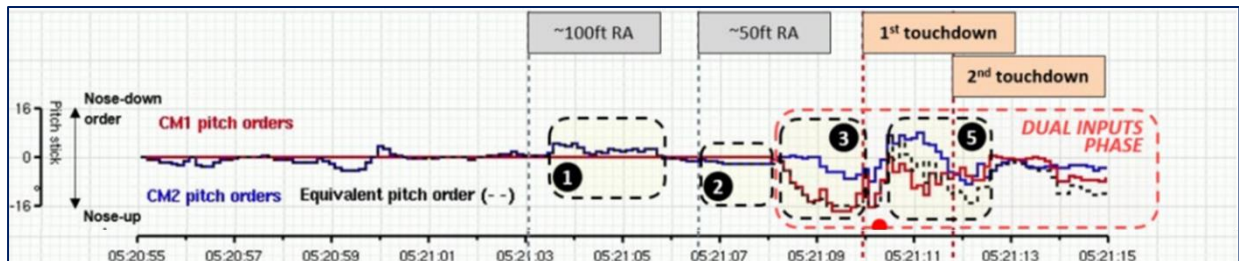
- From ~95ft RA to ~25ft RA, P2 applied slight nose-down then slight nose-up inputs, due to which Pitch angle progressively decreased from +2.5° to +1.5° then slightly increased up to +2°. Rate of descent increased from ~650ft/min to ~1000ft/min.
- At 05:21:07 Hrs. UTC, ~25ft RA, flare was initiated by P1 with a progressive full nose-up order. In the last 15ft, P2 applied a half of full nose-up order (dual inputs). Due to this Pitch angle increased from +2° to +4.5°.
- At 05:21:08 Hrs UTC, At ~10ft RA, thrust levers were progressively retarded to the IDLE detent leading to A/THR disconnection just after first touchdown.
- At 05:21:15 Hrs., UTC, Side stick inputs were simultaneously recorded on both P2 & P1 sides without activation of 'takeover priority push button'.

- In the last 15ft RA, P1 applied right deflection. A dual side stick input occurred for 8 seconds.
- In the last 75ft RA, a vertical gust of ~6kt and a tailwind gradient of ~6kt were encountered by the aircraft. CAS decreased from 148 kt to 140 kt
