Investigation Report On Incident to M/s Alliance Air Aviation Ltd.

(Alliance Air) Aircraft VT-RKJ on 09.02.2022

11. Phase of operation : Take-off roll
12. Type of Incident : System/Component Failure - Non-Power plant (SCF-NP)

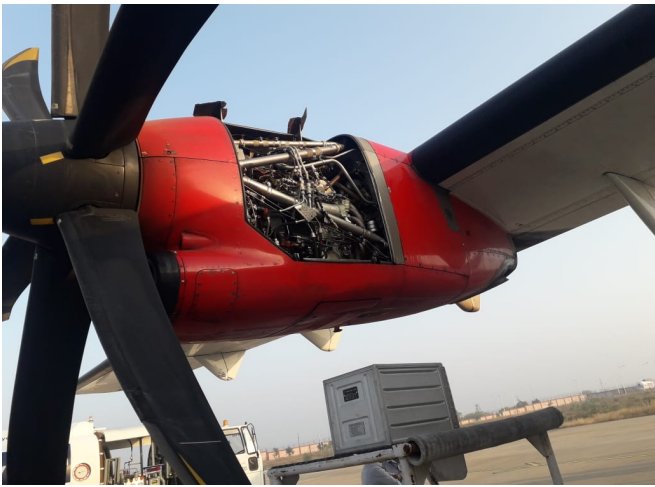
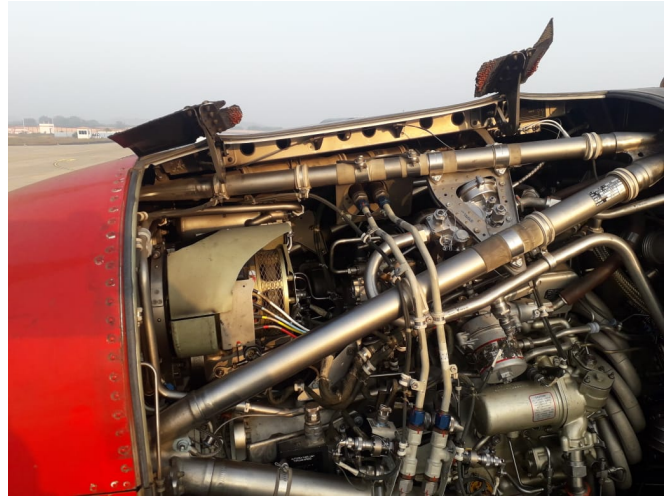
After landing at Bhuj, during post flight inspection the B1 AME (who travelled on-board) observed that the engine#2 inboard cowling was missing, same was informed to the PIC. The defect was reported to concerned internal departments and in turn to DGCA. No secondary damage was found on the aircraft after inspection.

During inspection of engine#2 at Bhuj, telescopic cowl stay rod on intermediate frame was found buckled with crack. Approx 1.5cm tear and lifting of structure observed on Center Beam Assembly at the points of hinged lateral cowl attachments both forward and rear.

Photographs of the RH engine after landing at Bhuj [lateral hinged inboard cowl missing]

The probable cause of the incident was improper locking of the inboard lateral hinged cowling of engine#2 prior to departure of the aircraft.

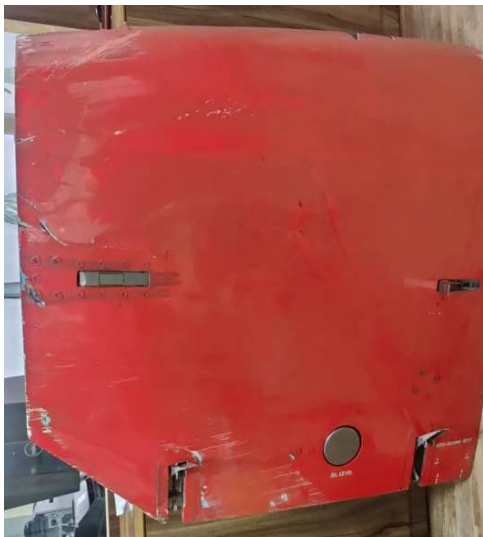
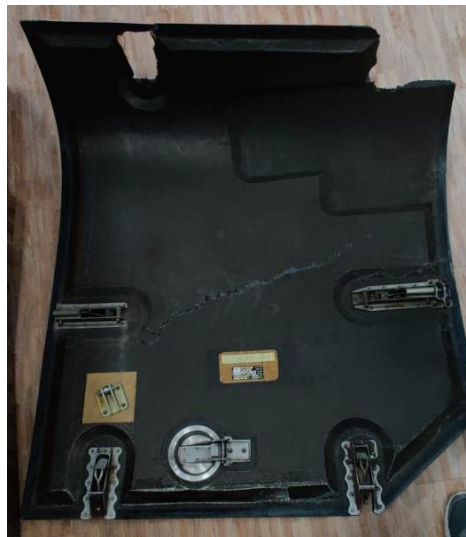
Photographs of the RH engine lateral hinged inboard cowl recovered from runway at Mumbai

The RH engine lateral hinged cowl(inboard) and stay rods were recovered on runway 27 abeam taxiway N4 at 210.7m from the displaced threshold of runway 27, 693.3m from start of runway and about 4.3m from the runway centerline.

1.16.1 The matter was taken up by M/s Alliance Air with M/s ATR. M/s ATR reported that, latches and fittings were not damaged and they concluded that locking of the cowl was not done properly and as soon as the aircraft took off, the airflow ripped the cowl from the nacelle.

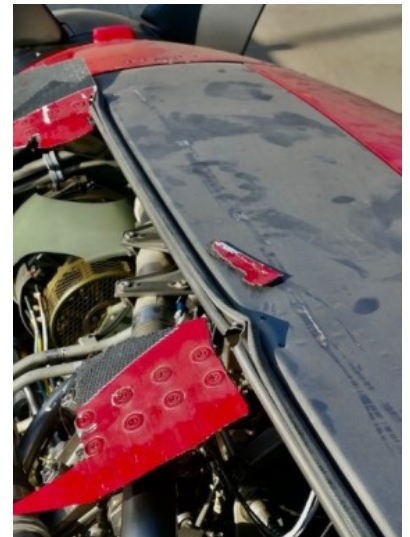
Photograph of the hinges holding the lateral hinged inboard cowl and upper beam

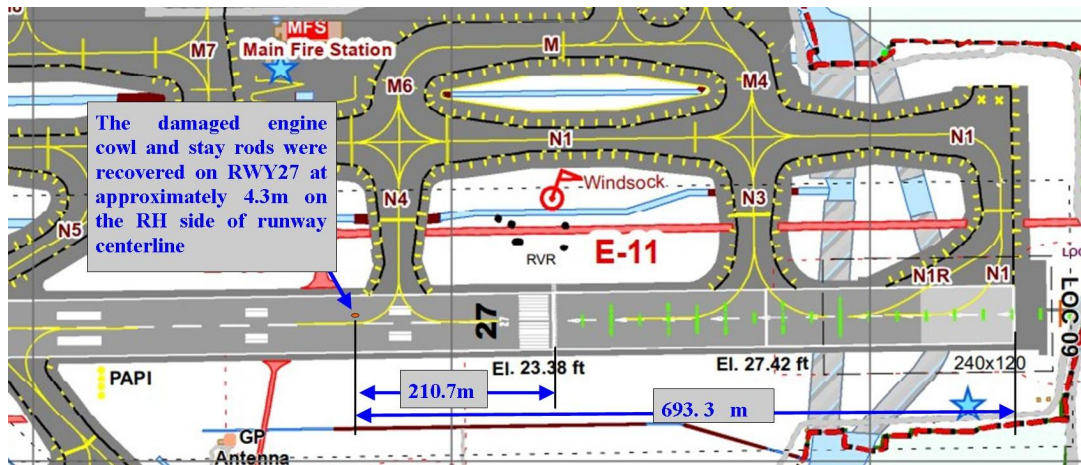
The location of damaged cowl depicted on Grid map of VABB (Mumbai) [Not to scale]

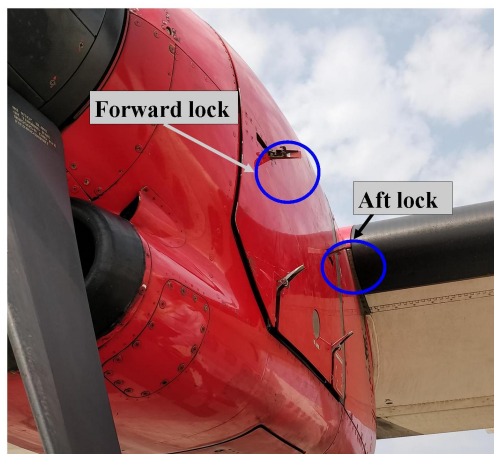
Fig 1(a)

Aft lock, forward lock and bottom locks in Open condition

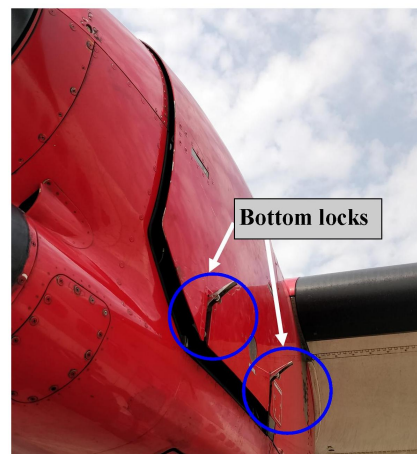
Fig 1 (b)

Aft lock and forward lock placed to locked position prior to closing the cowl and bottom locks remaining open

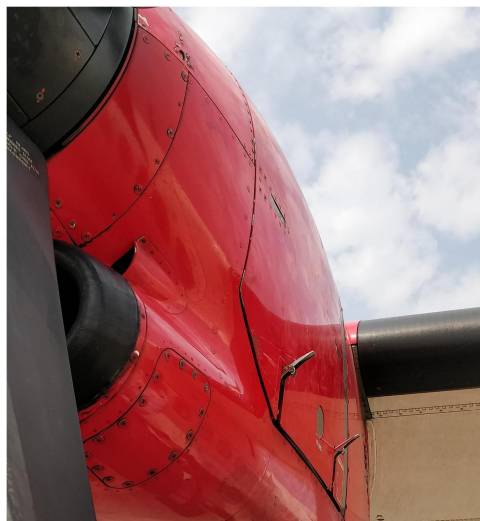
Fig 1(c)

Cowl closed and Aft lock and forward locked properly. Bottom locks remaining unlocked.

Figure 1(c) - When both the horizontal 'forward lock' and 'aft lock' latches are locked after fully closing the inboard lateral hinged cowl the cowl is flush with the other engine cowl fixed engine cowl/fairings, even if the bottom locks remain open. The unlocked position of the bottom lock latches are clearly visible in this condition.

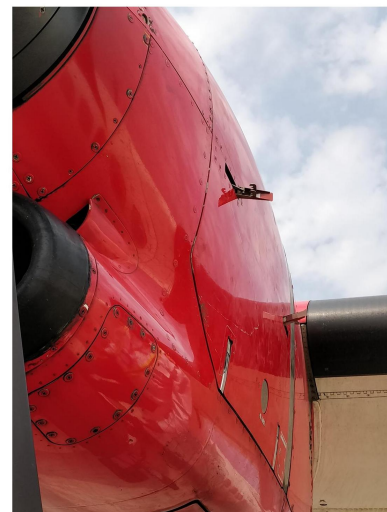
Fig 1(d)

Aft lock and forward lock remaining open. Both bottom locks locked after closing the cowl.

Figure 1(d) - When both the 'bottom lock' latches are locked after fully closing the inboard lateral hinged cowl the cowl is flush with the other engine cowl, even if the 'forward' and 'aft' locks latches remain open. The unlocked position of the 'forward lock' and 'aft lock' latches are clearly visible in this condition.
