**FINAL INVESTIGATION REPORT ON  
AIR TURN BACK INCIDENT DUE TO  
LOSS OF PRESSURIZATION TO  
M/s AIR INDIA LTD BOEING 787-800 AIRCRAFT  
VT-ANU ON 06/03/2019 AT DELHI**

**GOVERNMENT OF INDIA  
O/o DIRECTOR AIR SAFETY, WESTERN REGION,  
NEW INTEGRATED OPERATIONAL OFFICE COMPLEX,  
SAHAR ROAD, VILE PARLE (EAST), MUMBAI-400099**

On 06<sup>th</sup> March 2019, M/s Air India Ltd Boeing 787-800 aircraft VT-ANU was involved in air turn back incident due to loss of pressurization during climbing while operating flight AI-121 (VIDP-EDDF).

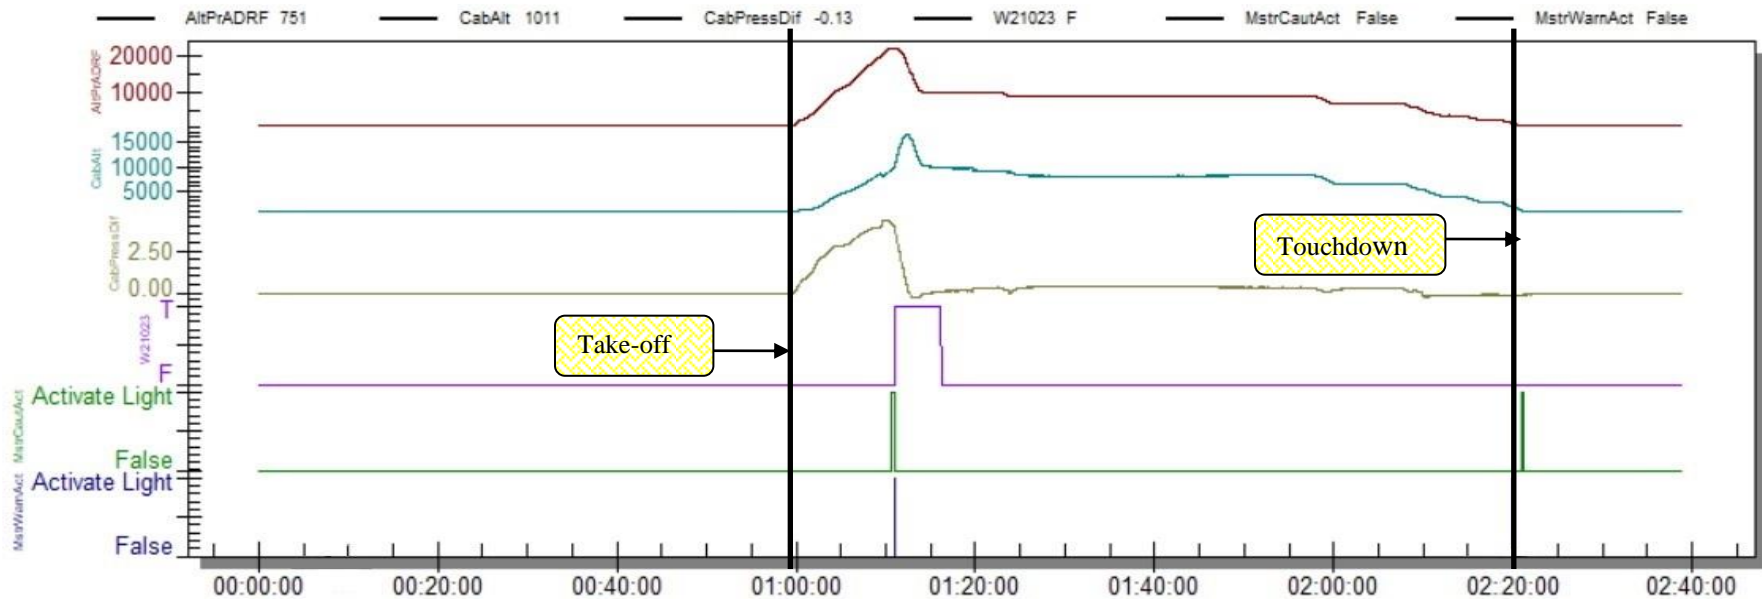
Figure # 1 Graphical representation of FDR data  
(Pressure altitude Vs Cabin altitude Vs Cabin pressure differential Vs Master caution Vs Master warning Vs Time)

The above graph depicts that the cabin altitude started climbing as soon as the aircraft started climbing. After about 10 minutes of take-off, the cabin altitude started rising rapidly. One minute later, master caution was activated (due to both outflow valves selected to be in manual mode) followed by master warning (due to excessive cabin altitude). Pressure altitude started decreasing immediately after generation of master warning depicting that the aircraft started descent as per NNC of CABIN ALTITUDE. The cabin altitude continued to rise at higher rates during descent and inversely cabin pressure differential started decreasing substantiating the loss of cabin pressure. Cabin altitude reached to its peak value 16573ft at 08:55:33hrs during descent. CABIN ALTITUDE EICAS (excessive cabin altitude) stayed for 05 minutes 12 seconds.

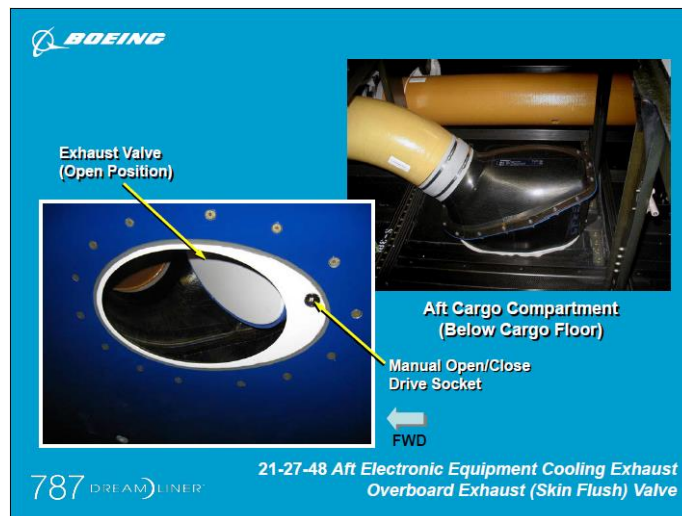
Figure # 4 Aft EE Cooling Exhaust Overboard (Skin Flush) Valve

EQUIP OVBD VLV AFT message indicates that the aft equipment cooling overboard valve is failed in the open position. Pressurizing the airplane with this valve open leads to a large pressure differential between the cabin and equipment cooling duct. This causes duct failure and subsequent loss of cabin pressure through the equipment cooling overboard valve.

History of snags & AHM reports prior to incident flight substantiate that the valve was generating intermittent faults and finally failed on 06/03/2019. As per the report of the M/s Collins Aerospace, the Aft EE Cooling Exhaust Overboard (Skin Flush) valve was confirmed defective, i.e. outside of test limits for Door Closure flushness tests. Hence the reason for the EQUIP OVBD VLV AFT advisory/ status messages generated throughout the flight and in previous sectors is attributed to the defective Aft EE Cooling Exhaust Overboard (Skin Flush) valve. The defect did not repeat after replacement of the valve substantiates the same.

- As per the report of the M/s Collins Aerospace, the Aft EE Cooling Exhaust Overboard (Skin Flush) valve was confirmed defective, i.e., outside of test limits for Door Closure flushness tests.
