**INVESTIGATION REPORT ON FORCED LANDING INCIDENT TO M/s
PIONEER FLYING ACADEMY PVT. LTD. CESSNA 152 AIRCRAFT VT-NNN
ATYAMUNA EXPRESS HIGHWAY ON 27.05.2021**

**GOVERNMENT OF INDIA, O/o DIRECTOR GENERAL OF CIVILAVIATION,
OPP. SAFDARJUNG AIRPORT, NEW DELHI-110003**

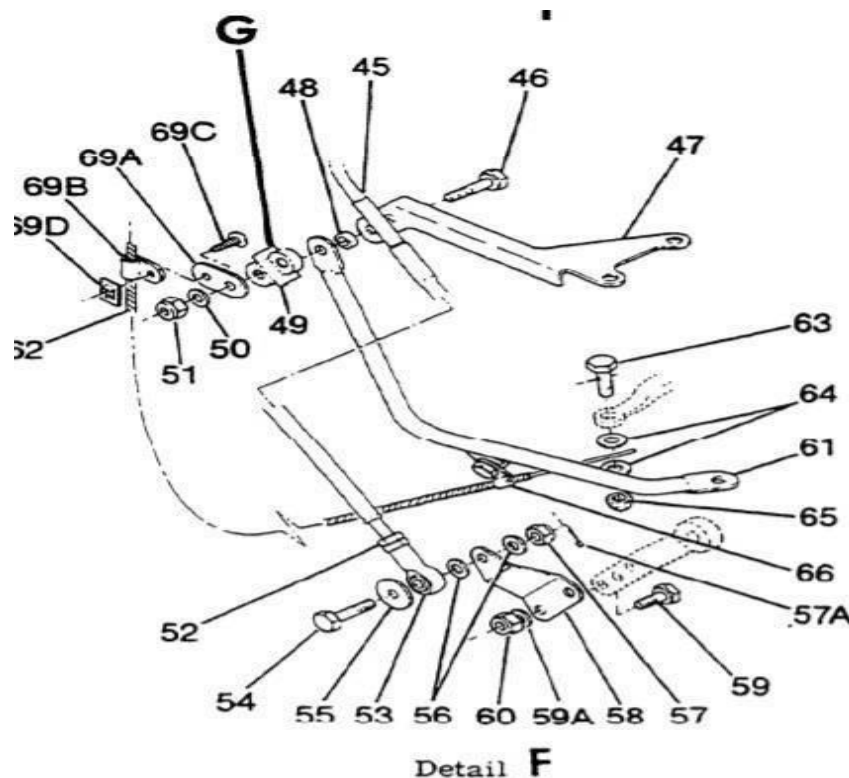
The installation procedure of Fuel Mixture control cable to carburetor end is shown in the figure and part No. 63,64 and 65 wherein a half threaded bolt passes through carburetor linkage. The Mixture Control Cable passes through a hole on half threaded bolt with a washer on the upper side and another washer on lower side and finally tightened with a bolt.

Fig-1: Part-F showing fitting of Fuel Mixture control cable on carburetor linkage at part No. 63, 64 & 65.

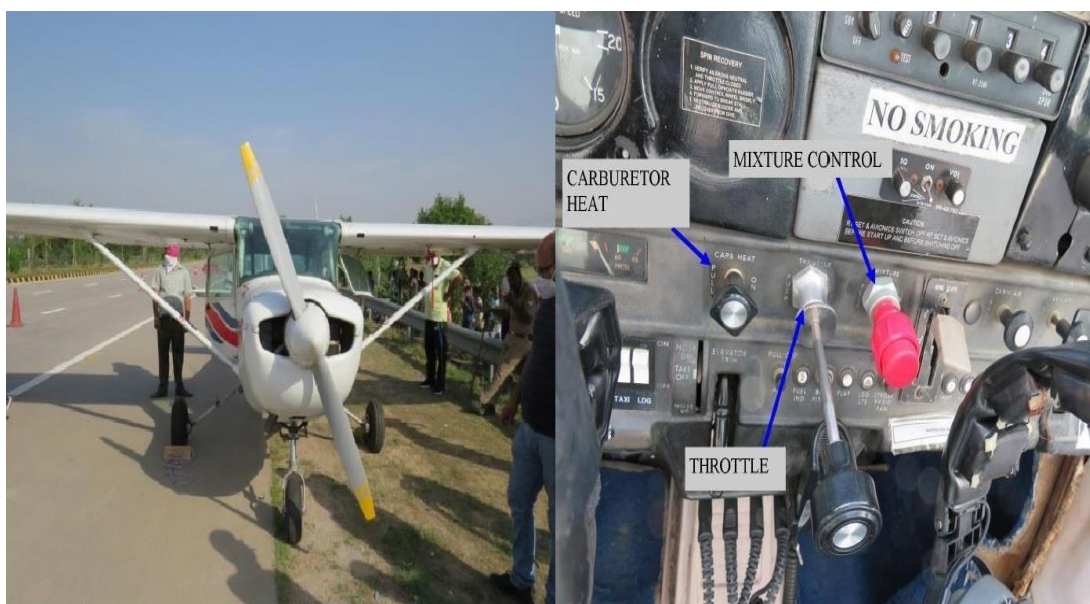
- Carburetor heat: OFF
- Throttle: IDLE,
- Mixture: RICH.
- Fuel shut off valve was ON.
- The fuel remaining in LH tank was 45 liters and fuel remaining in RH tank was 40 liters.
- The engine oil level was measured to be 05Qts.

The position of the controls is depicted in the figure below:

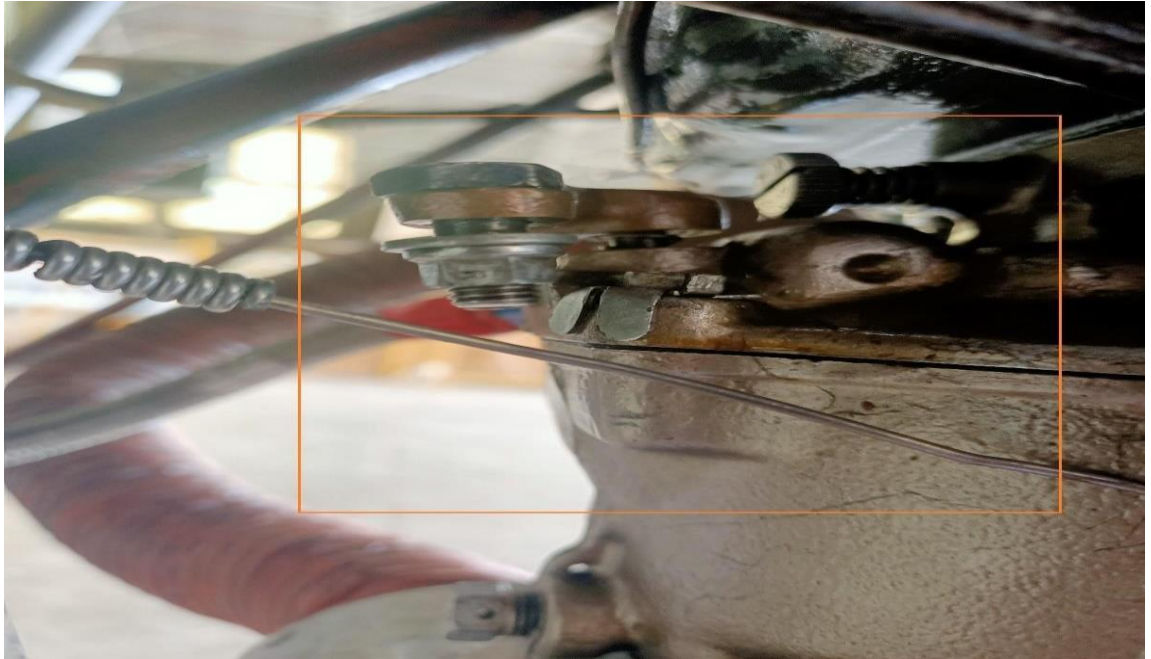
Fig-3: Indicating the fuel mixture control cable came out of carburetor linkage and carburetor linkage is containing only one washer

Fig-3 and Fig-4 taken from the aircraft involved in incident indicates that there was only one washer present to hold the fuel mixture control cable at carburetor linkage.

Post incident investigation revealed that only one washer was present in the carburetor linkage to hold the mixture control cable. This implies that maintenance personal did not ensure the proper tightness of mixture control cable with carburetor linkage by using two washers as required by Maintenance Manual. Same was also corroborated with the acceptance of the maintenance lapses by the AMEs involved in maintenance action.

The probable cause of the incident is slipping out of mixture control cable from carburetor linkage due to insufficient pressure caused by missing washer which further resulted in the loss of engine power during flight.

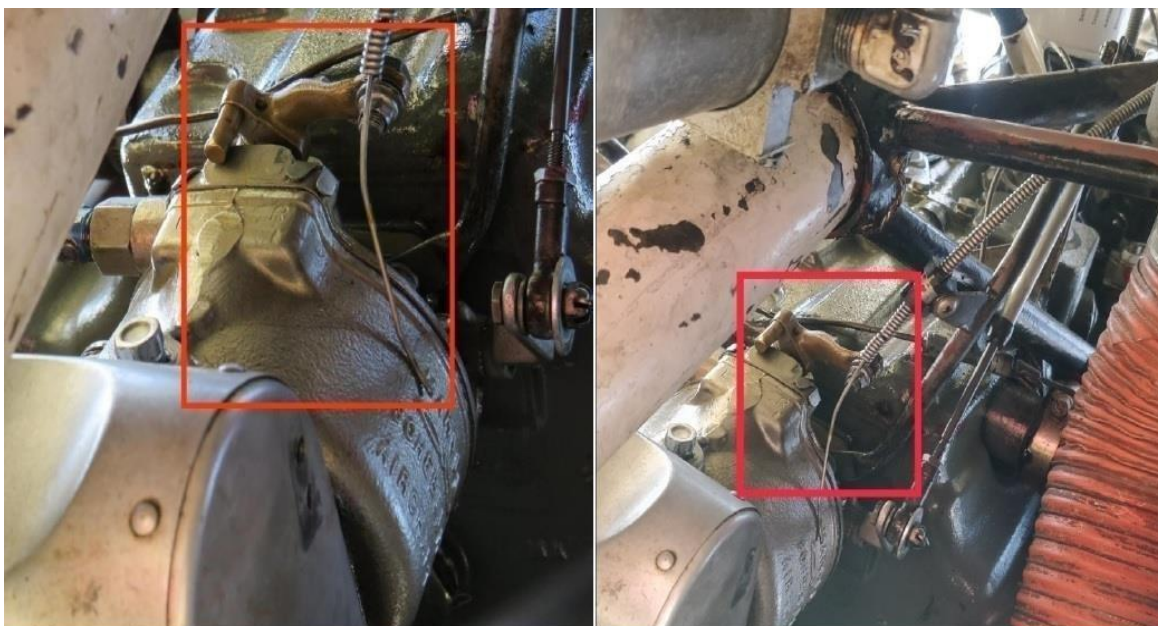
Fig-4: Indicating the fuel mixture control cable came out of carburetor linkage

After the incident engine was inspected for any sign of fuel or oil leakage, however no such sign of fuel/ oil leak observed. The detailed investigation revealed that the control cable connecting mixture control knob to the carburetor linkage had slipped out and disconnected from the carburetor end.
