**FINAL INVESTIGATION REPORT ON ABNORMAL RUNWAY  
CONTACT INCIDENT TO AIRCRAFT CESSNA 172S, VT-JSN,  
M/S BLUE RAY AVIATION PVT LTD AT MEHSANA ON  
17 DECEMBER 2022**

**GOVERNMENT OF INDIA  
OFFICE OF DIRECTOR OF AIR SAFETY (WR)  
INTEGRATED OPERATIONAL OFFICE COMPLEX,  
SAHAR ROAD, VILEPARLE (E), MUMBAI – 400099**

**FINAL REPORT ON ABNORMAL RUNWAY CONTACT INCIDENT TO  
AIRCRAFT CESSNA 172S, VT-JSN, M/S BLUE RAY AVIATION PVT LTD  
AT MEHSANA ON 17 DECEMBER 2022**

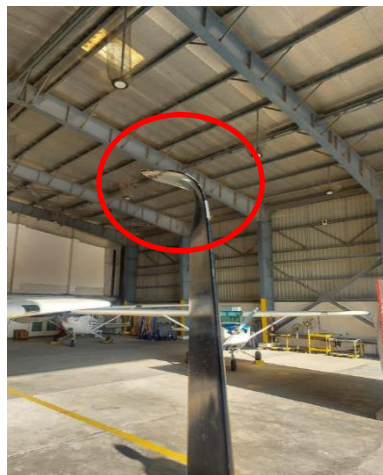
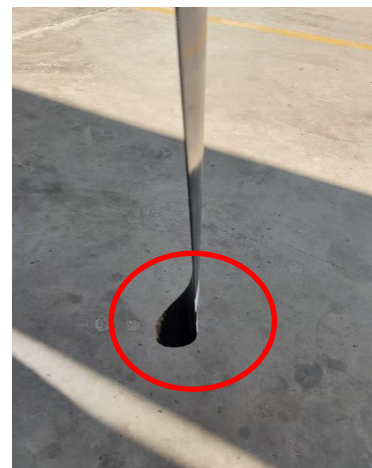
**Fig. 01 – Aircraft Propeller**

- 1.3.1 Aircraft Propeller** – The propeller is fitted in front of the engine and the engine is mounted on the nose section of the aircraft. The propeller is made up of aluminum alloy. Both the propeller blades were bent at the tips as a result of the propeller strike.

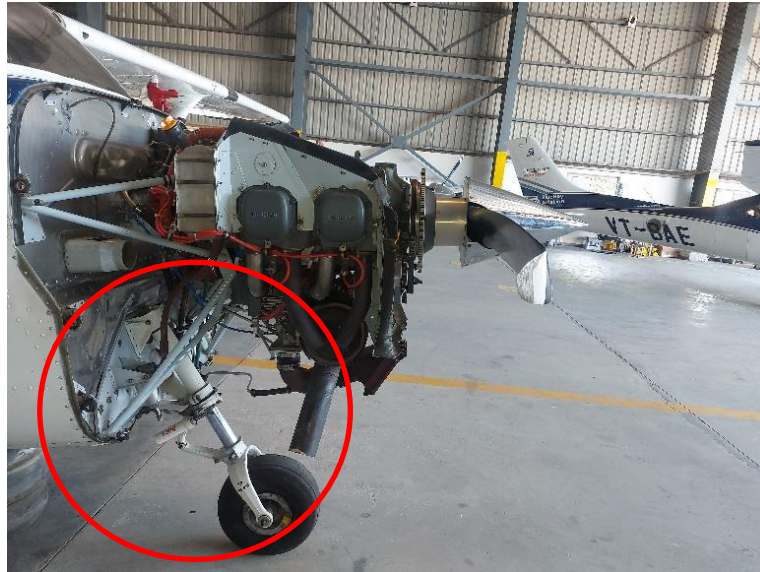
**Fig. 02 – Nose Landing Gear**

- 1.3.2 Nose landing gear** - The nose landing gear is connected to the rudder pedal. The nose landing gear strut was dislocated from its original orientation. The nose landing gear was shifted slightly front side and left side.

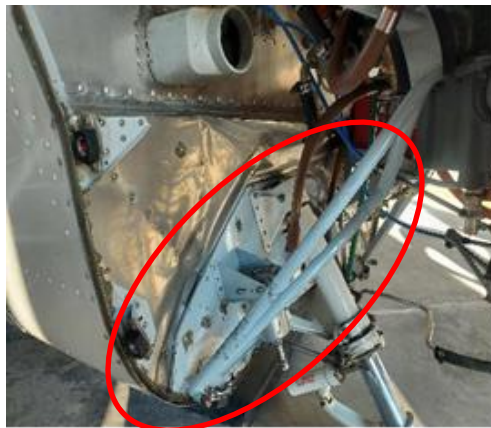
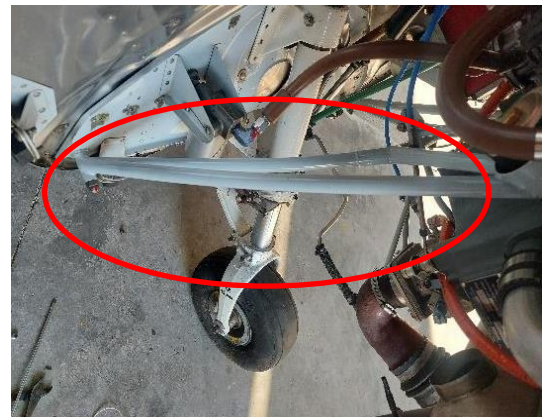
**Fig. 03 – Engine mount**

- 1.3.3 Engine mount** - It is located in front of the firewall. The engine mount strut was found bent.

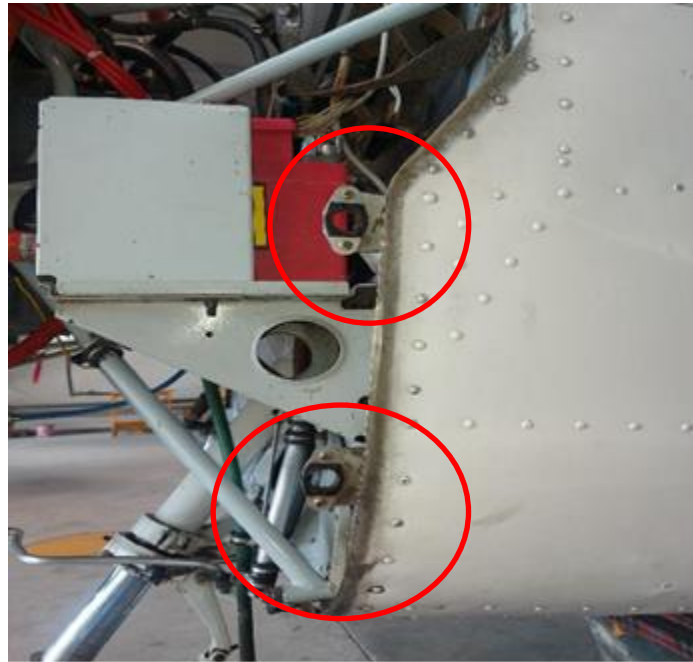
- 1.3.4 Shock mount** - Three shock mounts on the lower left side of the firewall (front section of the fuselage) were found sheared from the shock mount assembly.

**Fig. 04 - Shock mount rubber units sheared**

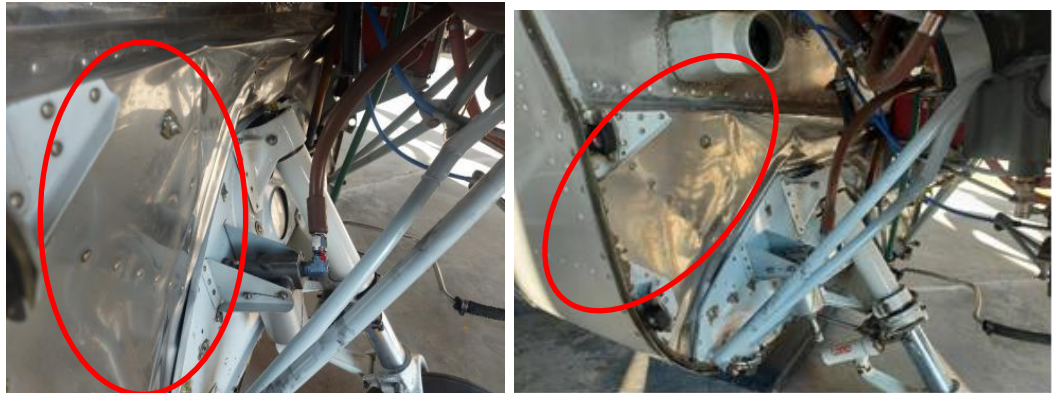
- 1.3.5 Lower firewall** - The lower firewall was buckled.

**Fig. 05 - Damaged Lower firewall**

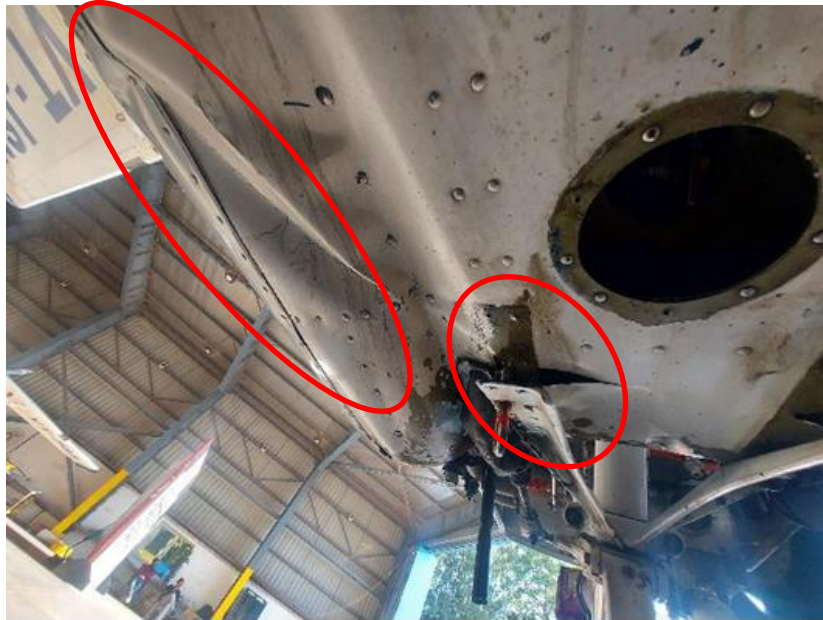
**Fig. 06 - Fuselage lower skin**

- 1.3.6 Fuselage lower skin wrinkled** –Fuselage lower skin was wrinkled and sheared due to impact. The wrinkle was spread in the bottom fuselage from NLG struts to the wing strut.

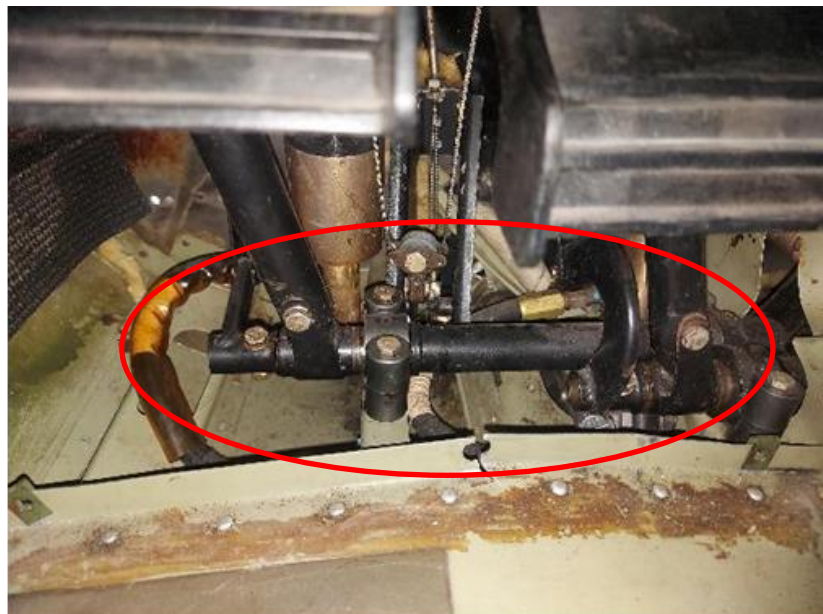
**Fig. 07- Rudder pedal bar**

- 1.3.7 Rudder pedal bar** – It is located below the rudder pedal in the cockpit. The rudder pedal bar was found bent.

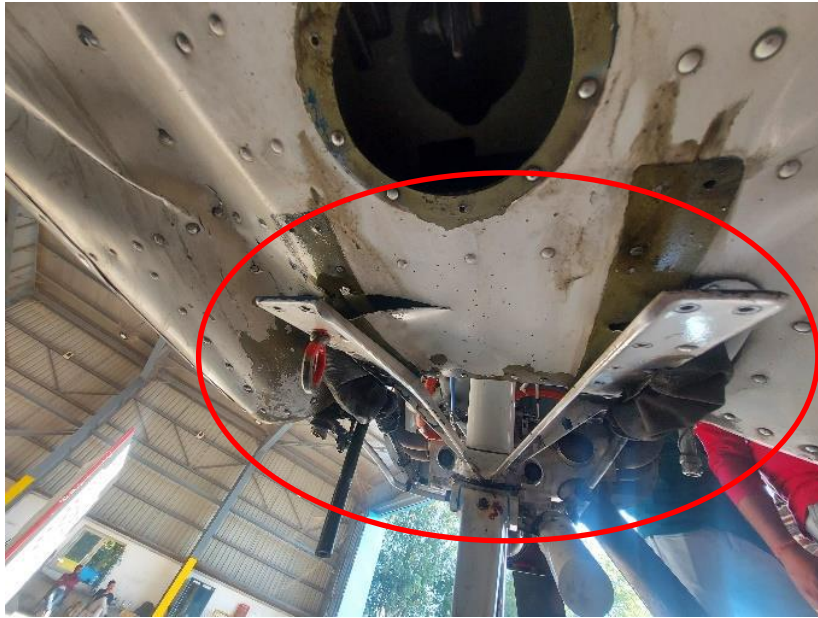
- 1.3.8 Nose gear support bracket** –The nose gear support bracket detached from the attachment with the fuselage lower skin.

**Fig. 08 - Nose gear support bracket detached from fuselage lower skin**

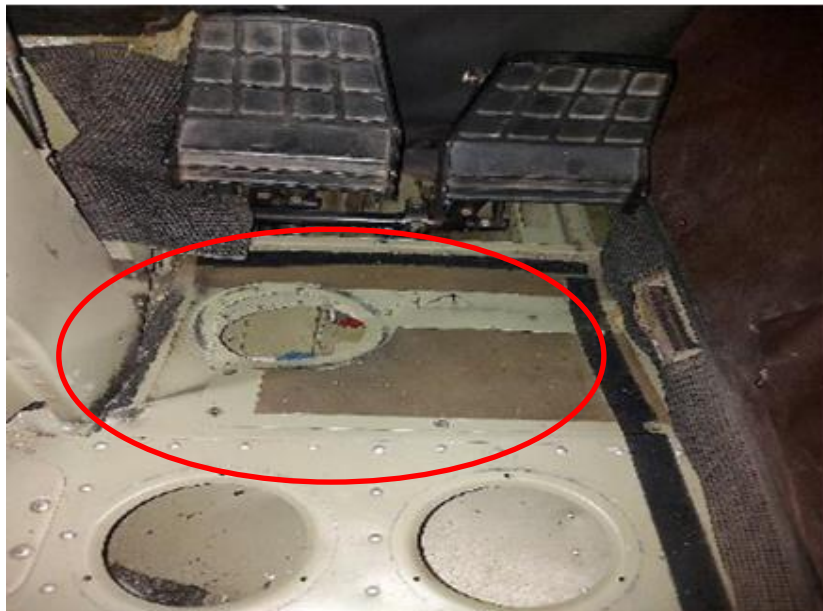
- 1.3.9 Cabin forward floorboard** - Cabin's forward floorboard was wrinkled.

**Fig. 09-Cabin forward floorboard wrinkled**

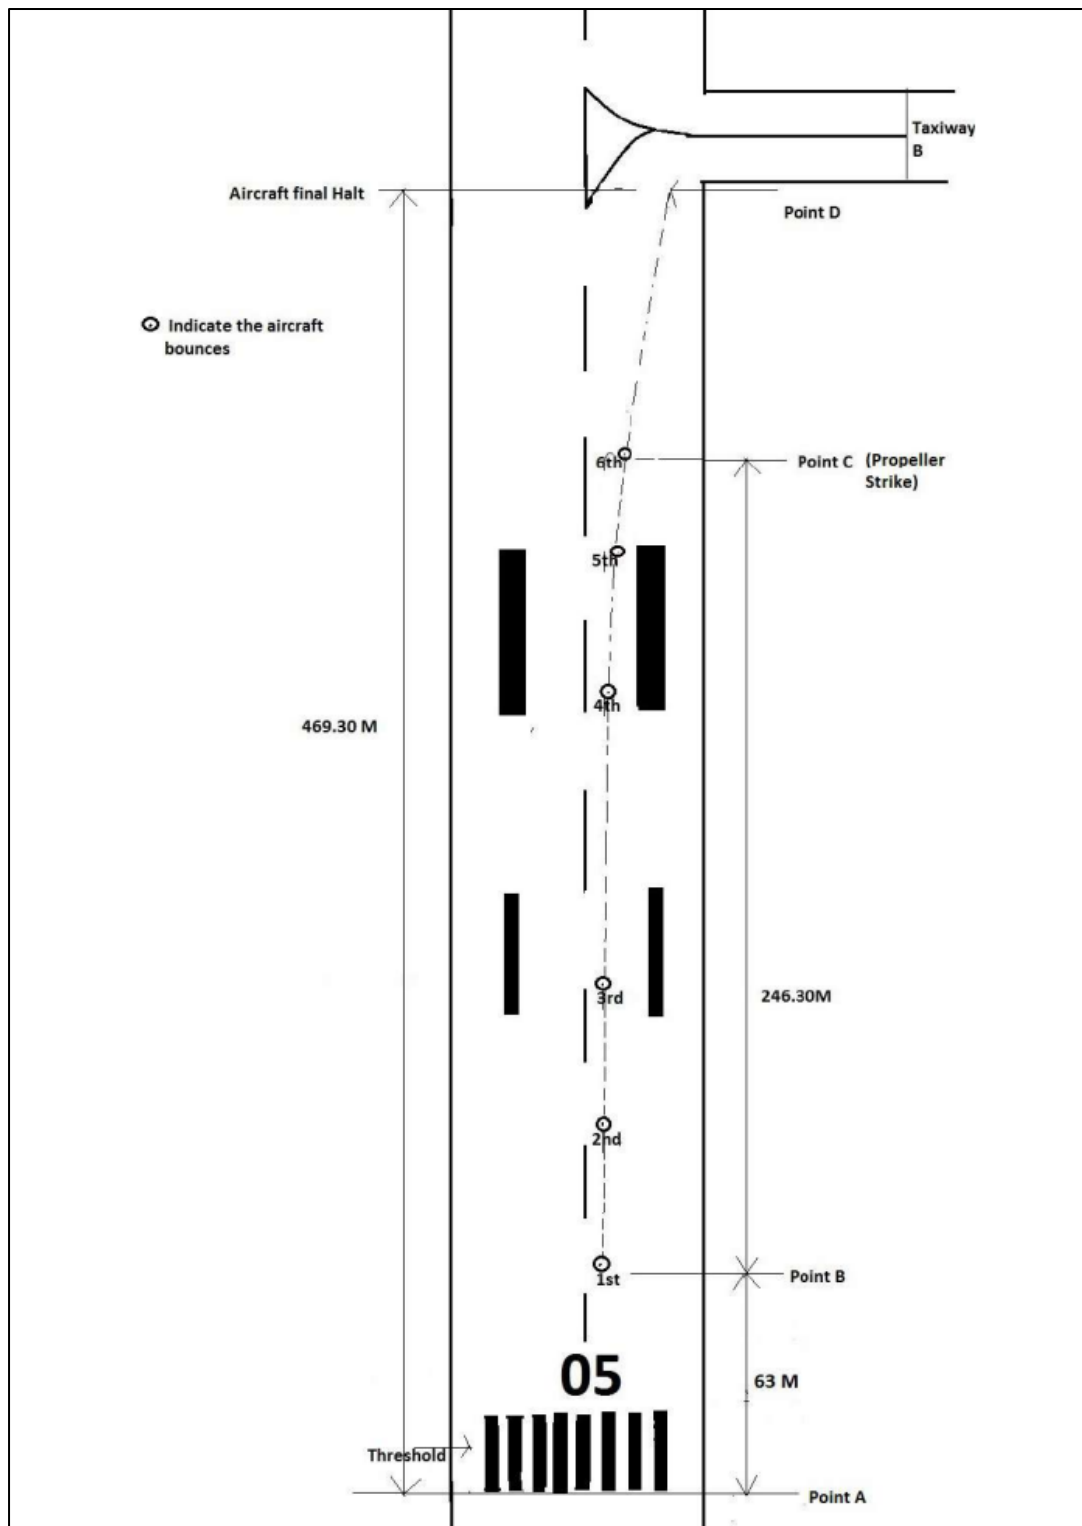
Fig. 10 – Path followed by aircraft on runway 05

- The distance between the threshold point of runway 05 and the aircraft touchdown Point is 63 m.
- The distance between the aircraft touchdown Point and propeller strike point is 246.30 m.
- The distance between the threshold point of runway 05 and the propeller strike point is 309.30 m.
- The distance between the propeller strike point and the aircraft stop point is 160 m.
- The distance between the propeller strike point and the centerline of the runway is 3 m toward the right side.
- The distance between the threshold point of runway 05 and the aircraft stop point is 469.30 m.
- The distance between the aircraft's final halt point and the centerline of the runway is 9.40 m toward the right side.

Refer the Runway Figure 10 describing the approximate path followed by the aircraft during the landing roll up to the final halt point:

- a) Point A – Threshold Point of the runway 05
- b) Point B – Initial touchdown Point of the Incident aircraft
- c) Point C – Propeller strike point
- d) Point D – Aircraft stop point
