BUILDING AND TIMBER PEST REPORT

45 Jean St
Woodridge, QLD 4114

Before You Buy BYB
08/08/2024

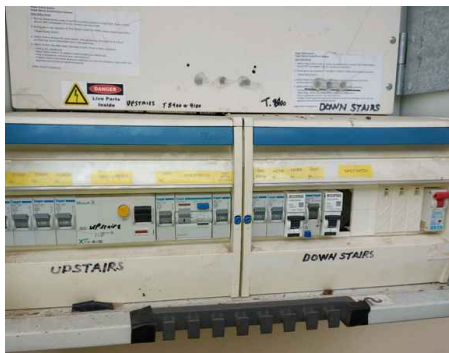
Electrical : Safety Switch Observed

A safety switch was observed, but not tested. It is recommended that the electrical system is fully inspected by a qualified electrician prior to use

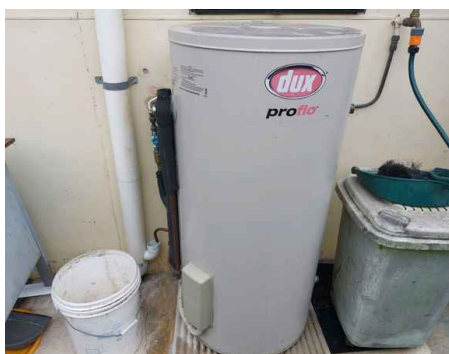
**Hot Water Service: Hot water provided by:**

Electric Water Heater (Tank)

No specific tests were carried out. No determination has been made as to the compliance, suitability or adequacy of the hot water system in relation to capacity, function or lifespan.

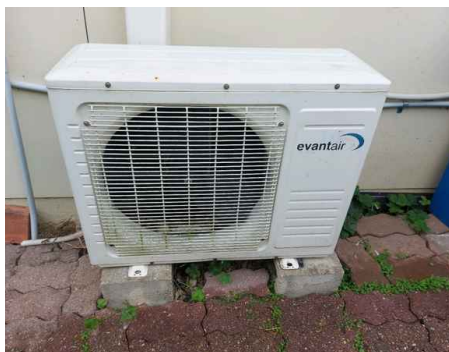
**Air Conditioning: Air Conditioning Installed**

Air-conditioning is installed to the property but has not been tested/inspected. We recommend a licensed air conditioning specialist to determine the status of the units.

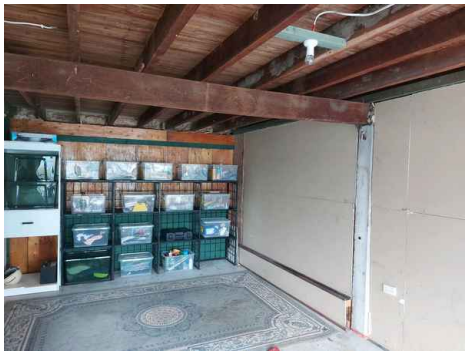
Linings to the subfloor limited the observable area.

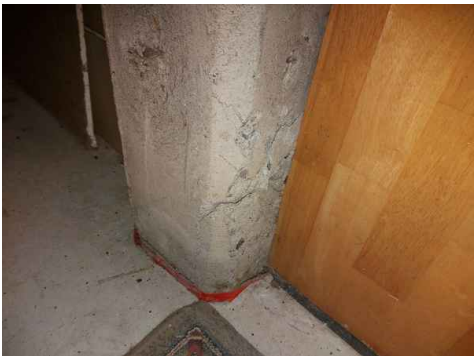
8.2.1 Stumps/Posts/Piers

CRACKED CONCRETE PIERS

Cracks/repairs to concrete pier/s were observed. This is often caused by corrosion of steel reinforcement, but may be caused by other factors.

Note: Corrosion of steel reinforcement is informally known as concrete cancer. Steel reinforcement corrodes when it is too close to the external surface of a concrete pier or brick pier. The effect is similar in both cases. The products of corrosion, rust, have a greater volume than the original steel. The steel grows in volume and pushes outwards. This causes the concrete or brickwork to crack. The cracks allow more air and more moisture into the pier. The corrosion process continues and accelerates.

Consult a structural engineer or qualified Re-stumper to determine any repairs or replacement required.

Contact a qualified structural engineer.

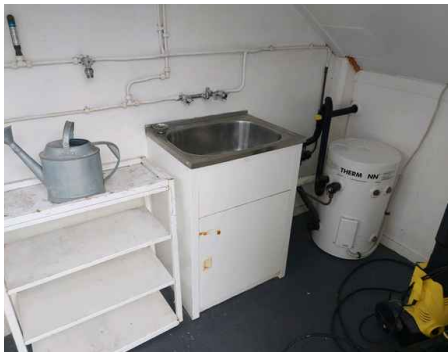
General: Deteriorated fixtures/cabinet

The fixtures are showing signs of deterioration. Maintenance, repairs or replacement are recommended.

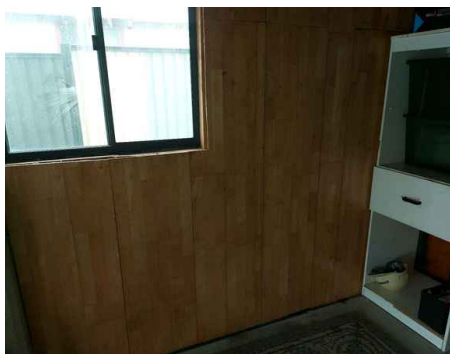
Australian Standard AS 3660 recognises that barriers shall not be bridged by structures attached to the main building e.g. steps, verandahs, access ramps, claddings, carports, or trellises unless alternative barriers are used to prevent access by termites to the structure.

Where bridging is noted below, consult a termite specialist/builder to rectify the condition, or alternative protection.
